DTB

Date: April 23, 2009
 Order No.: S-B-03.30/08i
 Supersedes: S-B-03.30/08h dated October 24, 2008
 Group: 03

SUBJECT: Model 164.156/172/186/871/886
Model 171.454/456
Model 203.052/054/056/087/092
Model 204.054/056/081/987
Model 209.356/372/456/472
Model 211.056/072/087/090/256/287
Model 216.371/386
Model 219.372
Model 221.171/186
Model 230.471
Model 251.156/165
Equipped with M272 or M273 Engine
Check Engine Light On / Fault Codes Current and/or Stored in ME-SFI Control
Module / Oil Leaking at Camshaft Adjustment Solenoid

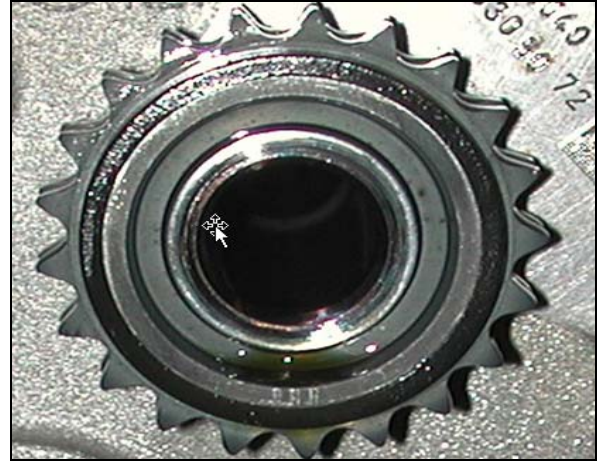
Figure 4 – **New Gear** (comparison) S-B-03.30/08i

Fault Code Scenario 1: DTC 1200 and/or 1208 is/are present in ME-SFI control module. The fault codes are recorded as current and/or stored in the fault memory. When the fault memory is erased and the engine is restarted, the fault codes reoccur immediately. This is due to the positioning of the timing chain driven camshafts relative to the crankshaft and can be caused by a worn sprocket on the balance shaft on engine M272 or by a worn guide (idler) gear for the timing chain on engine M273. Figure 1, 2 and 3 show extremely worn sprocket gears. Figure 4, for comparison, shows a new sprocket gear.

i **Note:** Refer to Figure 1 through 3 for examples of damaged / worn sprocket profile. Refer to Figure 4 for example of a new gear (for comparison).

- b) Only if worn (sprocket teeth profile damaged), replace the balance shaft on engine M272 or replace the guide (idler) gear of the chain drive on engine M273 as per WIS instructions AR03.20-P-1000* (* - applies to a specific model designation e.g. AR03.20-P-1000VA – model 171).
