John Dahlquist June 19, 2014 Version 3

With direct injection system for engines 157, 276, 278 (for example) the spark plug indexing is very critical as indicated in the picture and the warning information in WIS when replacing spark plugs.

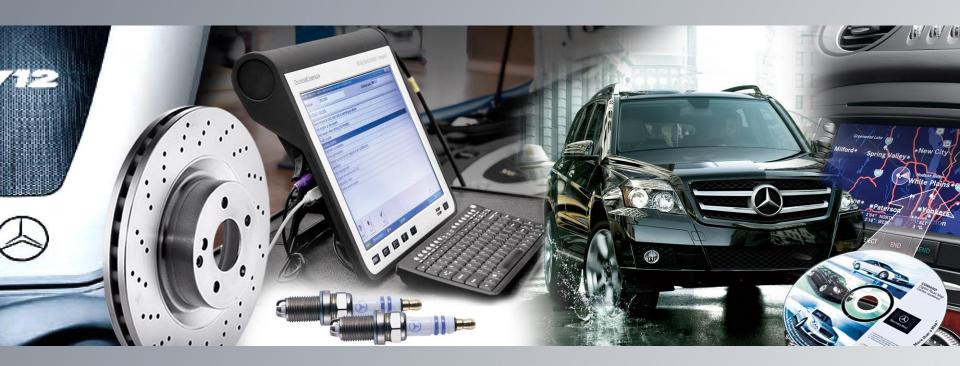
- Special spark plug
- Open side of electrode facing the injector
- Specific plug thread length
- Close-fitting requirement
- Specified torque must be observed

Installation: It is essential to adhere to the tightening torque as it influences the position of the spark plug electrodes in the cylinder.
