1999 W210

21 May 2021

252,011 kilometers

-Passenger side front door lock assembly failed so door would not close. Replaced with new 202-720-44-35. \$237 w/tax.

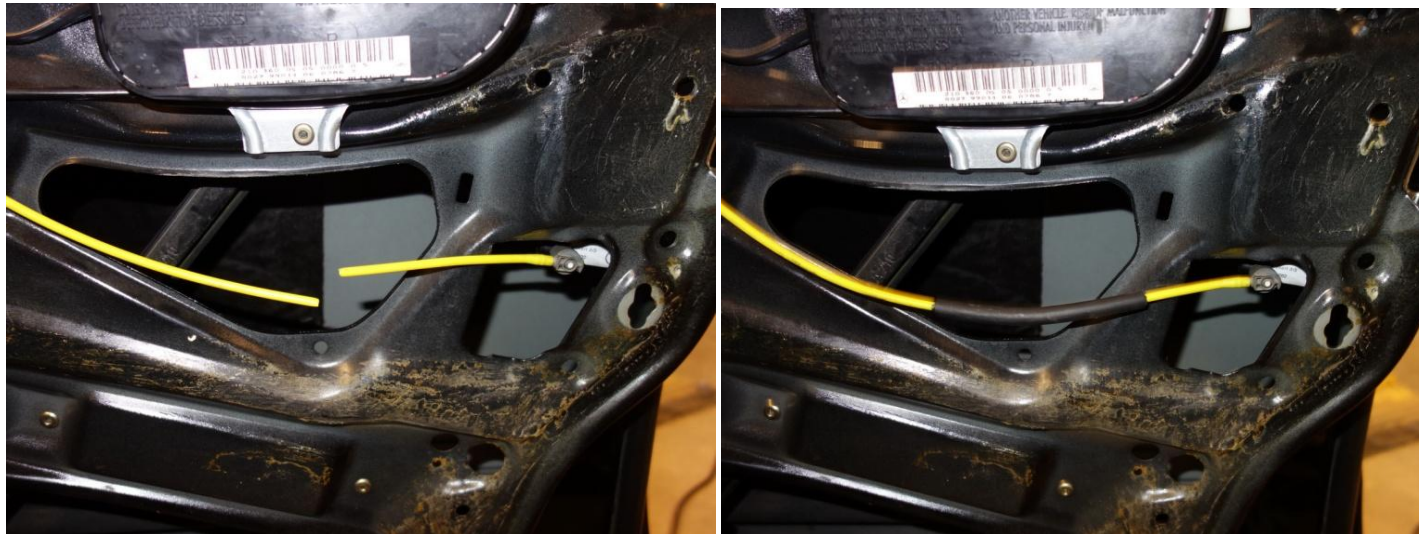
- Window in closed position.
- Disconnect battery negative cable at rear seat.
- No need to remove or disconnect air bag on this 1999 W210.
- Note: Rather than risk breaking the vacuum line connector, I find it easier to cut the line, remove the connector after removal of the lock assembly, then use vacuum tubing to reconnect the yellow hard line.
