Service Campaign Bulletin

Campaign No. 2005020003
April 2005

SUBJECT: **MODELS 163, 202, 208 210 WITH ENGINES 112,
MODELS 129, 163, 202, 208 210 215, 220 WITH ENGINES 113,
MODEL YEARS 1998 – 2000;
MODEL 170 WITH ENGINE 112, MODEL YEAR 2001
INSPECT, IF NECESSARY REPLACE HARMONIC BALANCER PULLEY**

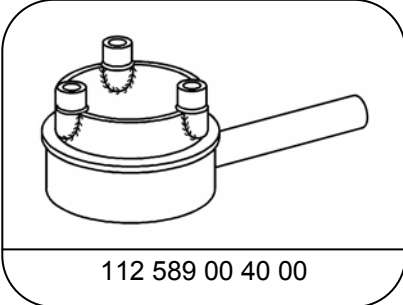
Special Tools

Please inspect your Special Tool 112 589 00 40 00 Counter Holding Tool for harmonic damper pulley (front of crankshaft) and assure that the three aluminum sleeves are in place and are in good condition. Note that replacement sleeves are available and can be ordered using the Special Tool Number: 112 589 00 40 01
