TO: Mercedes-Benz Dealer Principals, General Managers, Sales Managers, Service Managers, Parts Managers	FROM: Thomas Brunner, Department Manager, Vehicle Compliance and Analysis, Engineering Services
RE: Service Campaign 2016090006 Model 204 (C-Class) MY 2008 - 2009 Replace Driver-side and Passenger-side Airbag	DATE: January 6, 2017

Campaign No. 2016090006, **January** 2016

SUBJECT: **Model 204**
Model Years 2008 and 2009
Replace Driver-Side and Front Passenger Air Bag

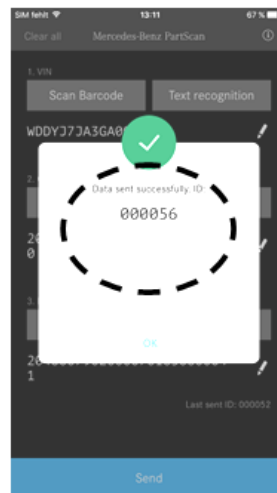
Figure 5

- Record the generated scan ID (Figure 5) on the repair order.
- The warranty claim must include generated scan ID (Figure 5) in the DTC field in NetStar.
- If parts scan app process fails document old part number, new part number and serial numbers for both parts manually on repair order include: “App submission error” on RO in warranty claim text.

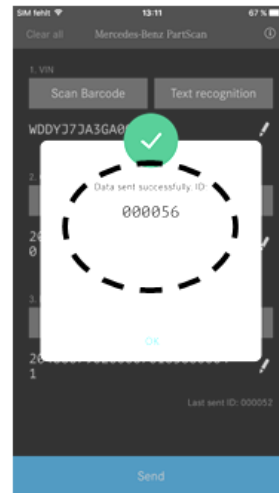
Figure 19

- It is not necessary to check the SRS system with Xentry diagnosis.
- Record the generated scan ID (Figure 19) on the repair order.
- The warranty claim must include generated scan ID (Figure 19) in the DTC field in NetStar.
- If parts scan app process fails document old part number, new part number and serial numbers for both parts manually on repair order include: "App submission error" on RO in warranty claim text.

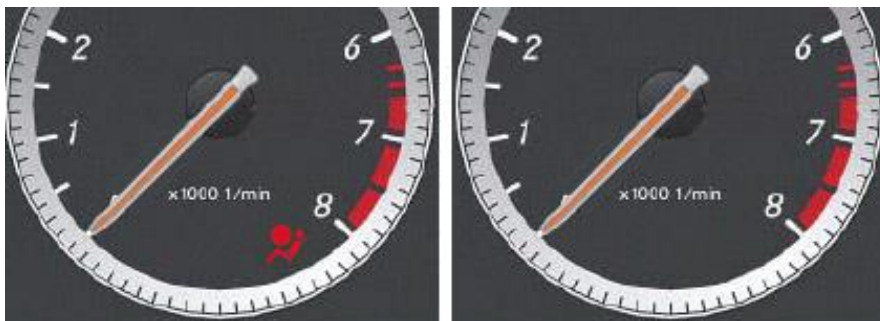
Figure 20 (shown on model171)

22. After installation of new airbag be sure to start engine and check whether SRS indicator lamp goes out after a few seconds (Figure 20).
