Document title General information on inspecting cylinder walls

Document number ah0100p030001a

General information on engines with cast iron cylinder barrels

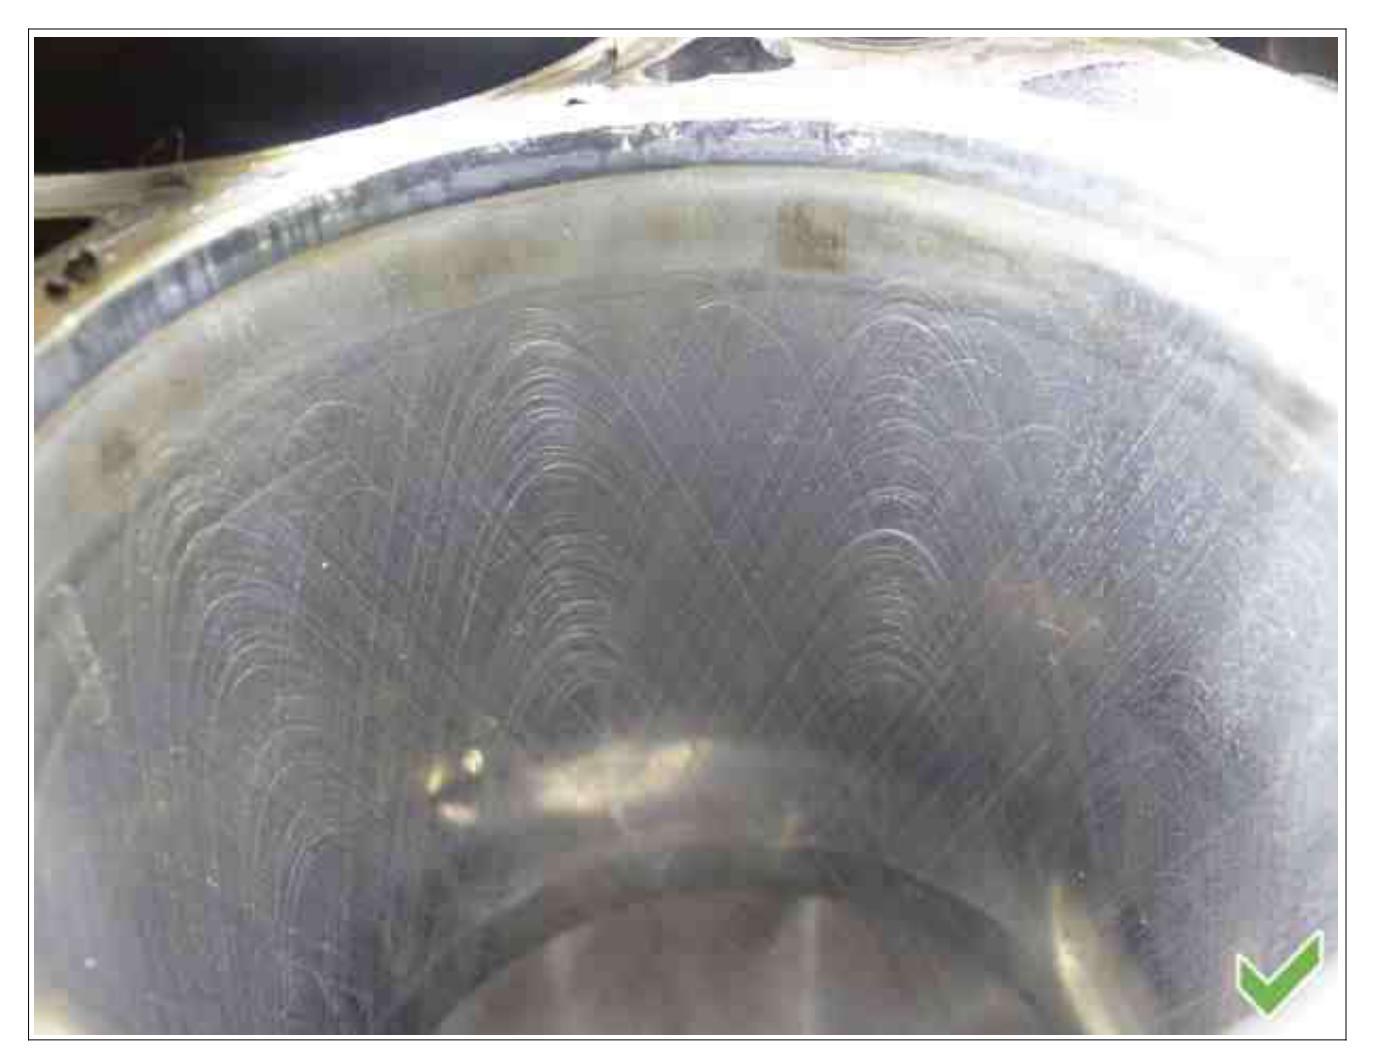
P01.00-3697-76

Ideal condition (for engine 622/626) Parabolic cut marks from honing clearly visible on cylinder wall. i Reuse crankcase.
