## 7G-TRONIC (722.9) in the Workshop Tips and Tricks

Service Information Brochure

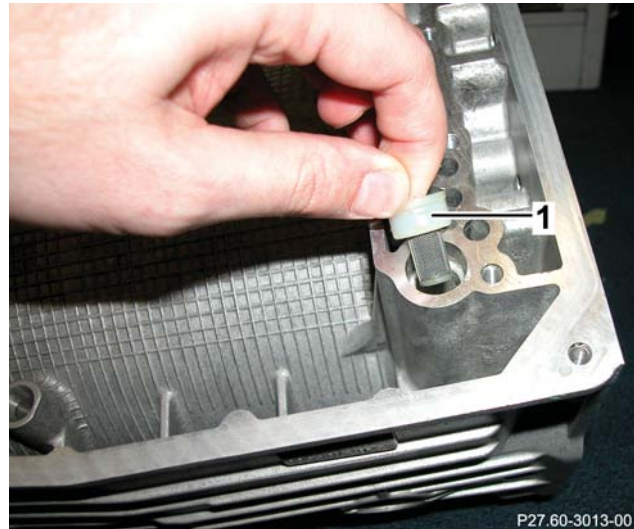
1 Converter return flow strainer  
**Electrohydraulic controller unit removed, front of transmission housing, on left in direction of travel**

Clean valves:

- 1 Unscrew bolt
- 2 Remove tension spring
- 3 Remove both valves (torque converter lockup clutch valve and working pressure control valve)
- 4 Carefully remove particles from fine-mesh filter using a cloth
- 5 Insert valves
- 6 Insert tension spring
- 7 Tighten bolt to 9 Nm

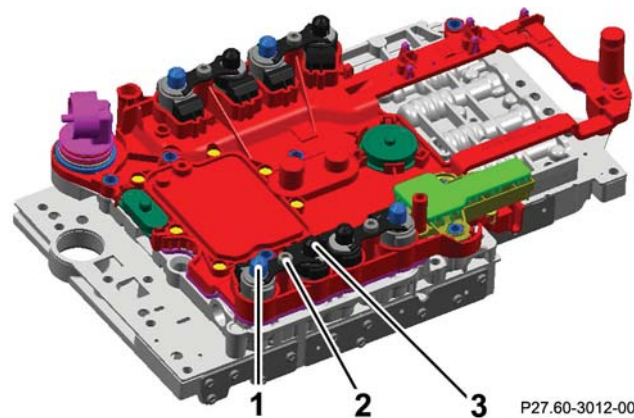
1 Torque converter lockup clutch valve  
2 Bolt  
3 Working pressure control valve  
**Clean torque converter lockup clutch valve and working pressure control valve**

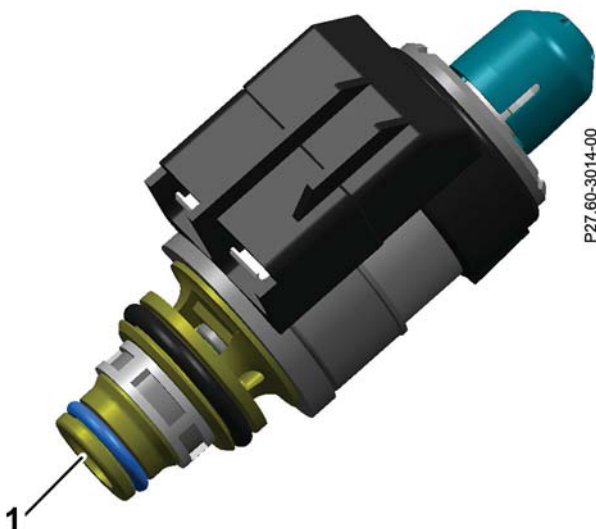
#### Valve

- 1 Fine-mesh filter

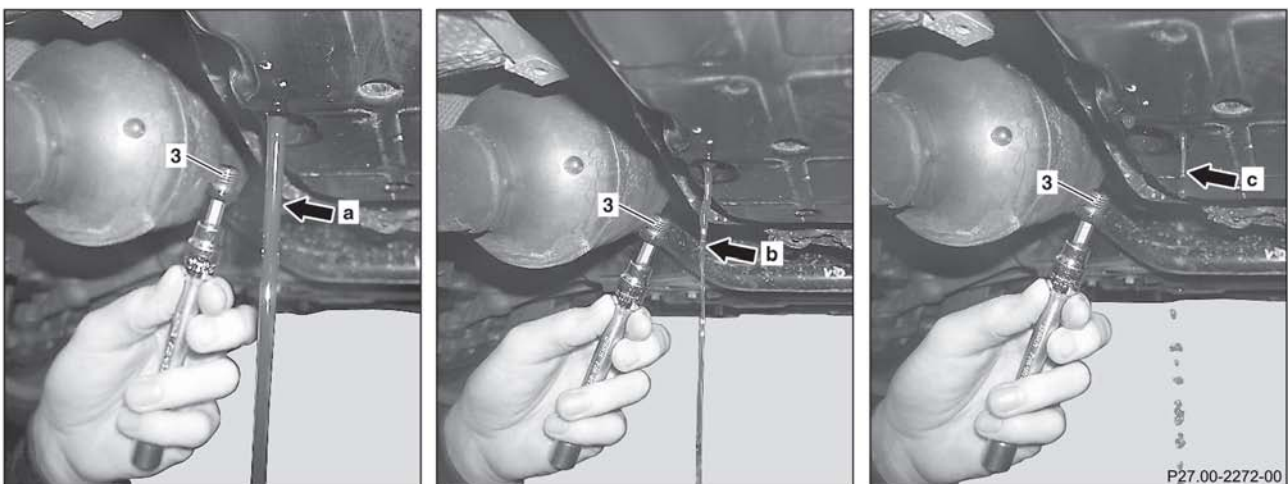
If more than 0.3 l of oil is required to reach the state indicated by arrow b, the oil level was outside the tolerance.

**Inspect oil level, adjust to correct level if necessary**

- a Transmission oil level is OK with this flow rate
- b Transmission oil level is OK with this flow rate

- c Transmission oil level must be corrected and re-checked with this flow rate
- 3 Oil drain screw

The transmission oil level is then adjusted to the center of the tolerance range. If the oil level was previously at the OK level on the drawing, it is possible that only 0.1-0.2 l of transmission oil was added. In this case, the transmission was **not underfilled** previously even though no oil ran out.
