Document title Evaluation of elastomer bearings

Document number ah0010p000101a

MODEL ALL

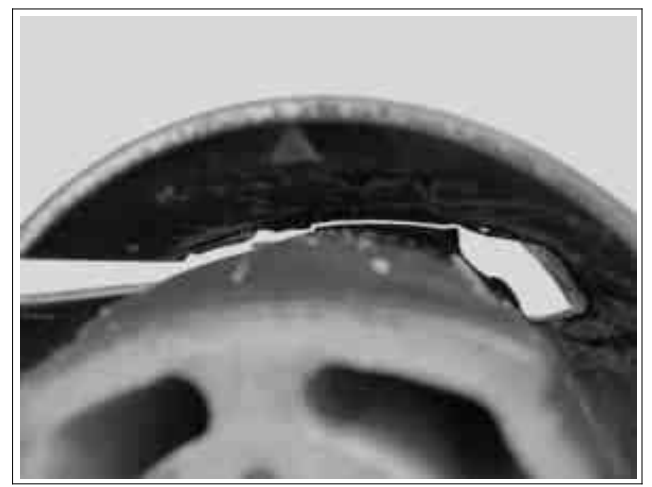
P35.10-2465-01

Component OK

During the manufacture of bearings, certain production methods or tools may cause a film to be left after injection molding.

This injection molding film can vary in its extent.

It does not represent a technical problem and should not be considered defective.
