7G-TRONIC (722.9) in the Workshop Tips and Tricks

Service Information Brochure

Order no. of this publication: 6516 1356 02

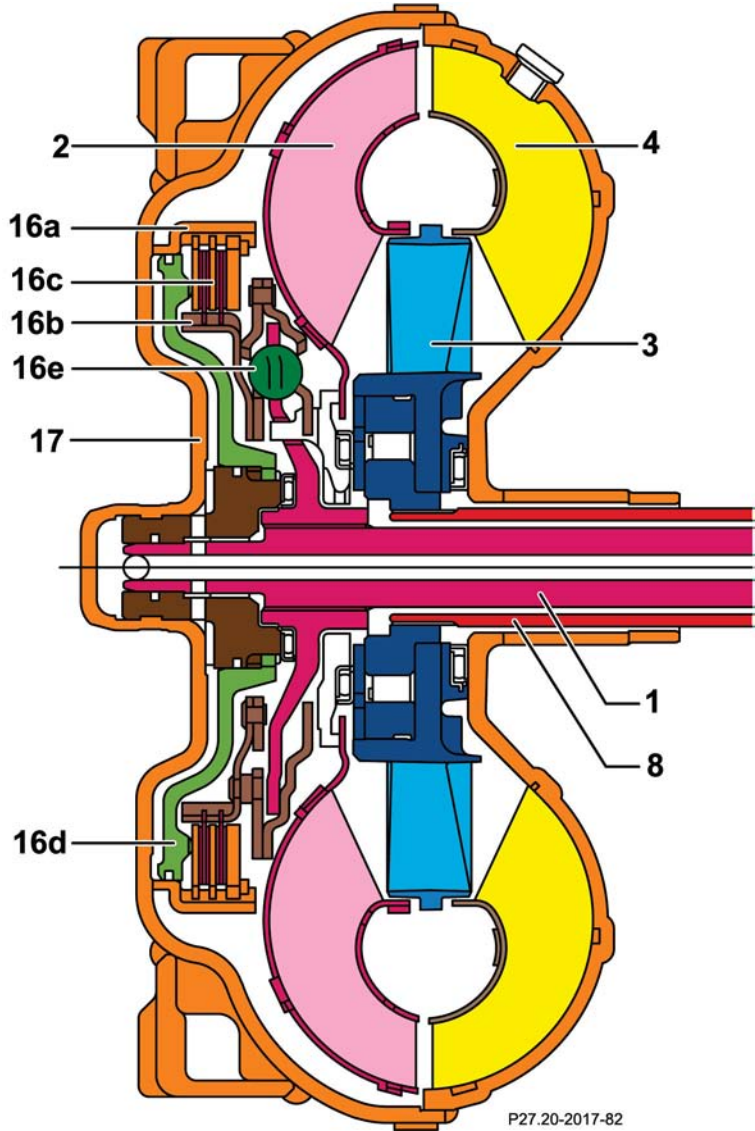
Torque converter lockup clutch (KÜB)

The cause of this may be:

- The disks of the lockup clutch are worn.
- The friction value of the disks has changed.
- Hydraulic actuation is not possible.

If there is a significant amount of wear debris in the transmission oil pan (see picture), it must be assumed that the torque converter lockup clutch is already seriously damaged.

In this case, it is recommended that the entire transmission including torque converter be replaced because the shavings will have spread out within the transmission. In addition, the oil cooler must be flushed. If an additional oil cooler with thermostat is installed, this must also be replaced because it cannot be flushed (thermostat does not open until temperature of approx. 85 °C is reached).

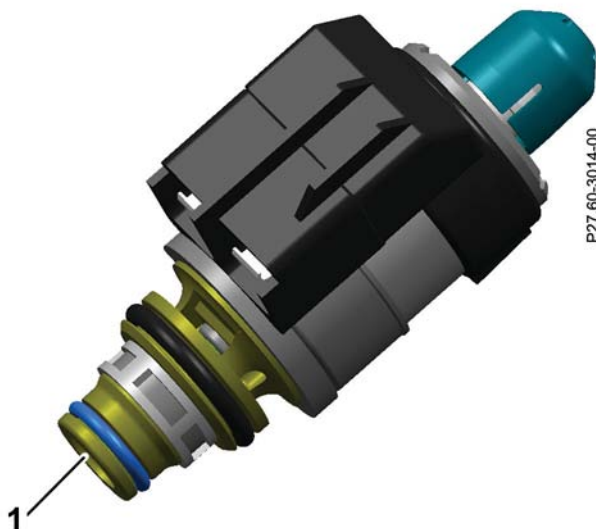
Valve

- 1 Fine-mesh filter

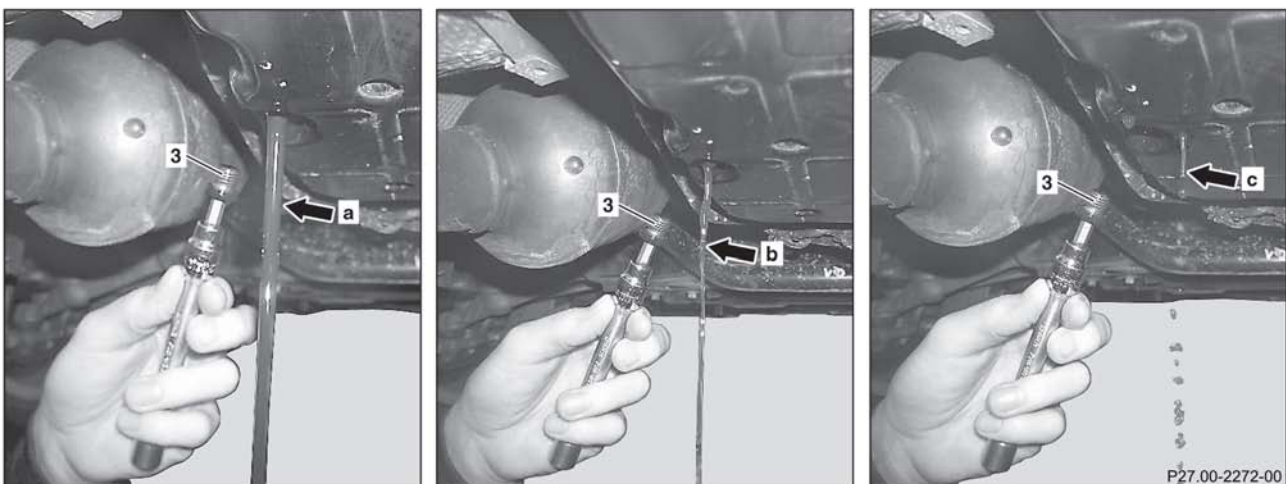
Inspect oil level, adjust to correct level if necessary

The transmission oil level is then adjusted to the center of the tolerance range. If the oil level was previously at the OK level on the drawing, it is possible that only 0.1-0.2 l of transmission oil was added. In this case, the transmission was **not underfilled** previously even though no oil ran out.

If more than 0.3 l of oil is required to reach the state indicated by arrow b, the oil level was outside the tolerance.

- a Transmission oil level is OK with this flow rate
- b Transmission oil level is OK with this flow rate

- c Transmission oil level must be corrected and re-checked with this flow rate
- 3 Oil drain screw
