~~2000 Mercedes Benz Truck ML 320 (163.154) V6-3.2L (112.942)~~

Campaign - Catalytic Converter Inspection/Replacement

Campaign No. 2005060014, September 2005
Revised November 2005

INSPECT CATALYST WELDS AND REPLACE [CATALYTIC CONVERTER](#) IF NECESSARY

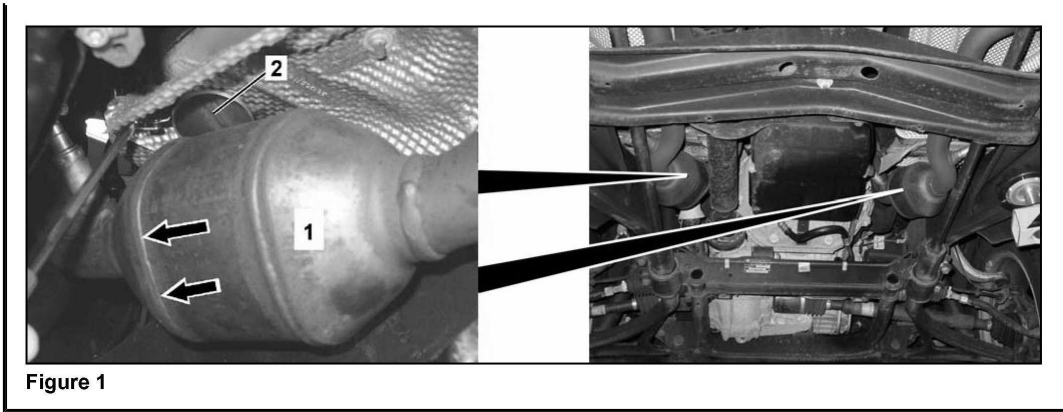
2. Visually inspect catalytic converter (1 Figure 1) for cracks and/or black exhaust residue at weld seam (arrows).

Note :Use mirror (2) to inspect upper surfaces. If cracks (3, Figures 2, 3) and/or black exhaust residue are present at weld seam proceed to subject

^ Hairline cracks on top welds of [catalytic converters](#) may be very difficult to detect during the visual inspection. Therefore, ensure this area is well illuminated when inspecting with mirror.

C: Replace [catalytic converter](#)/front exhaust system.
