# Evaluating Wear on AMG Carbon-Ceramic Rotors

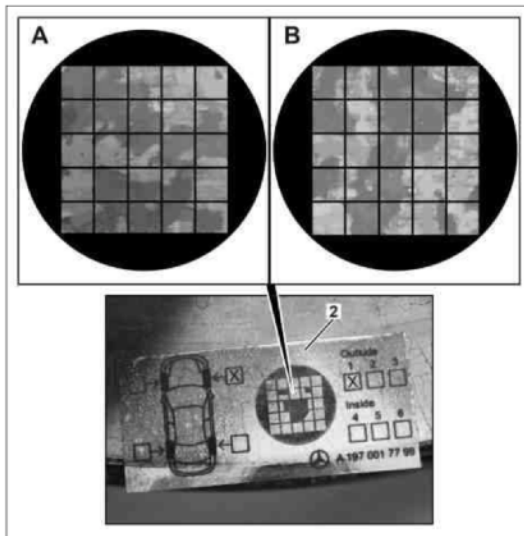
The WIS reference/example of "light points" is given by the following graphic and provides an example that's oversimplified, inadequate and leaves actual wear-indicator pictures very much open to interpretation.
