Service Campaign Bulletin

Campaign No. 2015050004, August 2015

SUBJECT: **Model 222 (S-Class), Model Year 2014 - 2015**
Check Radiator Fan, Replace If Necessary

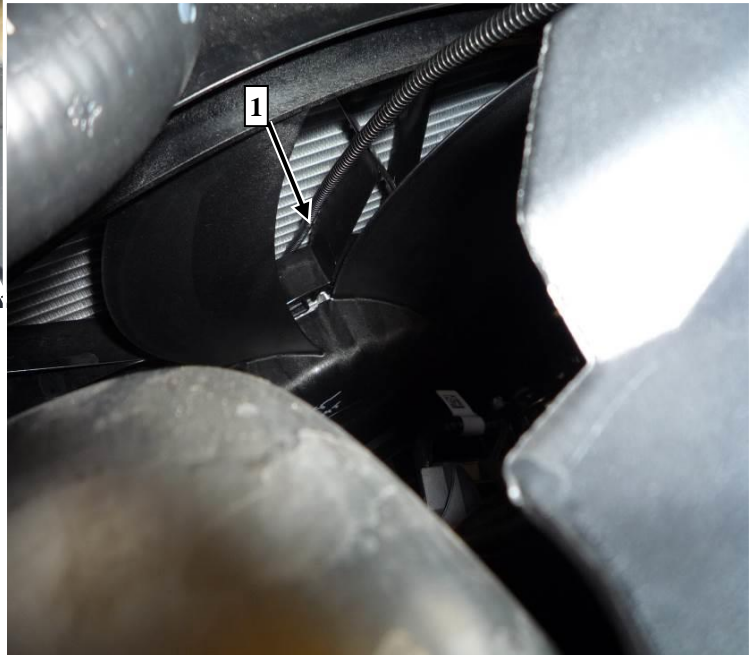
- If production date *is not* as of 2013-04-22 up to and including 2013-05-08 or as of 2013-10-11 up to and including 2013-10-15 (OK): Procedure is complete
- If production date *is* as of 2013-04-22 up to and including 2013-05-08 or as of 2013-10-11 up to and including 2013-10-15 (NOT OK): Proceed to step 2.

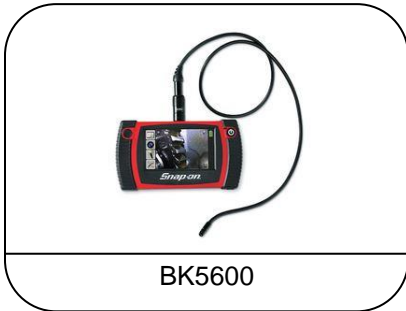
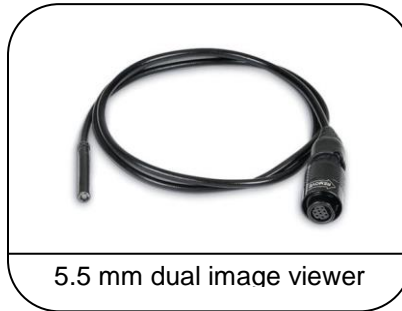
Snap-On ® BK5600 Borescope *
