Model 213, 238

Operation step 2

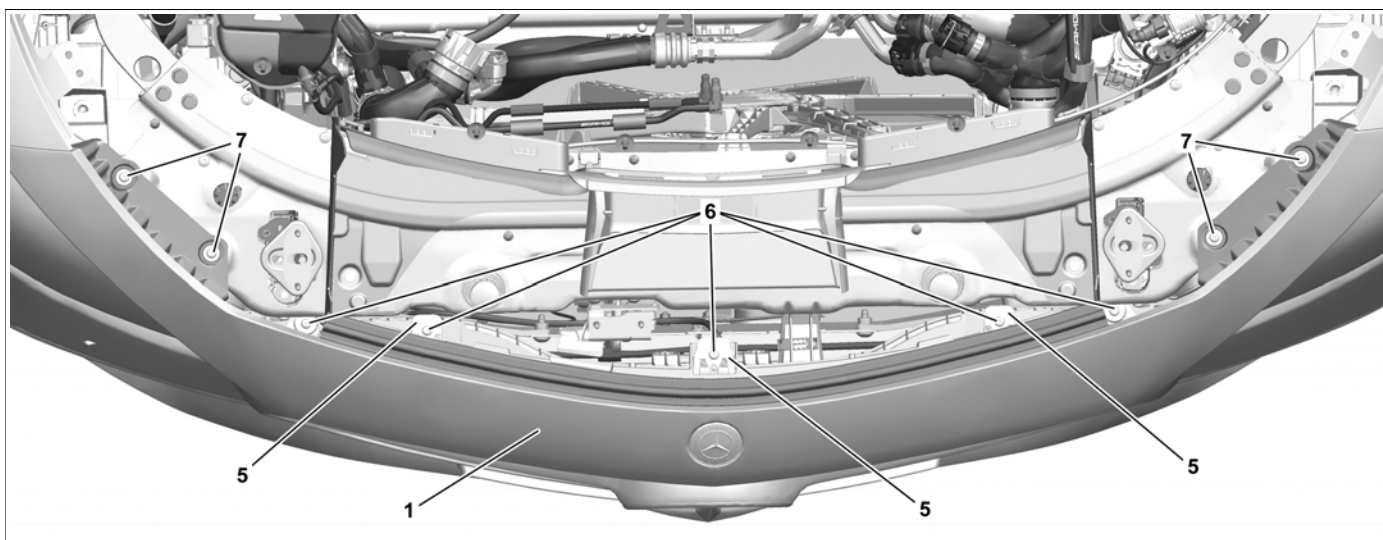
P88.20-4739-08

Shown on model 213.088

- 1 Front bumper
- 5 Catch hook

- 6 Bolts
- 7 Bolts

Information on preventing damage to electronic components due to electrostatic discharge		AH54.00-P-0001-01A
	Remove/install		
1	Disconnect battery ground line	Model 213 Model 238	AR54.10-P-0003LW AR54.10-P-0003LWO
2	Remove Mercedes star	Model 213, 238 with code 233 (DISTRONIC PLUS) Model 213, 238 with code 239 (DISTRONIC PLUS)	AR88.40-P-4050LW
3	Remove wheel arch liner from front fenders	Model 213.2 with code M035 (Allroad version)	AR88.80-P-0005LWT
4	Remove front engine compartment paneling		AR61.20-P-1105LWE
5	Remove fender liner in left and right front fender from front bumper (1)		AR88.10-P-1300LWE
6	Remove bolts (2) on left and right of front bumper (1)		
7	Remove bolts (3) on left and right of front bumper (1)		
8	Disconnect front bumper electrical connector (X26/38)		
9	Remove outside temperature sensor (B14) from front bumper (1)		
10	Remove bolts (7)	Model 213.088/089/288/289 Installation: Tighten bolts (7) only after adjusting the gap dimensions.

11	Remove bolts (6)	Installation: Tighten bolts (6) only after adjusting the gap dimensions.	
12	Unlock catch hooks (5) and remove	Installation: Press in catch hooks (5) only to first catch.	
13	Disconnect electrical connector from 360° camera at front	Model 213, 238 with code 501 (360° camera)	
14	Disconnect electrical connector from AIRPANEL	Model 213 with code 5U3 (AIRPANEL)	
15	Remove front bumper (1)	Helper required.	
	Check		
	General information on the impact absorber		AR88.20-P-1000-01A
