MODELS 211.0 /2 /6 up to 14.6.04 with CODE (581) Convenience automatic air conditioning

M2/9 Right defroster vent flap actuator motor

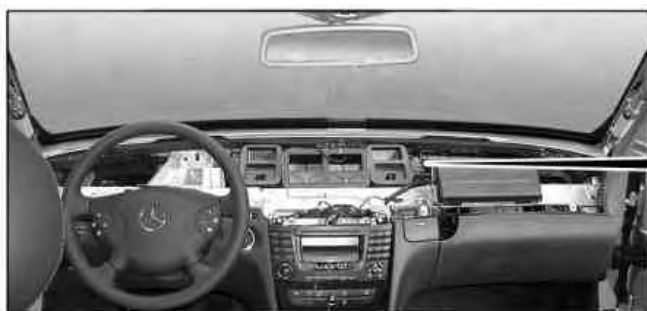
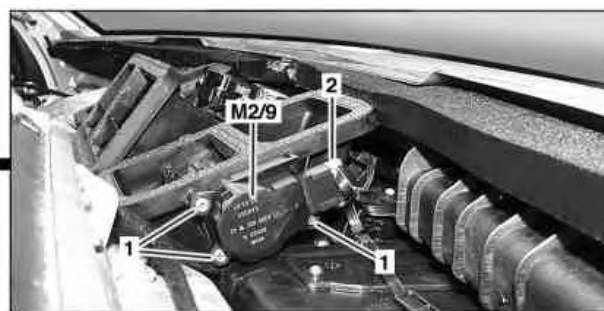
P83.10-2279-07

1 Bolts

2 Electrical connector

Remove/Install		
1	Remove top section of instrument panel		AR68.10-P-1020T
2	Remove bolts (1)		
3	Remove right defroster vent flap actuator motor (M2/9) and disconnect electrical connector (2)	Installation: When replacing the right defroster vent flap actuator motor (M2/), the position of the axle shaft of the right defroster flap must match the position of the right defroster vent flap actuator motor (M2/) actuator drive.	
4	Install in the reverse order		
5	Synchronize the actuator motors	Menu item, Actuation, Normalization of actuator motors	
	Connect STAR DIAGNOSIS and read out fault memory	STAR DIAGNOSIS diagnosis system	AD00.00-P-2000-04A *WH58.30-Z-1048-13A
