MODEL 211.2 except CODE (489) AIRmatic (semi-active air suspension)

MODEL 211.6

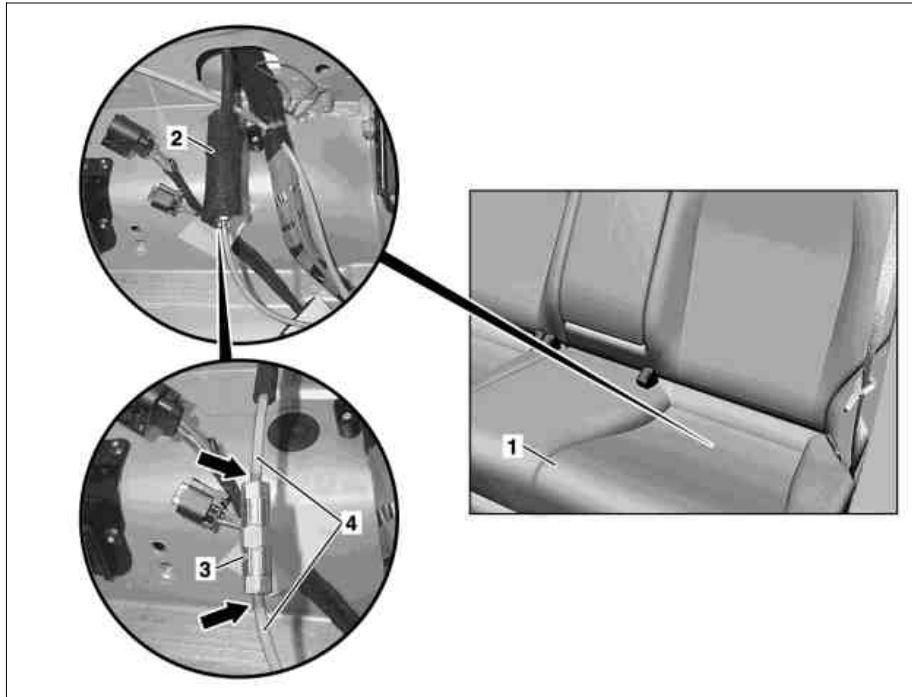
P32.22-2265-06

- 1 Rear seat cushion
- 2 Felt casing
- 3 Pressure line connector
- 4 Pressure lines

| 2 | Remove felt wrapping (2) from pressure line connector (3) and check if pressure lines (4) are inserted up to markings (arrows) in pressure line connector (3). | | |

| 3 | Spray leak detection spray onto pressurized line connection fitting (3) | <p>i Wait approx. 10 to 15 minutes after spraying. Minor leakages can be detected as a result (formation of a foam crown). Larger leaks are visible immediately. If pressurized line connection fitting is defective:</p> <p style="text-align: center;">↓</p> <p>Repair supply line connection for air suspension.</p> <p>i Installation: Attach felt casing (2) again after completing the leak test .</p> | AR32.22-P-2001-01T |

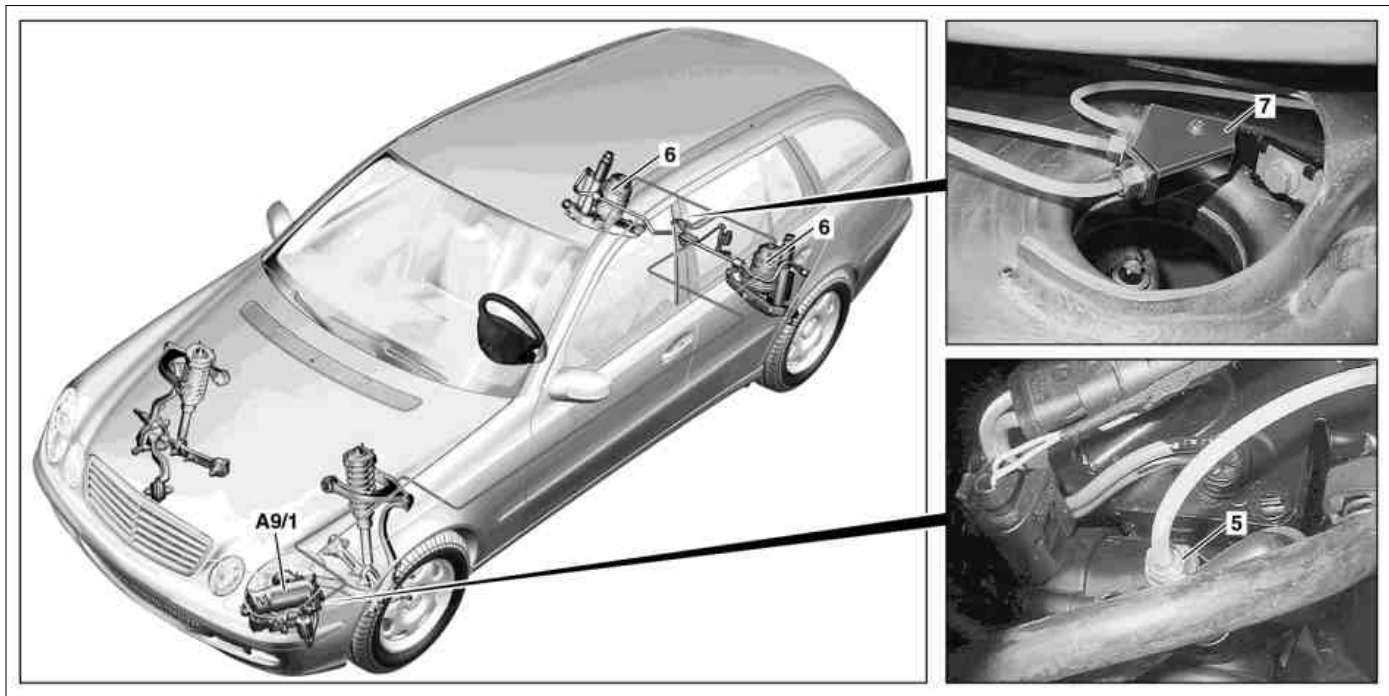
P32.22-2264-09

- 5 Pressure line connection
- 6 Air suspensions

7 Rear axle distributor unit

A9/1 AIRmatic compressor unit

| 5 | Spray leak detection spray onto pressurized line connection fitting (5) on AIRmatic compressor unit (A9/1) | <p>i Wait approx. 10 to 15 minutes after spraying. This allows smaller leaks to be detected (bubbles form). Larger leaks are visible immediately. If pressurized line connection fitting is defective:</p> <p style="text-align: center;">↓</p> <p>Repair supply line connection for air suspension.</p> | AR32.22-P-2001-01T |
| 6 | Spray leak detection spray onto the air spring (6) and the rear axle distributor unit (7) | <p>i Wait approx. 10 to 15 minutes after spraying. This allows smaller leaks to be detected (bubbles form). Larger leaks are visible immediately. If pressurized line connection fitting is defective:</p> <p style="text-align: center;">↓</p> <p>Repair supply line connection for air suspension.</p> | AR32.22-P-2001-01T |
