AR83.30-P-2006GH	Remove/install defroster vent flap actuator motor for windshield	3.5.01
------------------	------------------------------------------------------------------	--------

MODEL 163.154 /174 #A as of 289565,
163.157 /175

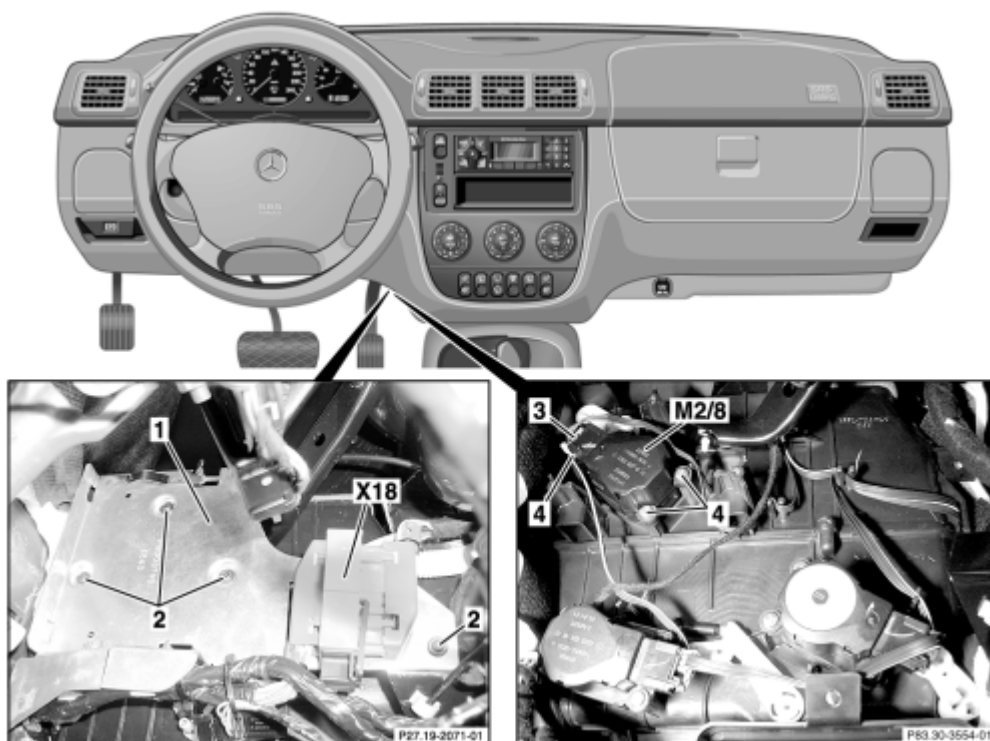
P83.30-3555-06

- 1 Bracket
- 2 Bolts
- 3 Connector
- 4 Bolts

M2/8 Defroster vent flap actuator motor
X18 Interior and taillamp wiring harness
connector, cockpit

Remove/install		
1	Remove cover below instrument panel (left)		AR68.10-P-1500GH
2.1	Remove electronic transmission control (ETC) control module	Only on models fitted with automatic transmission.	AR27.19-P-1719GH
3	Disconnect interior and taillamp wiring harness connector, cockpit (X18) from bracket (1)		
4	Remove screws (2)		
5	Move bracket (1) downwards and put to one side		
6	Disconnect plug (3)		
7	Remove screws (4) on defroster vent flap actuator motor (M2/8) from heater housing		
8	Remove defroster vent flap actuator motor (M2/8)	Installation: Adjust defroster vent flap actuator motor (M2/8) to the 0 position using STAR DIAGNOSIS.	
9	Install in the reverse order
