Engine 642 in model 164, 251

16.03.2016	Motorladeluftkanal nach Ladeluftkühler an Drosselklappensteller		BA09.41-P-1005-01J
------------	---	--	--------------------

Shown on model 164.1

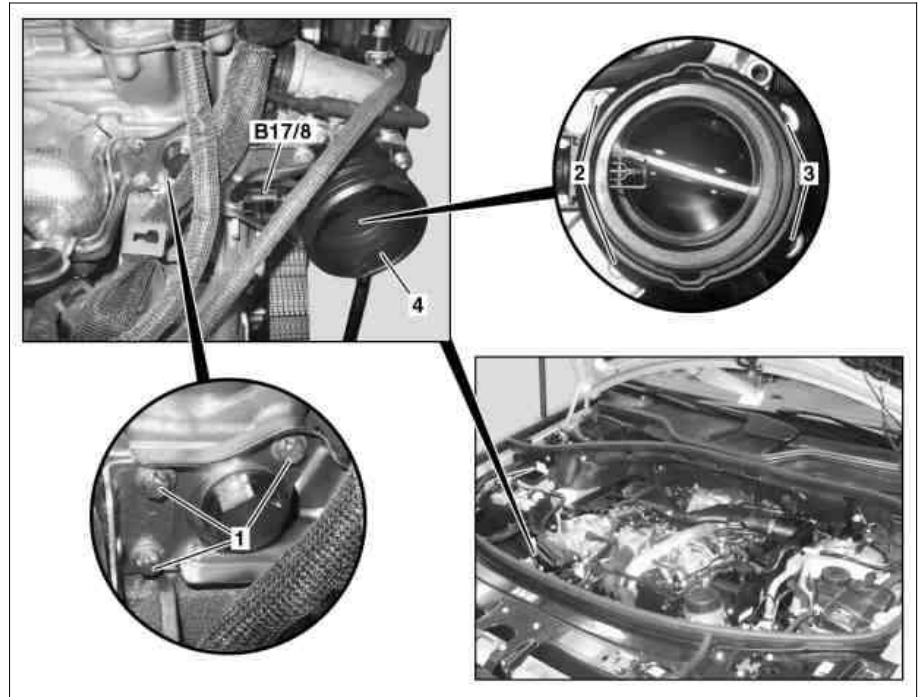
P09.41-2381-06

- 1 Bolts
 2 Bolts
 3 Bolts
 4 Engine charge air duct downstream of charge air cooler
 B17/8 Charge air temperature sensor

9	Remove engine charge air duct downstream of charge air cooler (4)	i Installation: Replace seal.	
10	Install in the reverse order
