MODEL 216

MODEL 221 except CODE (Z07) Top protection

Remove/install

Underbody protection

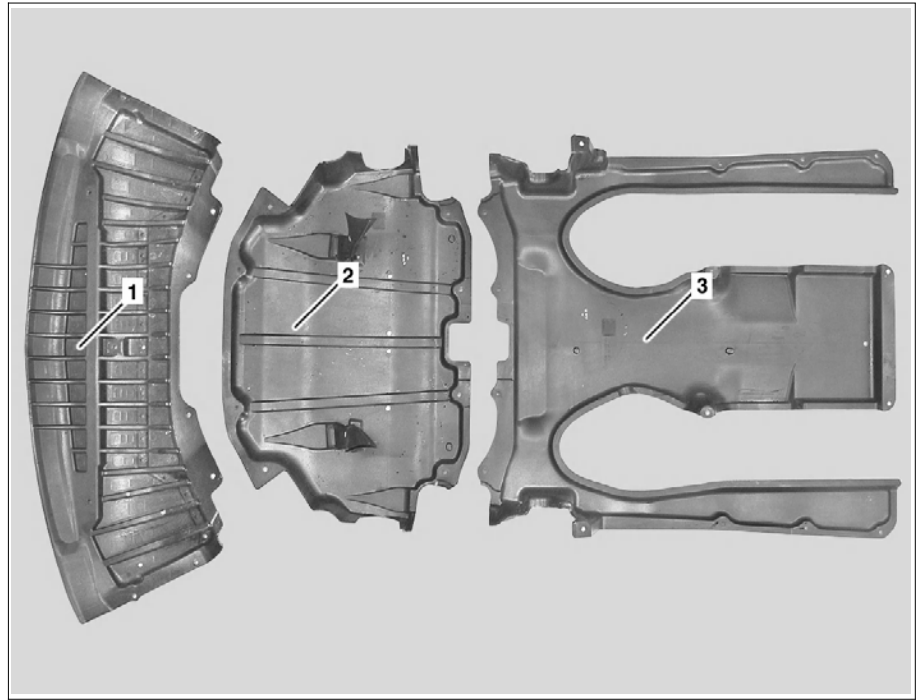
P61.20-2053-06

Shown on model 221

- 1 Front engine compartment paneling
- 2 Center engine compartment paneling
- 3 Rear engine compartment paneling

Danger!	Risk of death caused by vehicle slipping or toppling off of the lifting platform.	Align vehicle between columns of vehicle lift and position four support plates at vehicle lift support points specified by vehicle manufacturer.	AS00.00-Z-0010-01A
1	Raise vehicle with vehicle lift		
2	Remove front engine compartment paneling (1)		
3	Remove center engine compartment paneling (2).

*BA61.40-P-1001-01D
4	Remove rear engine compartment paneling (3).		
5	Install in the reverse order
