ENGINE 642 in MODEL 221

P09.41-2371-06

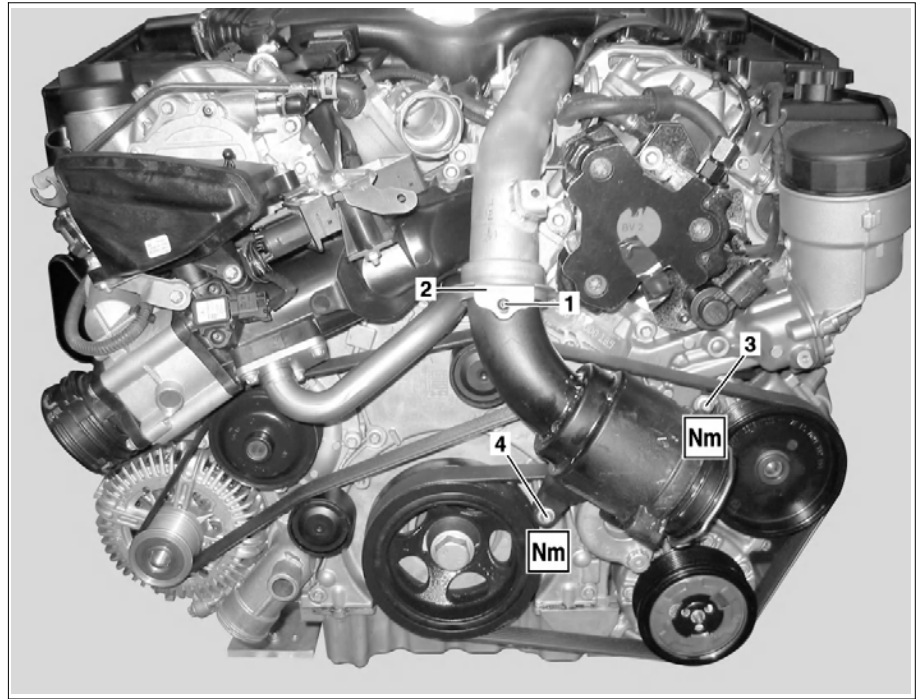
- 1 Bolt
- 2 Retaining plate
- 3 Bolt
- 4 Bolt

| | Remove/install | | |
|--|---|--|---|
| 3 | Unscrew bolt (1) | | |
| 4 | Remove retaining plate (2) towards the front | | |
| 5 | Unscrew bolt (3). | Nm Engine charge air channel upstream of charge air cooler to oil filter housing | *BA09.41-P-1003-01J |
| 6 | Unscrew bolt (4) | Nm Engine charge air channel upstream of charge air cooler to bracket | *BA09.41-P-1002-01J |
| 8 | Pull engine charge air channel upstream of the charge air cooler downwards and remove | | |
