Model 217, 222.0/1/9 up to model year 2018

Modification notes

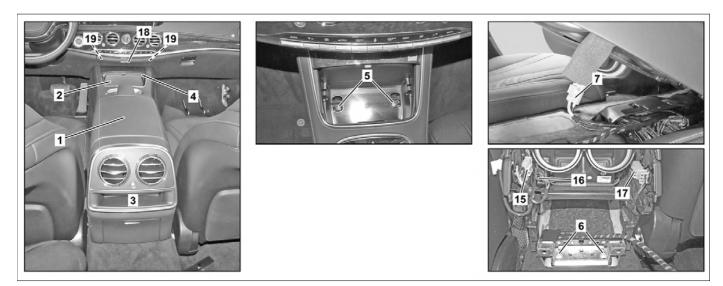
P68.20-4645-08

Shown on model 222 up to model year 2018 except code 582 (Air conditioning system in rear)

- 1 Center console
- 2 Stowage compartment
- 3 Cover
- 4 Cover
- 5 Bolts
- 6 Bolts

- 7 Electrical connector
- 15 Electrical connector
- 16 Electrical connector17 Electrical connector
- 18 Stowage compartment
- 19 Screw

8	Release and disconnect the electrical connections (15, 16, 17).		
9	Open the cover of the center console armrest (1).		
10	Remove the rear center console (1).	Model 217 up to model year 2018	AR68.20-P-2020LC
11	Remove the multimedia connection unit (A90/5) in the front stowage compartment.		AR82.60-P-1032LF
12	Remove cover (8).	Model 217, 222 up to model year 2018 with code 386 (Comfort telephony) Model 222 up to model year 2018 with code 856 (Business telephony in rear passenger compartment) except code 224 (Rear individual seat design)	
13	Remove the soft top control switch (S84).	Model 217.4 up to model year 2018	
			AR77.39-P-1000LCA
14 15	Remove screw/bolts (6).	Model 217	
10	Unscrew the bolts (30).	Model 217 up to model year 2018 Model 222.1/9 up to model year 2018 with code 224 (Rear individual seat design)	
16	Open the stowage compartment (18) on the instrument panel.		
17	Remove screws (19).

18	Release and disconnect the electrical connection on the stowage compartment (18) and remove the stowage compartment (18).

19	Lift the center console (1).	 Press cross strut down on center console (1) below stowage compartment in instrument panel. The cover (4) falls off the COMAND control unit (A40/3) when the center console(1) is lifted. Installation: Clip molding (4) into COMAND control unit (A40/3). Helper required. 	
20	Release and disconnect electrical connector(7).	Model 217 up to model year 2018 Model 222.0/1/9 up to model year 2018 except code 582 (Rear air conditioner)	
21	Release and disconnect the electrical connection for the touchpad on the center console (1).	Model 217, 222.0/1 up to model year 2018 with code 318 (Touchpad with rotary pushbutton) Model 222.9 up to model year 2018 with code 448 (Touchpad)	
22	Release and disconnect the electrical connections under the center console (1).	i The number of electrical connectors varies according to vehicle equipment.	
23	Remove the center console (1) toward the rear from the vehicle.	i Helper required.

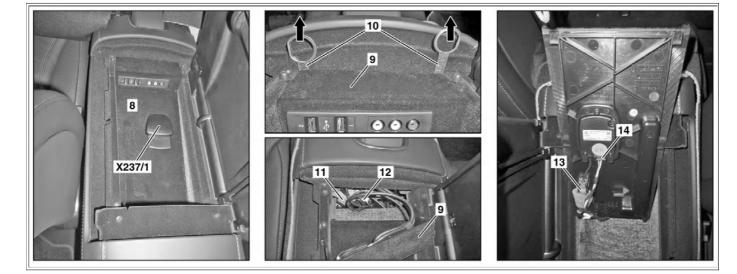
P68.20-4646-08

Shown on model 222 up to model year 2018 with code 386 (Convenience telephony) and code 582 (Air conditioning system in rear)

Shown on MODEL 222.1 with code 224 (Design individual rear seat system)

30 Bolts
