Model 217, 222.0/1/9  
up to model year 2018

P68.20-4645-08

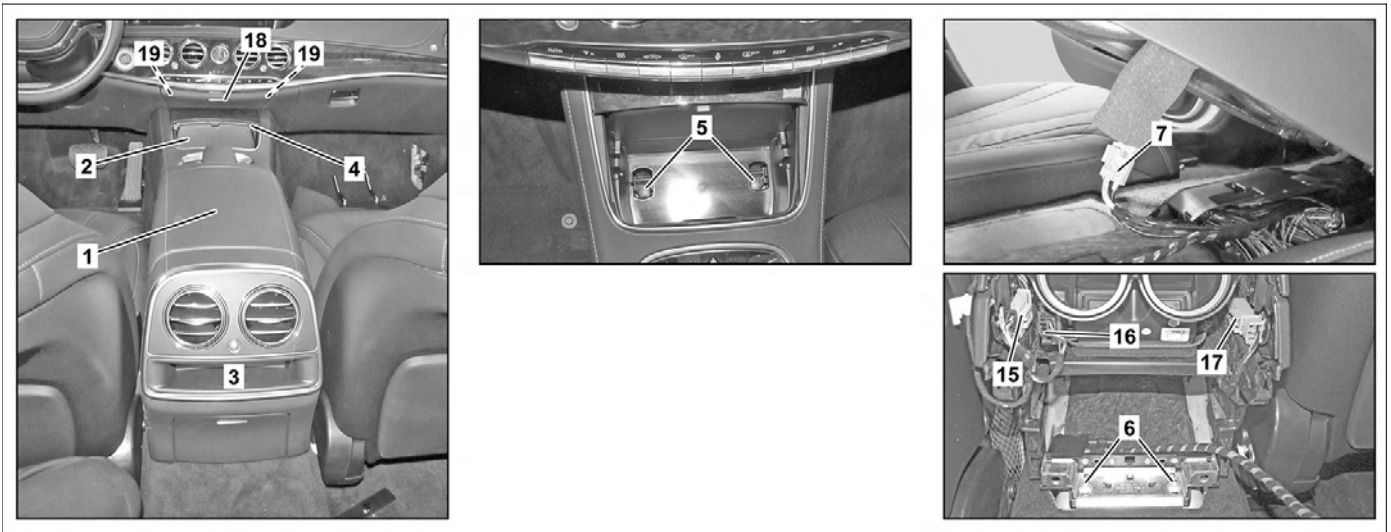
Shown on model 222 up to model year 2018 except code 582 (Air conditioning system in rear)

| 1 | Center console | 7 | Electrical connector |
| 2 | Stowage compartment | 15 | Electrical connector |
| 3 | Cover | 16 | Electrical connector |
| 4 | Cover | 17 | Electrical connector |
| 5 | Bolts | 18 | Stowage compartment |
| 6 | Bolts | 19 | Screw |

Notes on avoiding damage to optical fibers during repair work		AH82.60-P-0001-05AK
	Information on preventing damage to electronic components due to electrostatic discharge		AH54.00-P-0001-01A
☒ ☒	<b>Remove/install</b>		
1	Open stowage compartment (2)		
2	Remove rubber insert from stowage compartment (2)		
3	Remove bolts (5)		
4	Remove cover (3) from center console (1)		AR68.20-P-2350LF
5	Remove cup holder in rear	Model 222.1/9 up to model year 2018 with code 224 (Rear individual seat design)	AR68.00-P-5204LF
6	Remove rear entertainment unit (A26/18)	Model 222 up to model year 2018 with code P46 (Rear-Seat Entertainment Package) except code 224 (Rear individual seat design)	AR82.60-P-7697LF
7	Remove screws and remove bracket of rear seat entertainment system control unit (A26/18)	Model 222.0/1/9 up to model year 2018 with code P46 (Rear-Seat Entertainment Package) except code 224 (Rear individual seat design)

8	Disconnect electrical connectors (15, 16, 17)		
9	Open cover of center console (1) armrest		
10	Remove multimedia connection unit in front stowage compartment		AR82.60-P-1032LF
11	Remove cover (8)	Model 217, 222 up to model year 2018 with code 386 (Comfort telephony) Model 222 up to model year 2018 with code 856 (Business telephony in rear passenger compartment) except code 224 (Rear individual seat design)	
12	Remove soft top operation switch	Model 217.4 up to model year 2018	AR77.39-P-1000LCA
13	Remove bolts (6)		
14	Remove screws (30)	Model 217 up to model year 2018 Model 222.1/9 up to model year 2018 with code 224 (Rear individual seat design)	
15	Open stowage compartment (18) in instrument panel		
16	Remove screws/bolts (19)		
17	Disconnect electrical connector in stowage compartment (18) and remove stowage compartment (18)		
18	Lift center console (1)	<p><b>i</b> Press cross strut down on center console (1) below stowage compartment in instrument panel. The cover (4) falls off the COMAND control unit (A40/3) when the center console(1) is lifted.</p> <p><b>i</b> <b>Installation:</b> Clip molding (4) into COMAND control unit (A40/3).</p>

Helper required.	
19	Disconnect electrical connector (7)	Model 217 up to model year 2018 Model 222.0/1/9 up to model year 2018 except code 582 (Rear air conditioner)	
20	Disconnect electrical connector on touchpad on center console (1)	Model 217, 222.0/1 up to model year 2018 with code 318 (Touchpad with rotary pushbutton) Model 222.9 up to model year 2018 with code 448 (Touchpad)	
21	Disconnect electrical connectors under center console (1)

The number of electrical connectors varies according to vehicle equipment.	
22	Remove center console (1) toward rear from vehicle

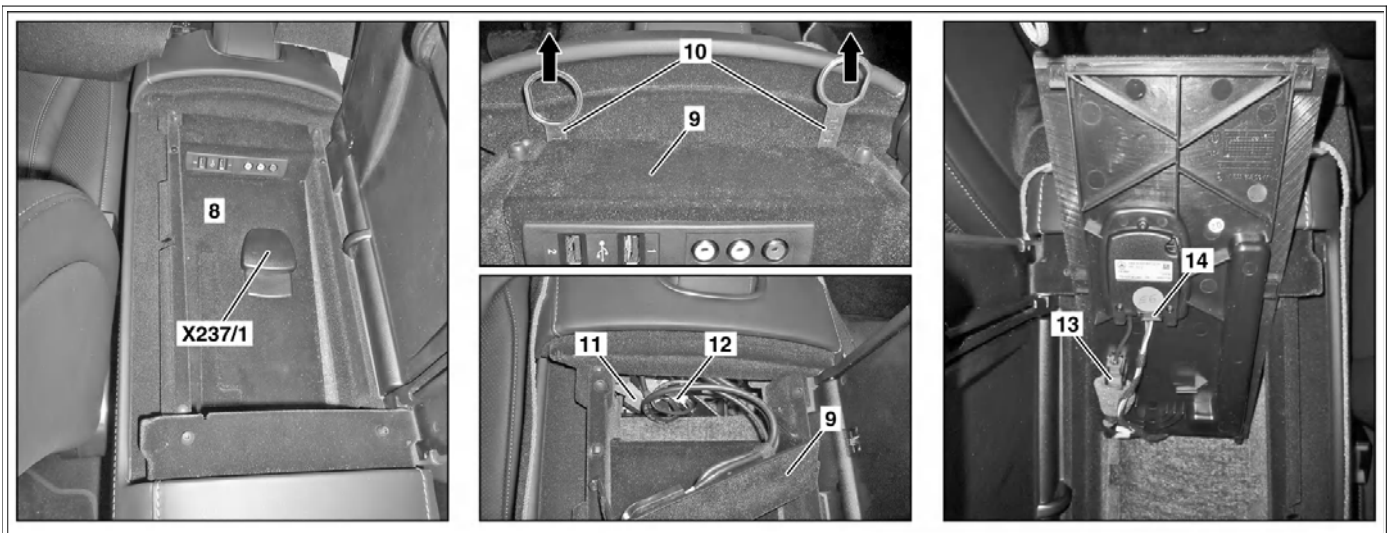
P68.20-4646-08

Shown on model 222 up to model year 2018 with code 386 (Convenience telephony) and code 582 (Air conditioning system in rear)

- 8 Cover

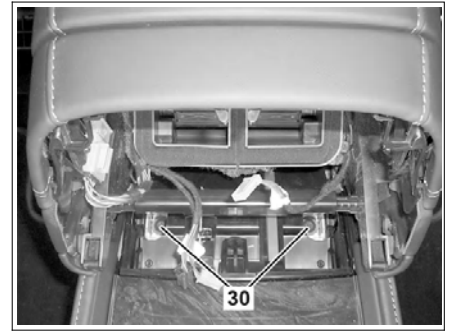
P68.20-4857-01

Shown on MODEL 222.1 with code 224 (Design individual rear seat system)

30 Bolts
