MODEL 230.4 with CODE (855) TELE AID

Remove/install		
1.1	Buffer basic data of D2B telephone and TELE AID transmitter/receiver (A35/17) in STAR DIAGNOSIS	When replacing D2B telephone and TELE AID transmitter/receiver (A35/17). i Installation: Transfer buffered basic data to new D2B telephone and TELE AID transmitter/receiver (A35/17).	
	Connect STAR DIAGNOSIS and read out fault memory	STAR DIAGNOSIS diagnosis system	AD00.00-P-2000-04A *WH58.30-Z-1048-13A
2	Switch off the ignition and remove the transmitter key from the EIS control unit	i On vehicles with code (889) Keyless Go, press the Keyless Go start/stop button repeatedly until the ignition is switched off. Remove the Keyless Go transmitter card or transmitter key from the vehicle and store beyond the reach of the transmitter (min. 2 m).	
3	Remove stowage box		AR68.20-P-2320R

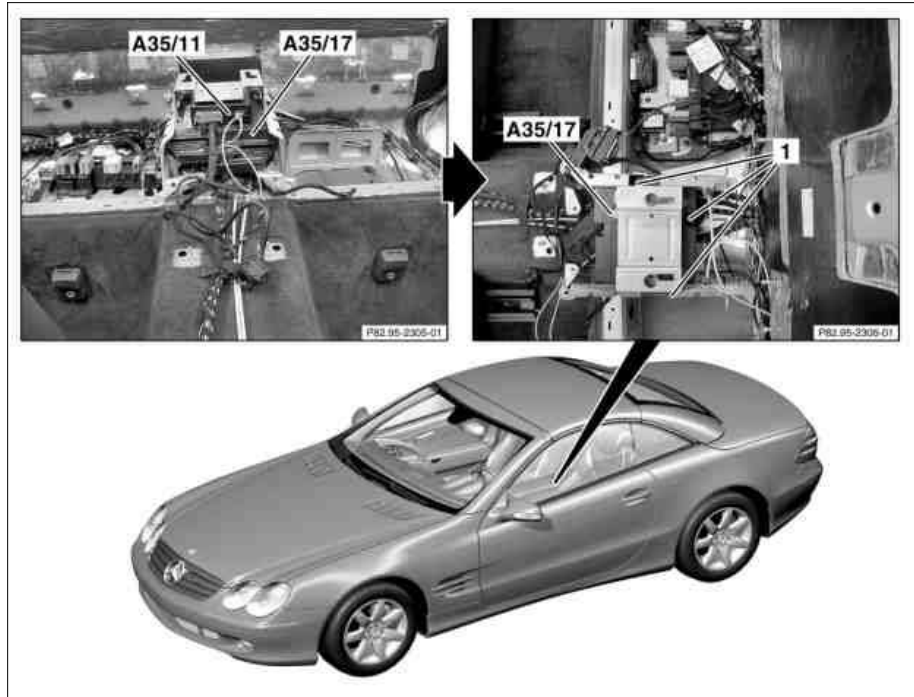
P82.95-2304-06

Shown on vehicle with code (813) Voice control system (VCS [SBS])

1 Bolts

A35/11 Voice control system control unit (with code (813) Voice control system (VCS [SBS]))

A35/17 D2B telephone and TELE AID transmitter/receiver

4.1	Remove voice control system control unit (A35/11)	For vehicles with code (813) Voice control system (VCS [SBS])	AR82.70-P-0003R
5	Remove bolts (1)		
6	Disconnect electrical connectors and fiber optic cable coupling from D2B telephone and TELE AID transmitter/receiver (A35/17)	w To avoid damaging them, do not kink fiber optic cables, route over sharp edges or bend in radii smaller than 25 mm. i Cover fiber optic cable coupling and implement connection on D2B telephone and TELE AID transmitter/receiver (A35/17). Refer to: ↓ Cover fiber optic cable	AR82.95-P-0005-01A
7	Remove D2B telephone and TELE AID transmitter/receiver (A35/17)		
8	Install in the reverse order
