## MODEL 231

P72.10-4006-11

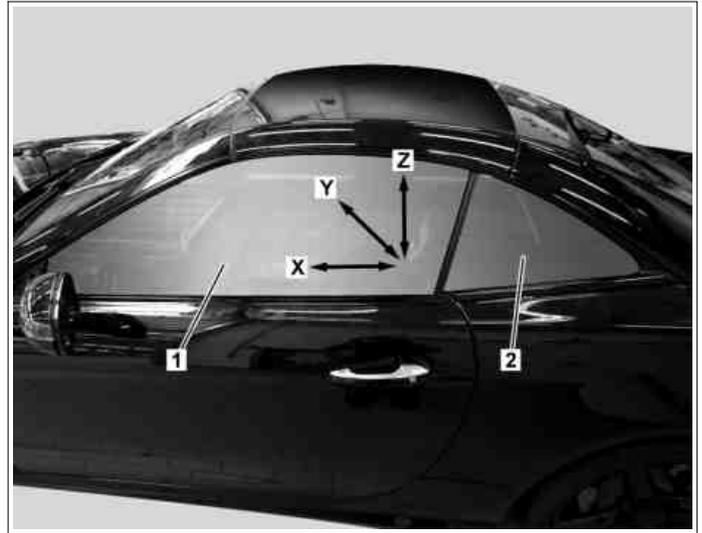
- 1 Crank window  
2 Rear side window

☒	Removing		
⚠ <b>Danger!</b>	<b>Risk of injury</b> caused by moving parts that can <b>pinch, crush</b> or, in extreme cases, even <b>sever</b> extremities	No parts of the body or limbs should be within the operating range of the mechanism when moving components.	AS00.00-Z-0009-01A
1	Completely move down rear side window (2)		
2	Remove door lining

To adjust crank window (1) in "X and Y direction".	AR72.10-P-1000RK
3	Remove outer sealing rail

To adjust crank window (1) in "X and Z direction".	AR72.10-P-1700RK
	<b>Adjust</b>		
4	Perform basic setting
