ELECTRICAL SYSTEM - ENGINE -- 203 CHASSIS			
aps	Fig. 86: Identifying Crankshaft Position Sensor Remove/Install Components - Engine 272.920/940/941 2006 Mercedes-Benz C230

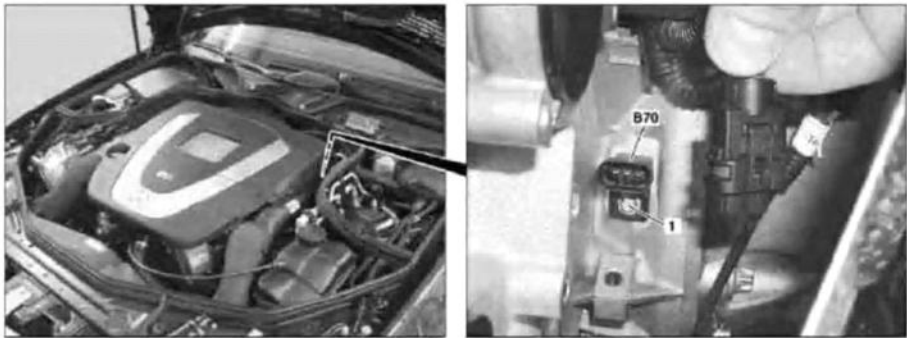
1 Bolt	B70 Crankshaft Hall sensor	P07 04251508	
Tuesday, November 23, 2010 12:22AM		Page 1	© 2005 Mitchell Repair Information Company, LLC.
