## star bulletin

Order No.: P-B-15.30/55a

SUBJECT: Model 203.040/052/054/056/061/064/065/076/081/084/087/092/261/264/281/284/740/747/764

**Engine Not Starting / Starter Fuse Malfunctioning**

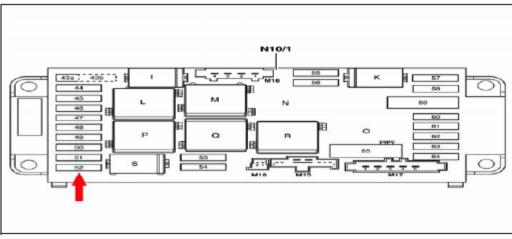
Figure 1

If you receive customer reports in the above model vehicles of the engine not starting, the Starter Fuse in the Driver Signal Acquisition and Actuation Module (SAM) may be malfunctioning. The Driver SAM should be fitted with a larger 20 Amp fuse.

- 1. Perform a visual inspection of the Driver SAM (N10/1) and determine which fuse is installed in socket 52 (Figure 1, arrow). Consult STAR Finder for more information on the location of this fuse (10/1f52).
- 2. Replace the currently installed 15 Amp fuse with the 20 Amp fuse specified in this DTB.
- 3. Record the fuse rating change on the vehicle's Fuse Chart.
