Date: March 29, 2010
Order No.: S-B-01.30/28a
Supersedes: S-B-01.30/28 June 8, 2009
Group: 01

**SUBJECT: MY-All, All Models Equipped with M272 and M273 Engines
Cylinder Head-Related Complaint Guidelines**

Complaint Process Guidelines (Pages 2-4)

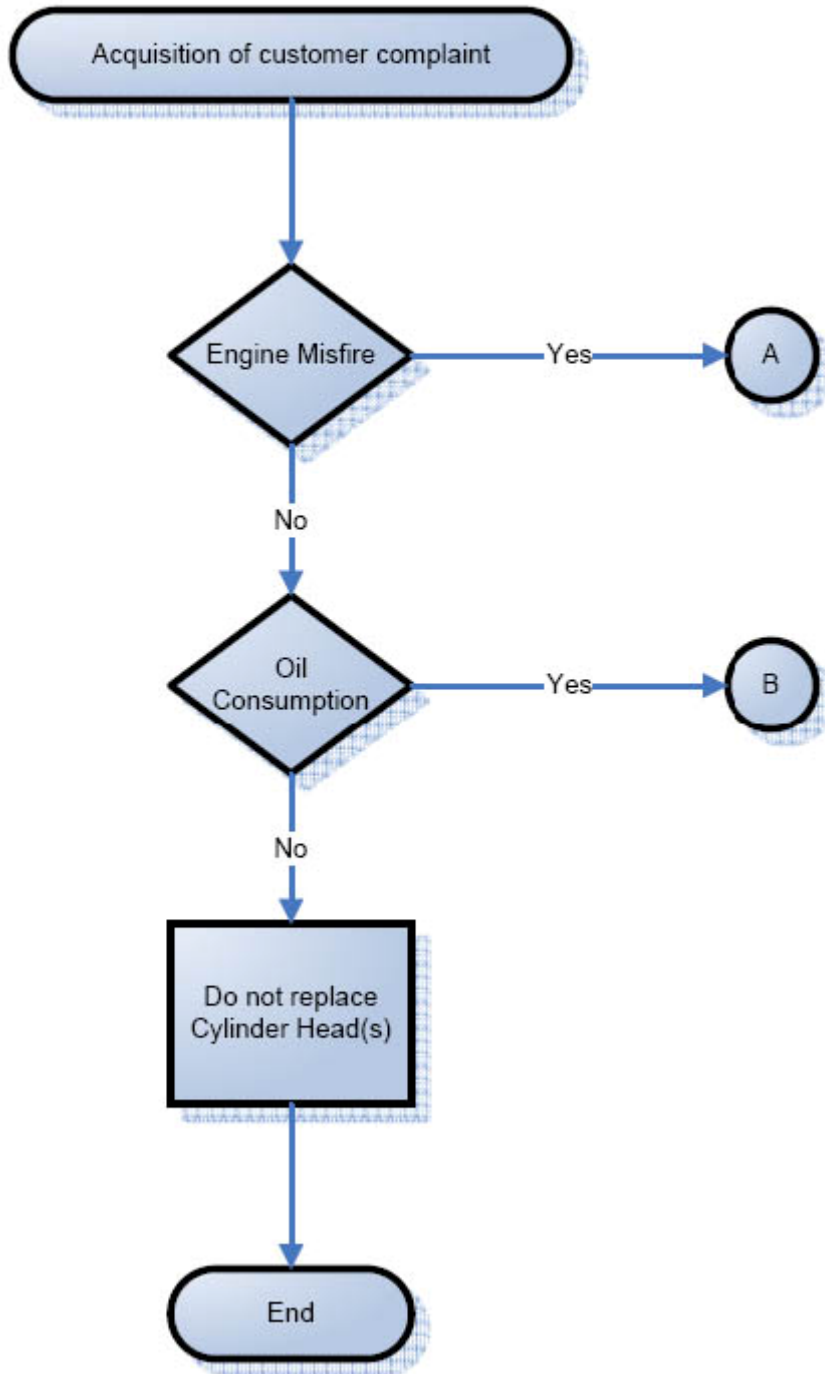
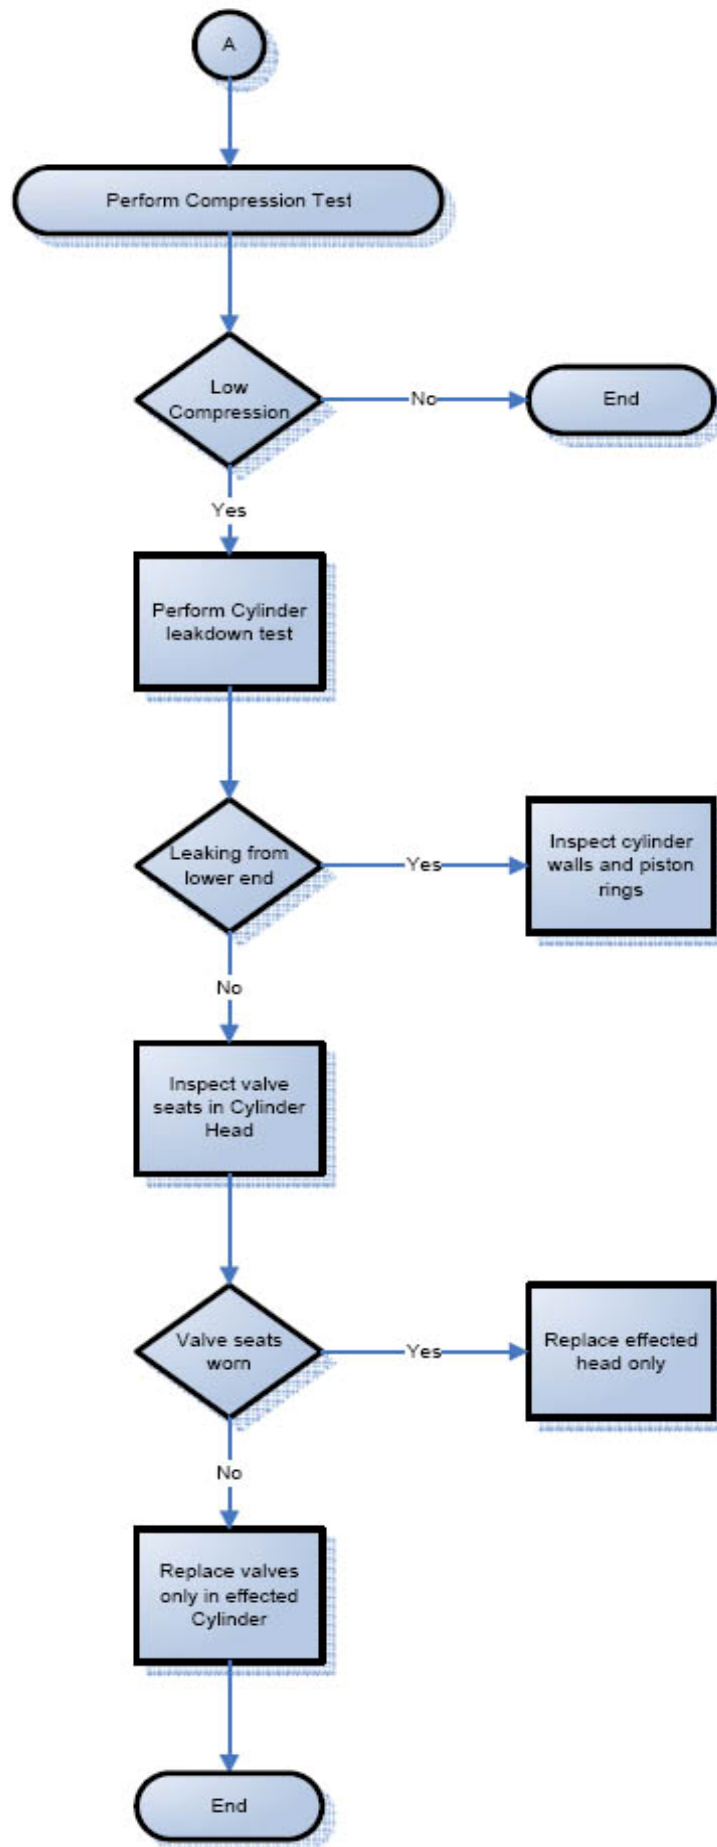
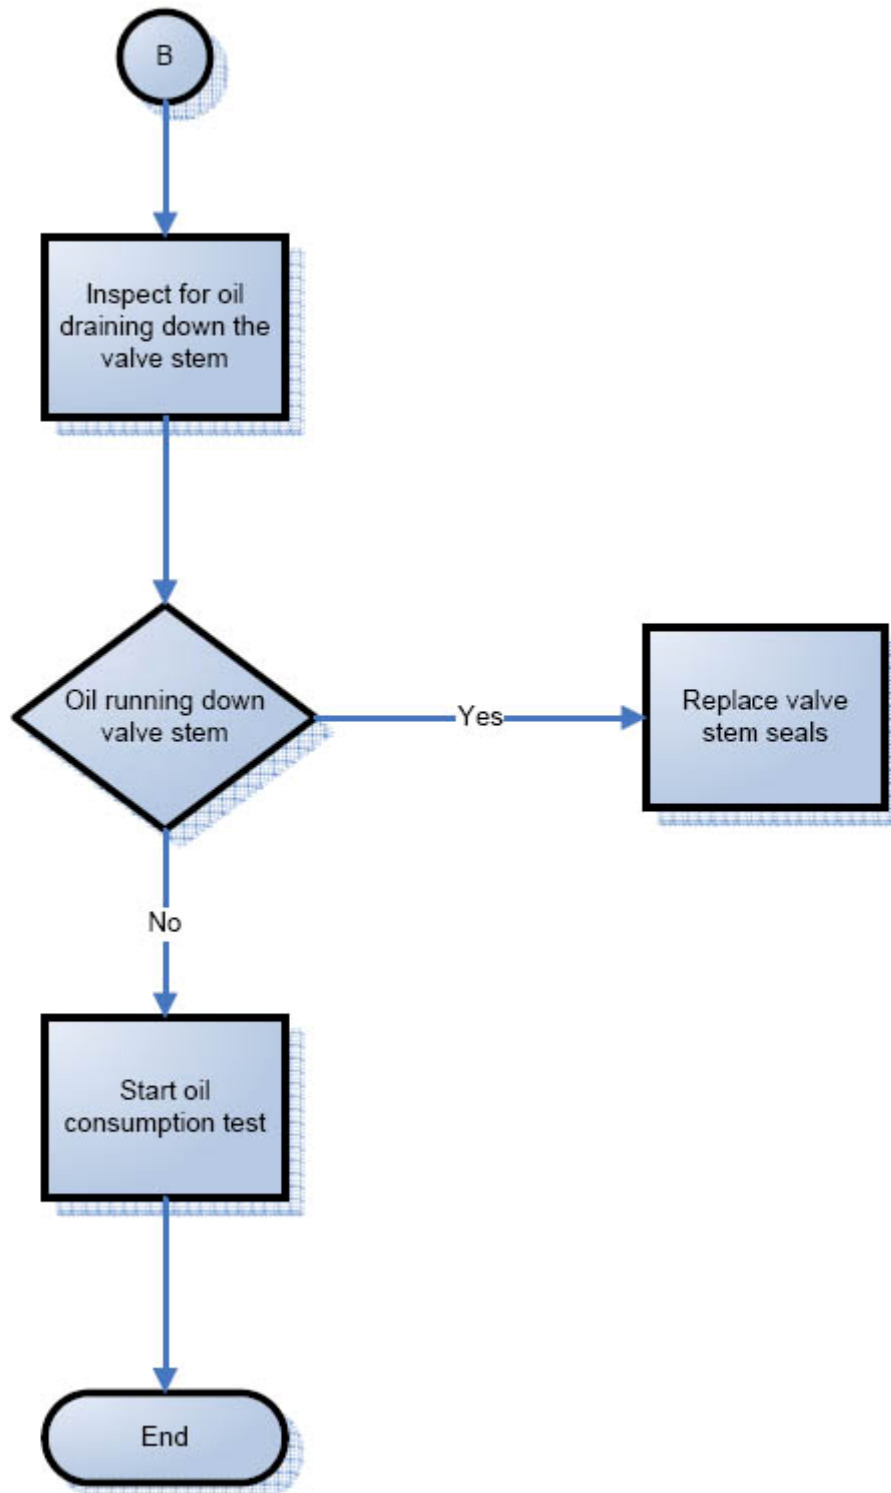
M272 and 273 Cylinder Head

If you receive customer reports regarding vehicles equipped with Engine 272 or 273 related to a misfire or oil consumption, follow the guidelines herein to determine further actions.

i **Note:** Do not replace cylinder heads based on suspicion alone and follow the guidelines to make a proper determination. Only the compression and leak down test values taken from engines at operating temperature could be taken for consideration. Proper inspection of combustion chamber requires MB Special Tools approved Borescope.

Perform checks and / or repairs according to published WIS (such as, AH01.00-P-0300-01VA), DTB (such as S-B-07.61/72a - misfire codes; DTBs and LIs in group 18 or 01 related to oil consumption) and other official documents.

i **Note:** Use only approved methods to remove any carbon deposits when performing a repair. Mechanical carbon deposit cleaning (and use of any sand paper, abrasive pads or disks or sanding tools) is not allowed under warranty and cylinder heads should not be removed to do that. Use only approved fuel additives - Keropur part # A000 989 25 45 12. Dealers might be debited when performing unapproved or incorrect repairs as well as when unnecessarily replacing parts.

i **Note:** If the guideline test steps are inconclusive, revert to the SDS guided test as indicated by the DTB S-B-07.61/72a and / or properly determine a root cause of the complaint.
