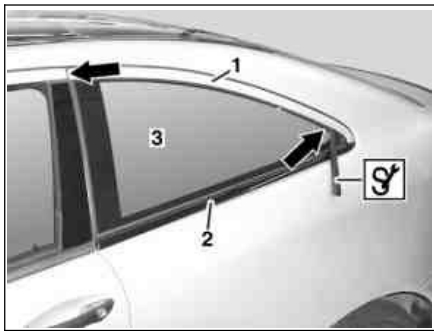
P67.30-2057-01

- 1 Top molding
- 2 Bottom molding
- 3 Rear side window
- 4 Upper mounting clips
- 5 Bottom mounting clips

Removal		
1	Unclip top molding (1)	Assembly wedge Start at front at the first three mounting clips (4)	*1 10589035900
2	Move top molding (1) toward front	This loosens the top molding (1) on the last mounting clip.	
3	Remove top molding (1)		
4	Unclip bottom molding (2)	Assembly wedge	*1 10589035900
5	Remove bottom molding (2)		
	Installing		
6	Check mounting clips (4) and (5)	Replace damaged mounting clips (4) and (5).	
7	Align top molding (1) at mounting clips (4) and press on	Use lubricant	*BR00.45-Z-1010-06A
8	Align bottom molding (2) at mounting clips (5) and press on		
9	Check molding (1) and (2) position, correct if necessary.
