MODEL 204.0## (except 204.077) 1# , 204.2## (except 204.277) 1# , 204.3## (except 204.377) 1#
 with CODE 954 (Avantgarde)
 without CODE 233 (DISTRONIC PLUS)
 without CODE 239 (DISTRONIC PLUS and BAS PRO)

Illustrated on model 204.3

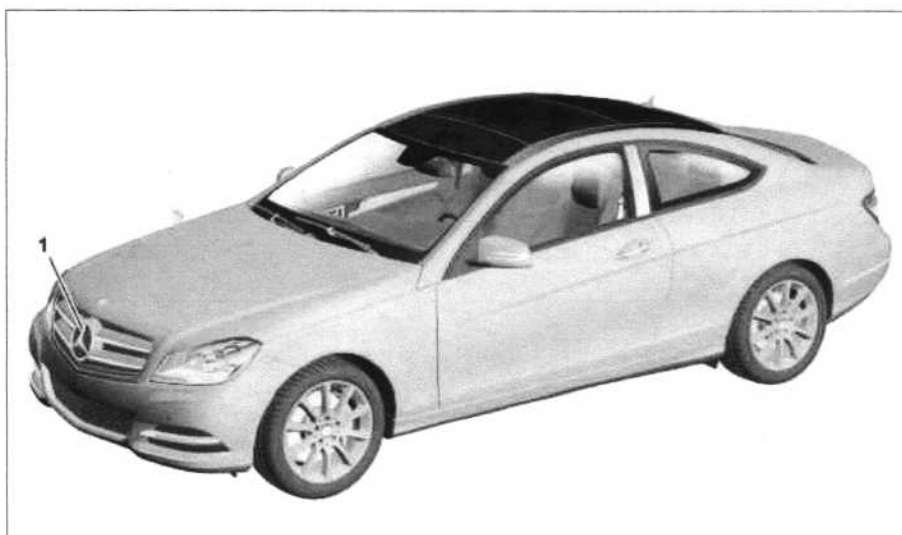
P88.40-3028-05

1 Illuminated Mercedes star

Remove		
	Information on preventing damage to electronic components due to electrostatic discharge		AH54.00-P-0001-01A
1	Detach front SAM control unit with fuse and relay module and place to one side		
			AR54.21-P-1260CW
2	Remove radiator grille		AR88.40-P-4001CW
3	Remove Mercedes star in radiator grille	Mercedes star is no longer required.	
4	Move drivers seat toward rear		
5	Disconnect battery ground line		
			AR54.10-P-0003CW
6	Remove front left inner door sill		
7	Detach edge guard in area of door sill and A-pillar panel		
8	Remove A-pillar panel on left side at bottom		
9	Remove cover below left of instrument panel		
10	Remove accelerator pedal		
			AR30.12-P-1321CW
11	Remove left floor covering on front footwell		
	Install		
12	Install wiring harness and illuminated Mercedes star control unit (1)	New passenger car wiring harness repair kit Wiring harness repair kit, basic	AZ88.40-P-0010-01CW *220589049900 *000589139900

13	Install illuminated Mercedes star (1) and connect		
14	Install remaining parts		
15	Document retrofitted equipment via vehicle documentation (VeDoc)	Attach note "Illuminated Mercedes star retrofitted according to AZ88.40-P-0010CW" field organization texts for design group 88.	
16	Check illuminated Mercedes star (1) for proper function	The illuminated Mercedes star (1) is switched on by opening a door as well as by activating the ambient illumination. The illuminated star (1) switches off automatically approx. 5 minutes after a door is opened or after the ambient illumination is switched off
