AR41.10-P-0100CW	Remove/install propeller shaft intermediate bearing and replace grooved ball	
	bearing

## MODEL 204, 207, 212, 218, 231

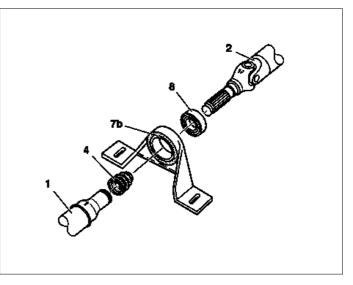
P41.10-2002-11

- 1 Front propeller shaft
- Rear propeller shaft 2
- 4 Rubber boot 7b
- Rubber bushing
- 8 Grooved ball bearing

i	Notes on sensor system for trunk lid opening/ closing		AH80.61-P-0001-01A
XX	Remove/install		
1	Remove propeller shaft	MODEL 204, 207	AR41.10-P-0050CW
		MODEL 212, 218	AR41.10-P-0050EW
		MODEL 231	AR41.10-P-0050RK
2	Separate front propeller shaft (1) and rear propeller shaft (2) at the slide connection		AR41.10-P-0050-05TX
		<b>i</b> Installation: When fitting the propeller	
		shafts (1, 2) together, make sure that the marks line up with each other.	
		Long-life grease	*BR00.45-Z-1001-06A
3	Pull boot (4) off front propeller shaft (1)	<b>i</b> Installation: Replace damaged rubber boot (4) and ensure that it is seated correctly.	
4	Detach rubber mount (7b) together with grooved ball bearing (8) from rear propeller shaft (2)		AR41.10-P-0100-07TX
			AR41.10-P-0100-05TX
		S Puller, two-arm	*000589883300
		S Puller arms	*129589003400
5	Press grooved ball bearing (8) out of rubber mount (7b)		AR41.10-P-0100-02TX

<b>i</b> Installation: Press rubber mount (7b) together with grooved ball bearing (8) onto joint fork of rear propeller shaft (2).	
		S Drift	*126589031500
		Image: Second state      Image: Second stat  <	*116589094300
6	Install in the reverse order
