### Model 204, 207, 212, 218

#### Shown with model 204.0

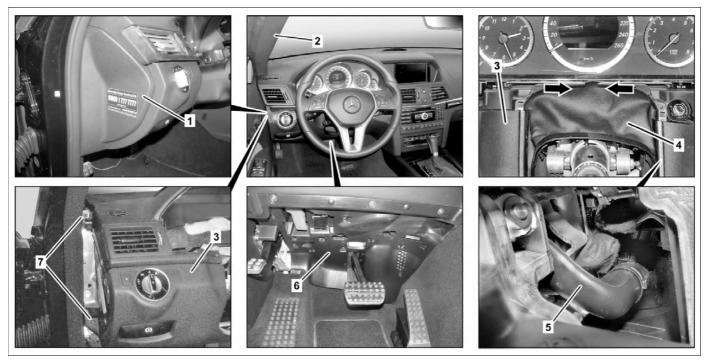
P91.60-4432-09

- 1 Cover
- 2 Left A-pillar paneling
- 3 Instrument panel
- 8 Nut
- 9 Driver kneebag
- 10 Electrical connector
- 11 Nut
- 12 Left bracket
- 13 Right bracket
- 14 Bolts

10	Remove foam element in area of left bracket (12)	Model 204, 207, 212	
11	Remove screw/bolts (7)		
12	Unscrew nut (8)	Nm Nut, kneebag to crossmember	*BA91.60-P-1003-01M
13	Remove left bracket (12)	Model 207	
14	Unscrew nut (11) and remove right bracket (13)	Nm Nut, kneebag to crossmember	*BA91.60-P-1003-01M
15	Remove screws/bolts (14)	Nm Screw/bolt, kneebag to instrument panel (below the cover under instrument panel)	*BA91.60-P-1016-01M
16	Remove instrument panel (3) in direction of vehicle interior with aid of a second person, remove driver kneebag (9) from instrument panel (3) and guide into footwell until electrica connector (10) can be disconnected	Lift instrument panel (3) just far enough in the direction of the vehicle interior that the driver kneebag (9) can be removed.  The instrument panel (3) may be damaged otherwise.	
17	Release and disconnect electrical connector (10), remove driver kneebag (9)	Removal lever	*203589043300

18	Install in the reverse order		
4	Check		
19	Check and erase vehicle fault memory using the diagnostic system	After replacing the driver kneebag (9).
