AR68.20-P-2350LW	Remove/install cover on center console	07.04.2017
------------------	--	------------

Model	205 with transmission 722, 724, 725
Model	213 with transmission 725
Model	253 with transmission 724, 725

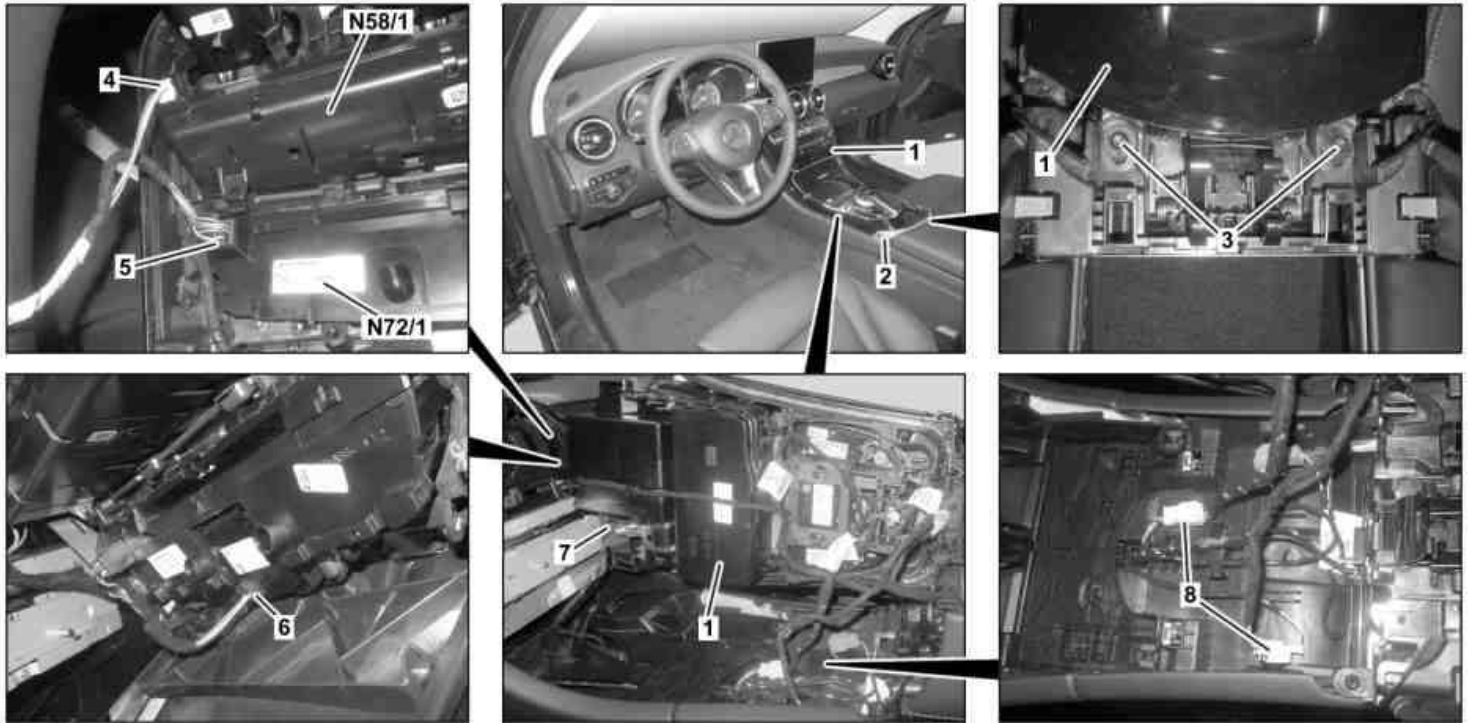
P68.20-4707-09

Shown on model 205 with code 581 (automatic air conditioning)

1	Center console cover	6	Electrical connector
2	Stowage box cover	7	Electrical connector
3	Bolts	8	Electrical connectors
4	Electrical connector	N58/1	Climate control operating unit
5	Electrical connector	N72/1	Upper control panel control unit

Topical notes=severity=N	Information on preventing damage to electronic components due to electrostatic discharge		Information on preventing damage to electronic components due to electrostatic discharge
☒☒	Remove/install		
1	Switch off ignition and store transmitter key outside of transmission range (min. 2 m)		
2	Remove stowage box cover (2)	Model 205 with transmission 722, 724, 725 Model 253 with transmission 724, 725	Remove/install cover on stowage box
		Model 213 with transmission 725	Remove/install cover on stowage box
3	Unscrew bolts (3) from center console cover (1)		
4	Lift center console cover (1) at rear and move out of instrument panel at top front until electrical connectors (4, 5) are accessible	⚠ Cover center console and instrument panel with a cloth. Otherwise, the center

console and instrument panel can be damaged.	
5	Disconnect electrical connector (4) from air conditioning operating unit (N58/1)	Model 205 with transmission 722, 724, 725 with code 581 (Automatic air conditioning) Model 213 with transmission 725 with code 581 (Automatic air conditioning) Model 253 with transmission 724, 725 with code 581 (Automatic air conditioning)	
6	Disconnect electrical connector (5) at upper control panel control unit (N72/1)		
7	Disconnect electrical connectors (6, 7, 8)

The number can vary according to the equipment.	
8	Remove cover on center console (1)		
9	Install in the reverse order
