AR68.20-P-2000LW	Remove/install center console	19.11.15
------------------	-------------------------------	----------

Model	205 with transmission 722, 724, 725
-------	-------------------------------------

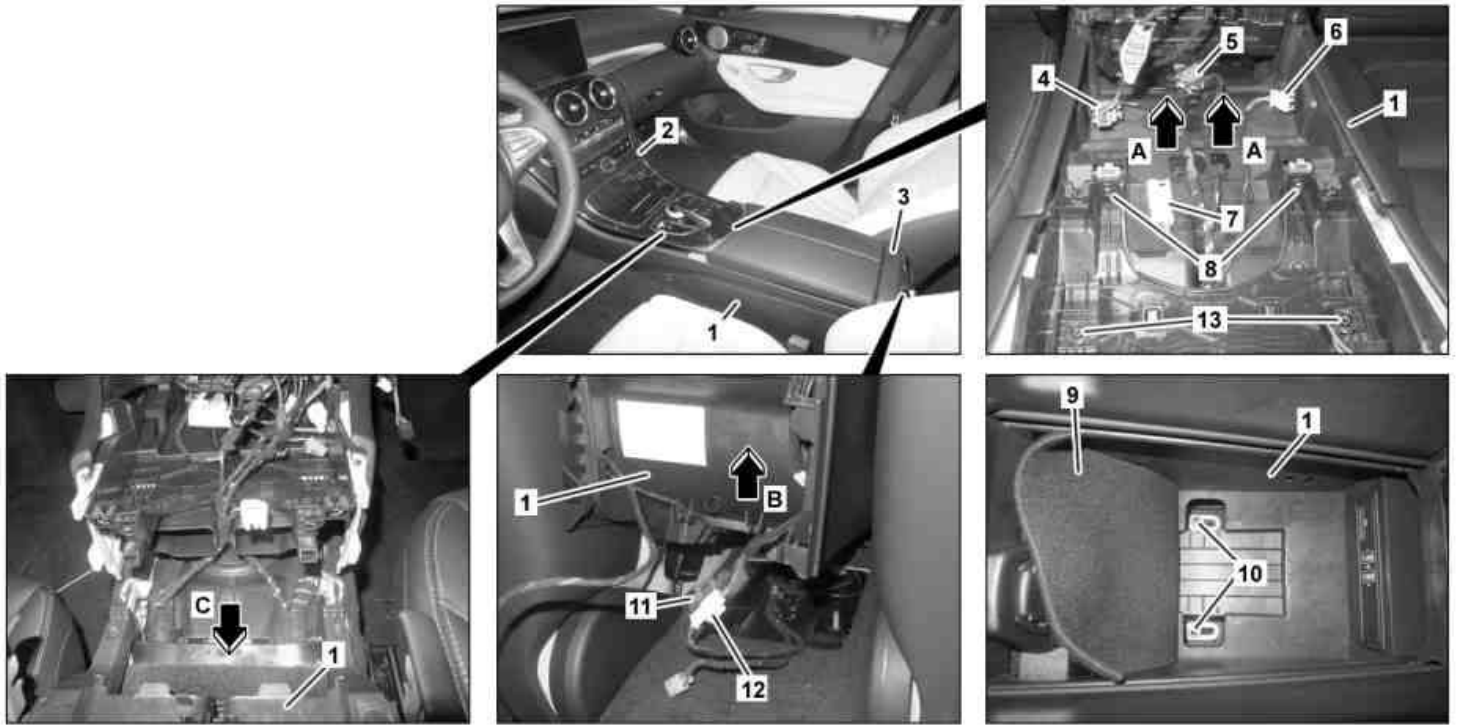
P68.20-4710-09

Shown on model 205.0 with code 386 (Comfort telephony)

1	Center console	8	Bolts
2	Center console cover	9	Cover
3	Rear center console cover	10	Nuts
4	Electrical connector	11	Electrical connector (with code 386 (Comfort telephony))
5	Electrical connector	12	Electrical connector (with code 386 (Comfort telephony))
6	Electrical female connector	13	Bolts
7	Electrical female connector

Remove/install		
1	Remove center console cover (2)	■ Remove/install cover on center console
2	Remove rear center console covering (3)	■ Remove/install rear cover on center console
3	Disconnect electrical connector (4) and unclip from center console (1)	i The number can vary according to the equipment.
4	Disconnect electrical connection (5)	i The number can vary according to the equipment.
5	Unclip electrical sockets (6, 7) from center console (1)	i The number can vary according to the equipment.
6	Unclip wiring harness from center console (1) (arrows A)	
7	Lift paneling (9) in armrest stowage compartment and lay down to side	
8	Unscrew nuts (10)	
9	Remove screws (13)	
10	Remove bolt (8)	
11	Disconnect electrical connections (11, 12)	Model 205 with transmission 722, 724, 725 with code 386 (Comfort telephony)

12	Lift center console (1) at rear (arrow B) and move out of instrument panel (arrow C) toward rear

Installation: Ensure that air duct is seated correctly on air conditioning housing.	
13	Install in the reverse order
