| AR83.10-P-4501LW | Remove/install side air nozzle | 21.01.2016 |

| Model | 205 |
| Model | 213 |
| Model | 253 |

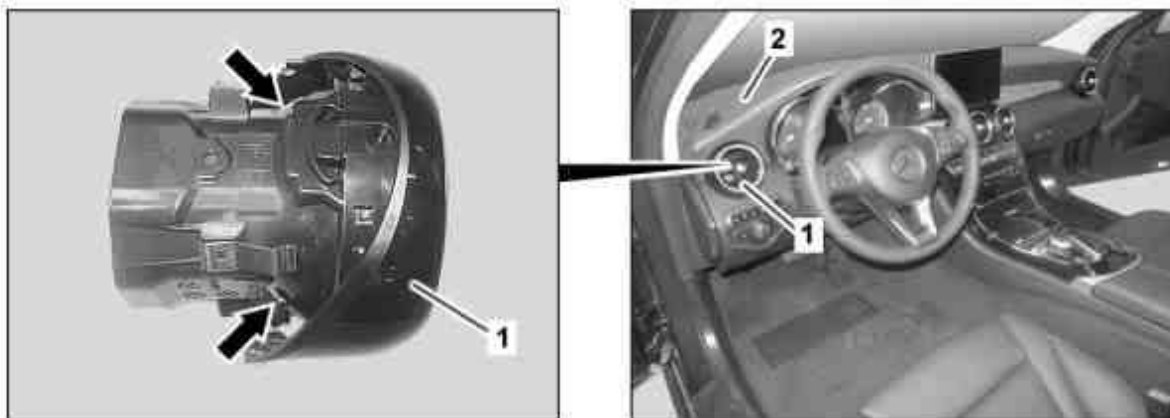
P83.10-2874-04

Shown on model 205.### 1#

| 1 | Left side vent |
| 2 | Instrument panel |

| 2 | Insert extraction hook into side notches (arrows) of left side air vent (1) and pull left side air vent (1) out of instrument panel (2) | Installation: "Make sure that ""TOP"" marking on left side air vent (1) is pointing upwards." | |
