Model 167.1/9

except code 21U (Video recording function (Dashcam))

© Moreodos Ponz AC 9/9/00 1	_/10/20, az54.71-p-0001me. Retrofit front and rear Mercedes-Ben	7 Dooboom	Page 2 of 3

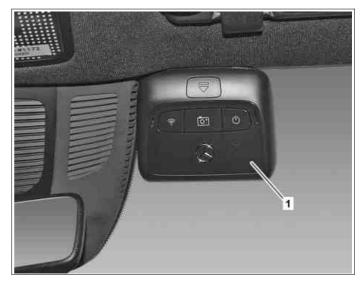
P54.71-A101-11

1 Dashcam at front

Adhesive tape roll, non-woven Tesa tape, 50 meters, 50 mm wide Wiring harness repair kit, basic	*BR00.45-Z-1144-02A *000589139900
		New passenger car wiring harness repair kit	*220589049900
19	Latch dashcam at front (1) into dashcam mount opposite direction of arrow on eject button.	Mount dashcam at front (1) at the earliest one hour after gluing on the dashcam mount. Otherwise, the dashcam mount may work its way loose.	
20	Latch dashcam at rear (2) into dashcam mour opposite direction of arrow on eject button.	Mount dashcam at rear (2) at the earliest one hour after gluing on the dashcam mount. Otherwise, the dashcam mount may work its way loose.	
21	Perform initial startup.		AZ54.71-P-0001-02LWE
⊯ GF 22	National settings for Mercedes-Benz dashcam Install remaining parts.		GF54.71-P-0010-02LWE
	Update Vehicle Documentation (VeDoc)		
23	Attach "Mercedes-Benz dashcam retrofitted at front and rear as per AZ54.71-P-0001ME note" under field organization texts to DG 54, DG 67 and DG 68.

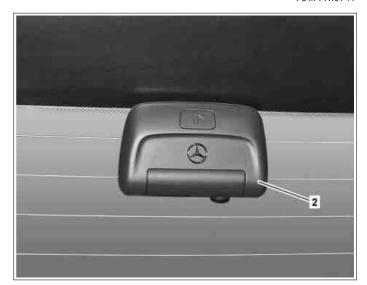
P54.71-A102-11

2 Dashcam at rear

7	Remove covers over securing eyes for front and rear partition net on driver's side.	Y Long wedge	*115589035900
8	Remove left C-pillar trim and place to one side with attached seat belt.	Model 167.1/9	
FAR FAR		Model 167.1 Model 167.9 except code M036 (Maybach version)	AR68.30-P-4490ME AR68.30-P-4490MEX
9 ⊯AR ⊯AR	Remove D-pillar trim on driver's side.	Model 167.1/9 Model 167.1 Model 167.9 except code M036 (Maybach version)	AR68.30-P-4497ME AR68.30-P-4497MEX
10 ≆AR	Remove overhead control panel control unit.	version)	AR82.20-P-1000ME
X 11	Install Retrofit front dashcam mount.		AZ54.71-P-0001-00LWE
		When pressing on, ensure that the pressure is applied directly on the adhesive point. The maximum adhesive strength is only reached after approx. 72 h at 20 °C. During the first hour avoid the application of any mechanical load. Otherwise adhesion problems may occur.	
12	Retrofit rear dashcam mount.	Cleaner	*BR00.45-Z-1025-04A AZ54.71-P-0003-00LWE

When pressing on, ensure that the pressure is applied directly on the adhesive point. The maximum adhesive strength is only reached after approx. 72 h at 20 °C. During the first hour avoid the application of any mechanical load. Otherwise adhesion problems may occur.	
K.Pl	Barrana	Cleaner	*BR00.45-Z-1025-04A
13	Remove Remove cover for rain and light sensor.		
⊯ AR			AR82.30-P-7801ME
14 ⊯AR	Remove both sun visors.		AR68.60-P-5480ME
15	Pull off front and rear edge guard on driver's side in area of roof lining.		
16	Release front and rear roof lining on driver's side.		
17 ⊯AR	Remove upper liftgate trim.		AD72 20 D 6621ME
X	Install		AR72.20-P-6631ME
18	Retrofit wiring harness for dashcam. Notes on the use of paint scraping nuts on ground connections		AZ54.71-P-0001-01ME AH00.19-P-1000-20A
		Left footwell ground point Silikonspray Silikon-Fluid, 0.4 I art. no. 0893 221 000	*BA00.19-P-1033-01M *BR00.45-Z-1133-06A
