MODEL 218

Information on preventing damage to electronic components due to electrostatic discharge		AH54.00-P-0001-01A
	Remove/install		
1.1	Switch off ignition and remove transmitter key from electronic ignition lock control unit	MODEL 218 without CODE 889 (KEYLESS-GO)

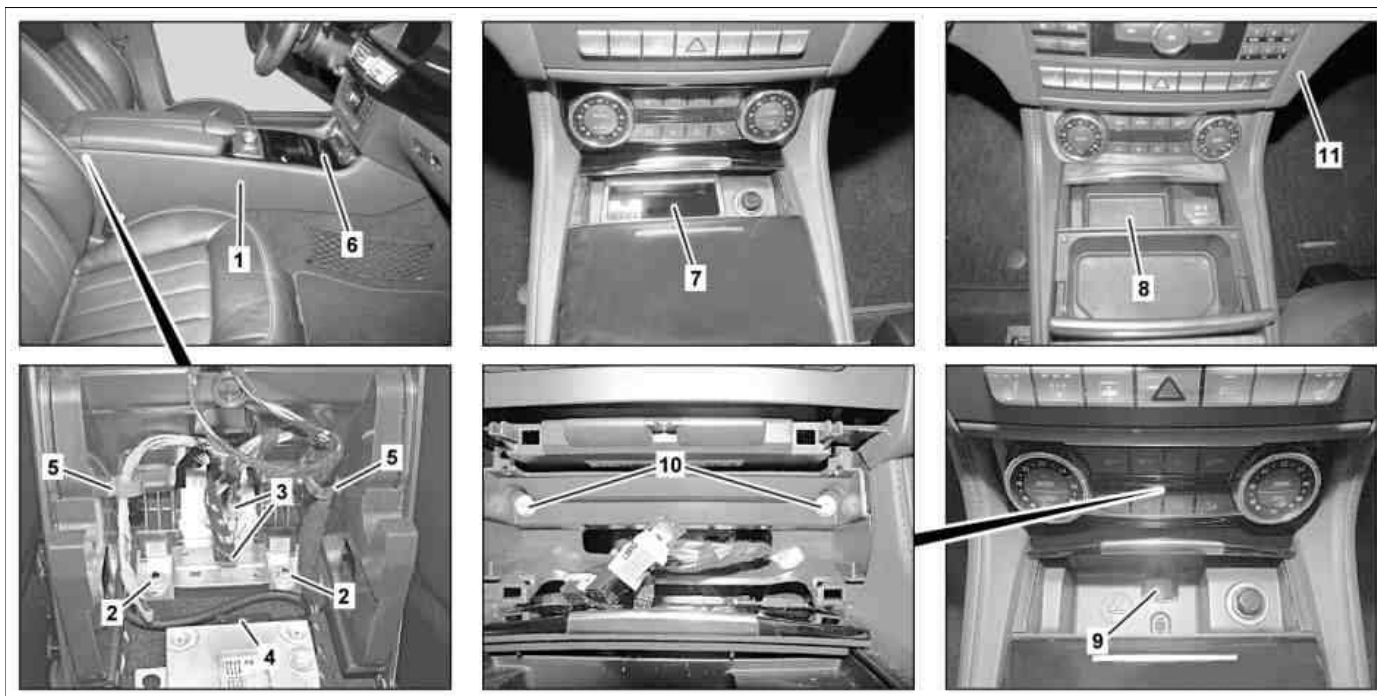
P68.20-4346-09

Shown up to model year 2015

| 1 | Center console, front | 5 | Retaining clip | 9 | Screw |
| 2 | Nut | 6 | Cover | 10 | Bolts |
| 3 | Electrical connectors | 7 | Ashtray (with CODE 301 (Ashtray package/smoker package)) | 11 | Instrument panel |
| 4 | Electrical connector (up to model year 2015 with CODE 518 (Media Interface)) | 8 | Insert (except CODE 301 (Ashtray package/smoker package)) | | |

2.1	Remove rear center console	MODEL 218.3	AR68.20-P-2020EL
2.2	Remove rear air vent	MODEL 218.9	AR83.10-P-4800EL
3	Unscrew nuts (2)		
4	Disconnect electrical connectors (3)		
5	Disconnect electrical connectors in rear area of front center console (1)	i The number of electrical connectors depends on the vehicle equipment.	
6	Disconnect electrical connection (4)	MODEL 218 up to model year 2015 with CODE 518 (Media interface)	
7	Unclip retaining clips (5)		
8	Remove air conditioning control and operating unit		AR83.40-P-6350EW
9	Remove radio or radio with Auto-Pilot-System or COMAND controller unit	i Depending on vehicle equipment.	AR82.60-P-7502EW
10	Disconnect electrical connector for AUX-socket (arrow) on electrical line (12) in radio mounting shaft	MODEL 218 up to model year 2015 without CODE 518 (Media interface)	
11	Remove green 2-pin coupling on video line from green 2-pin coupling housing on COMAND control unit	MODEL 218 up to model year 2015 with CODE 512 (COMAND APS with DVD changer) with CODE 518 (Media interface) MODEL 218 up to model year 2015 with CODE 518 (Media interface) with CODE 527 (COMAND APS with single DVD drive (with navigation))

12	Open cover (6)		
13.1	Remove ashtray (7)	MODEL 218 with CODE 301 (Package SMOKER)	
13.2	Remove insert (8)	MODEL 218 without CODE 301 (Package SMOKER)	
14	Unscrew screw/bolt (9)		
15	Remove bolts (10)		
16	Pull front center console (1) toward out of instrument panel (11) and remove from vehicle	i Installation: Ensure that electrical lines are routed correctly in area of front center console (1).	
17	Install in the reverse order

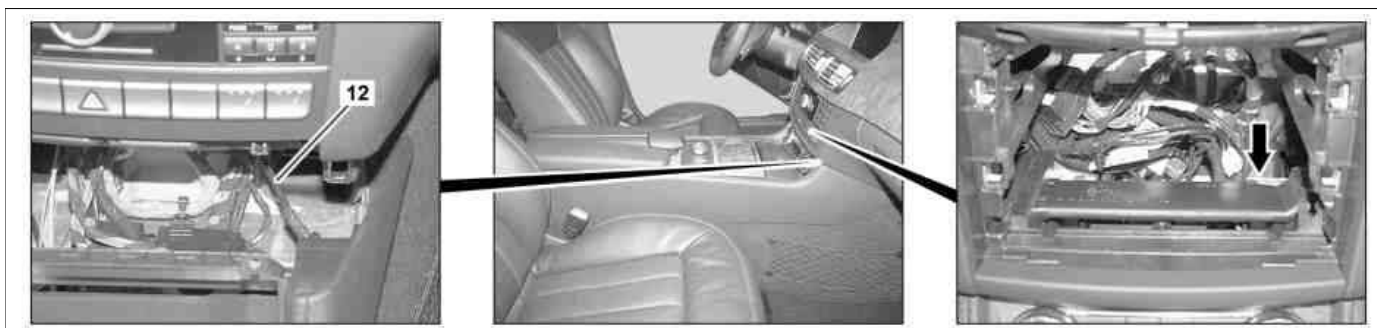
P68.20-4384-07

Up to model year 2015 except CODE 518 (Media Interface)

- 12 Electrical line
