MODEL 220, 215

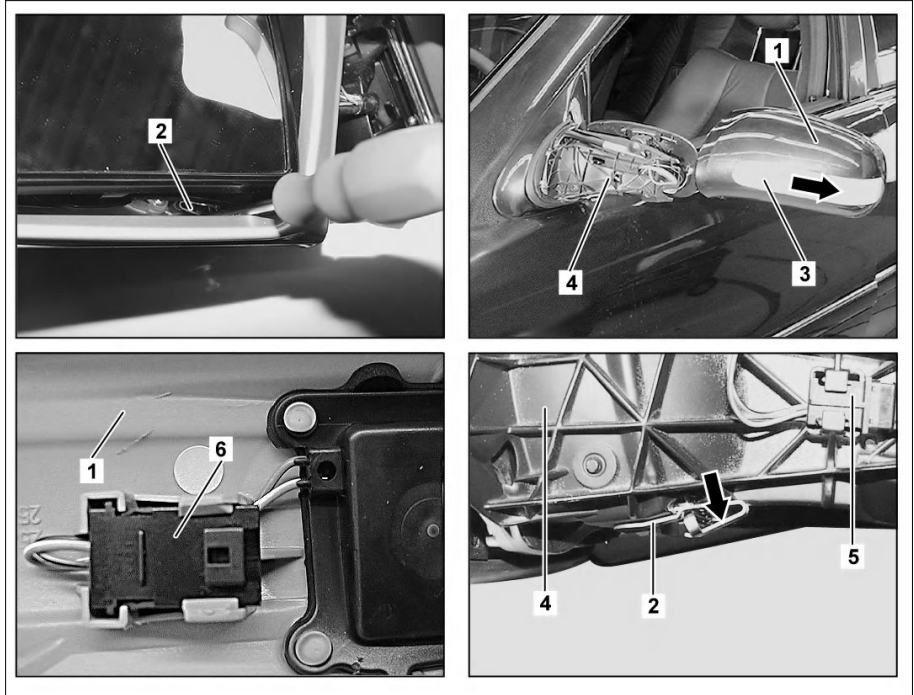
P88.70-2033-06

Shown on model 220 up to VIN: 316716

- 1 Paneling
- 2 Bottom catch spring
- 3 Turn signals
- 4 Outside mirrors
- 5 Turn signal connector on outside rearview mirror
- 6 Turn signal connector in outside rearview mirror covering

| ☒ | Remove | | |
|---|---|---|---|
| 2.1 | Release bottom catch spring (2) | Model 220 up to VIN: 316716<br><b>i</b> Do not damage paintwork. | |
| 4.1 | Move bottom catch spring (2) to initial position | Model 220 up to VIN: 316716 | |
| 5.1 | Check position of connector for turn signal on outside rearview mirror (5) and turn signal connectors in outside rearview mirror covering (6) | Model 220 up to VIN: 316716<br><b>⚠</b> If the connectors are not in the correct position, damage can occur when the covering (1) is installed. | |

| 6 | Push on paneling (1) | <p>Ensure that the covering (1) is arrested in the end position by the bottom catch spring (2) or top catch spring (7).</p> <p>Model 220 up to VIN: 316716</p> <p>ⓘ Ensure that the turn signal connector is connected properly to the outside rearview mirror (5).</p> | |

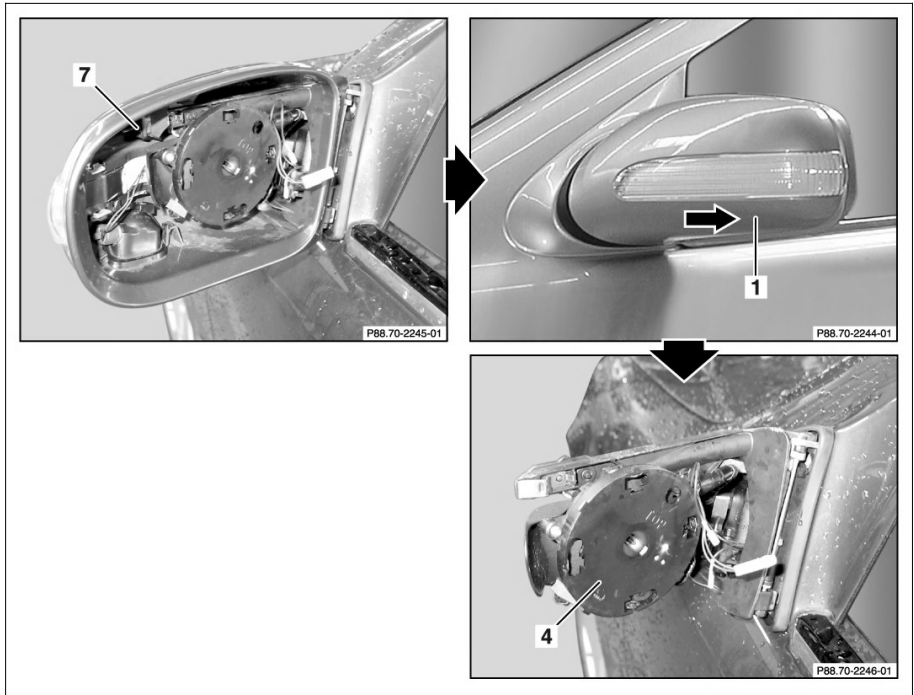
P88.70-2243-06

Shown on model 220 as of VIN: 316717

- 1 Paneling
- 4 Outside mirrors
- 7 Upper catch spring

| ☒ | Remove | | |
|---|---|---|---|
| 1.1 | Remove mirror glass | Model 220 as of VIN: 316717 | AR88.70-P-9020M |
| 2.2 | Release top catch spring (7) | Model 220 as of VIN: 316717<br><b>i</b> Avoid damaging paint. | |
