MODEL 169.0 /3, 245.2

Remove/install

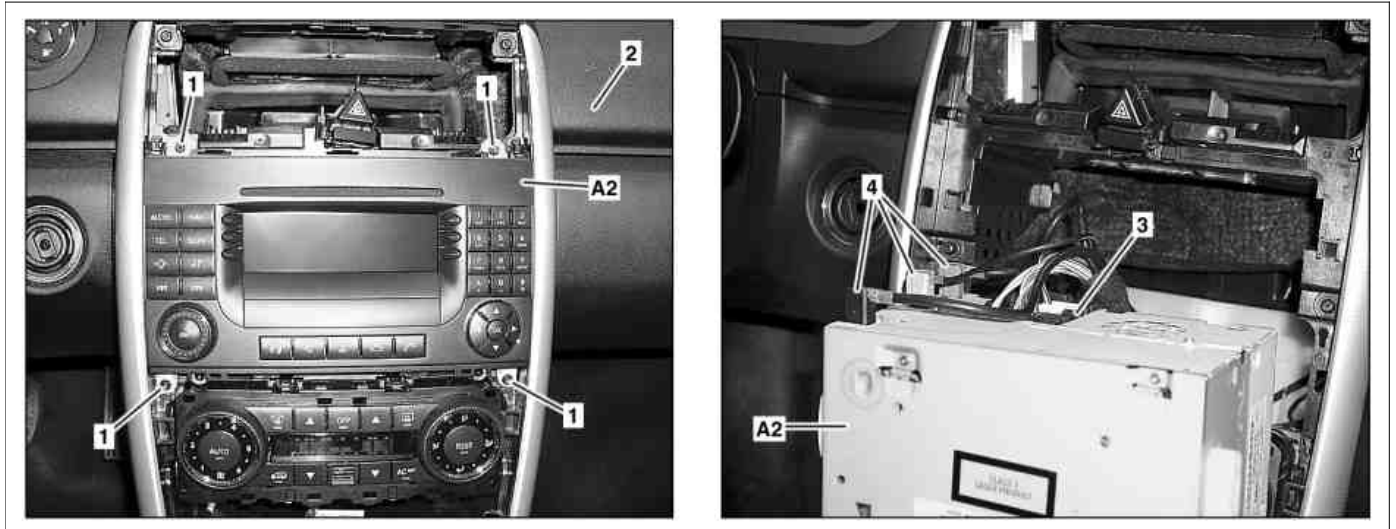
P82.60-4765-08

Shown on model 169.0 with code (523)

MB Audio 20 radio

1 Screw

2 Instrument panel

3 Fiber optic cable coupling (not with code (520) Audio 5 CD radio)

4 Electrical connectors

A2 Radio

Connect STAR DIAGNOSIS and read out fault memory	i Installation: transfer temporarily stored basic data to the new radio (A2).	AD00.00-P-2000-04AK
2	Remove center air vent		AR83.10-P-4503AK
3	Remove control and operating unit cover		AR68.20-P-2314AK
4	Remove bolts (1)		
5	Release latching hook at top of HEAT control and operating unit, AAC or C-AAC	For vehicles with code (520) Audio 5 CD radio	
6	Pull radio (A2) out of instrument panel (2) until rear of radio (A2) is accessible		
7	Release, disconnect and cover fiber optic cable coupling (3)	Not for vehicles with code (520) Audio 5 CD radio

8	Disconnect electrical connectors (4) and remove radio (A2)	i The number of electrical connectors (4) can vary depending on the vehicle equipment.	
9	Install in the reverse order
