Instructions for removing/replacing the seatbelt feeder mechanism

07 W209 CLK coupe, but probably similar for other years.

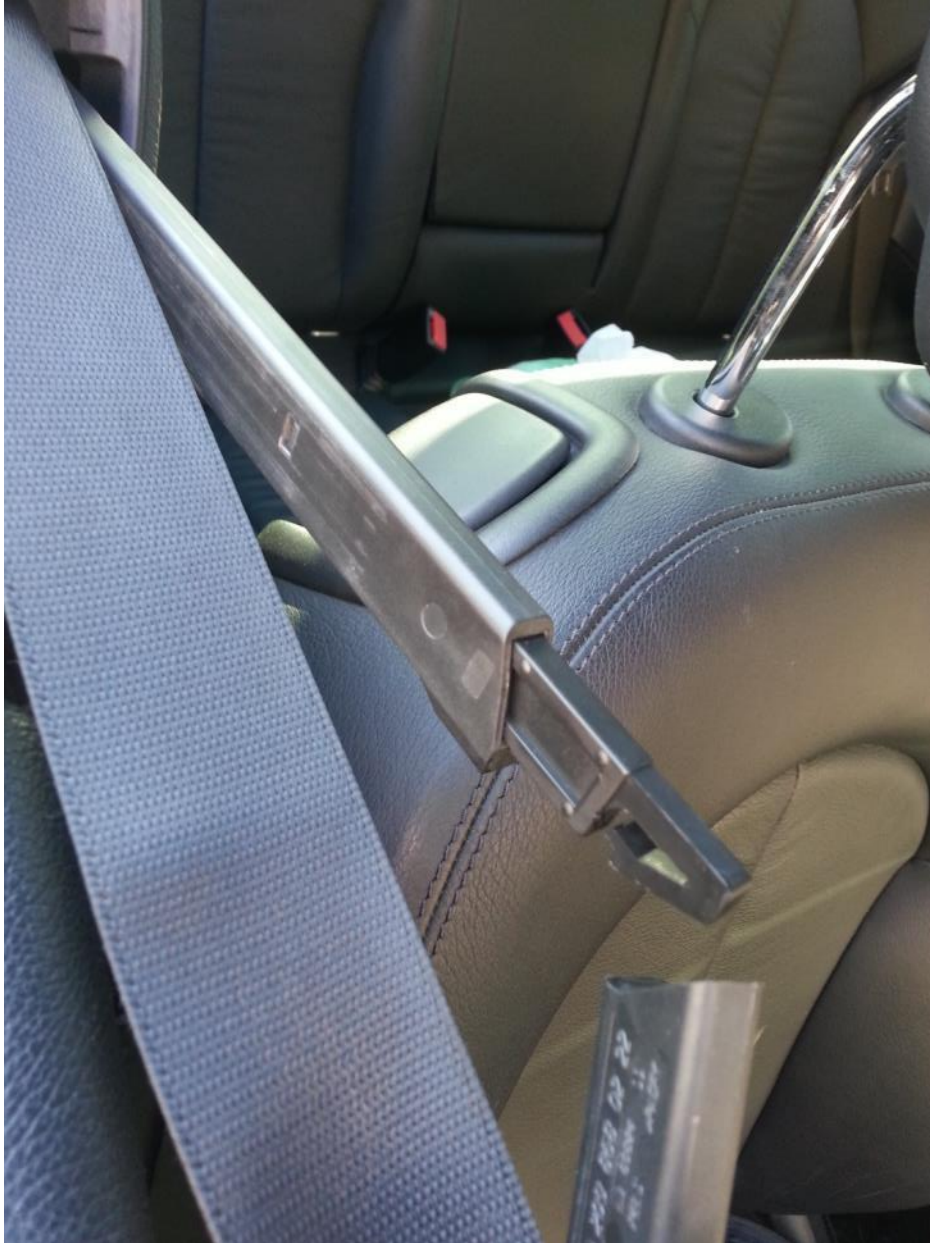
1. This is actually optional but helps a bit to make things a bit easier down the road. Remove the front part of the feeder arm. There's a little hold in the bottom of the extendable part that you can get at with a thin flathead screwdriver or something of that nature. Takes a bit of effort to get it done.

Obviously turn the car on to accessory and open+close the door to get the arm to extend.

If your arm does not extend, no biggie. Just pull it out by hand, carefully so you don't ruin it somehow (leave the car off)... you can even remove the whole arm if you like.

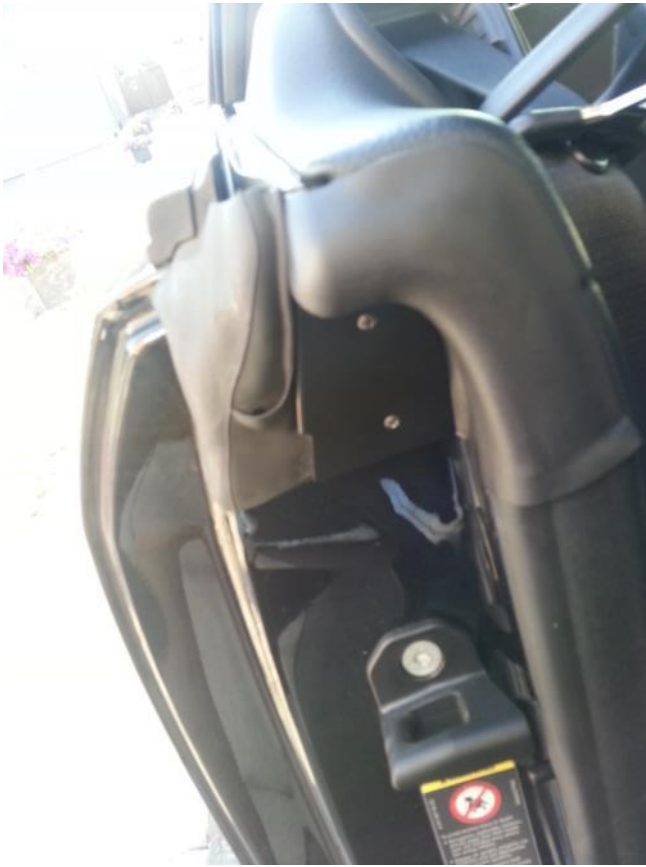
2. Get these two screws off.

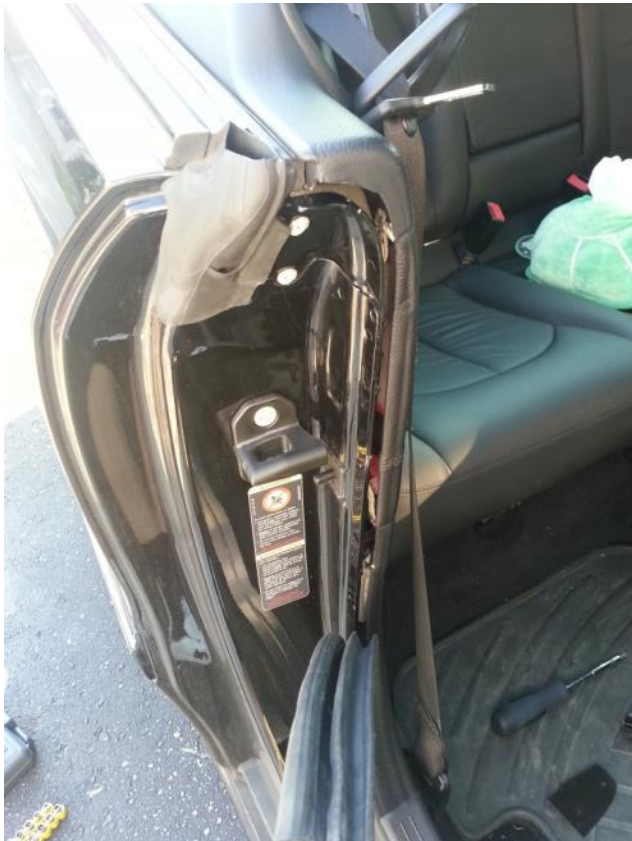
3. And remove the rubber weather stripping. Two pieces, one smallish rubbery “elbow” piece and the big weatherstripping piece that goes down to the sill.

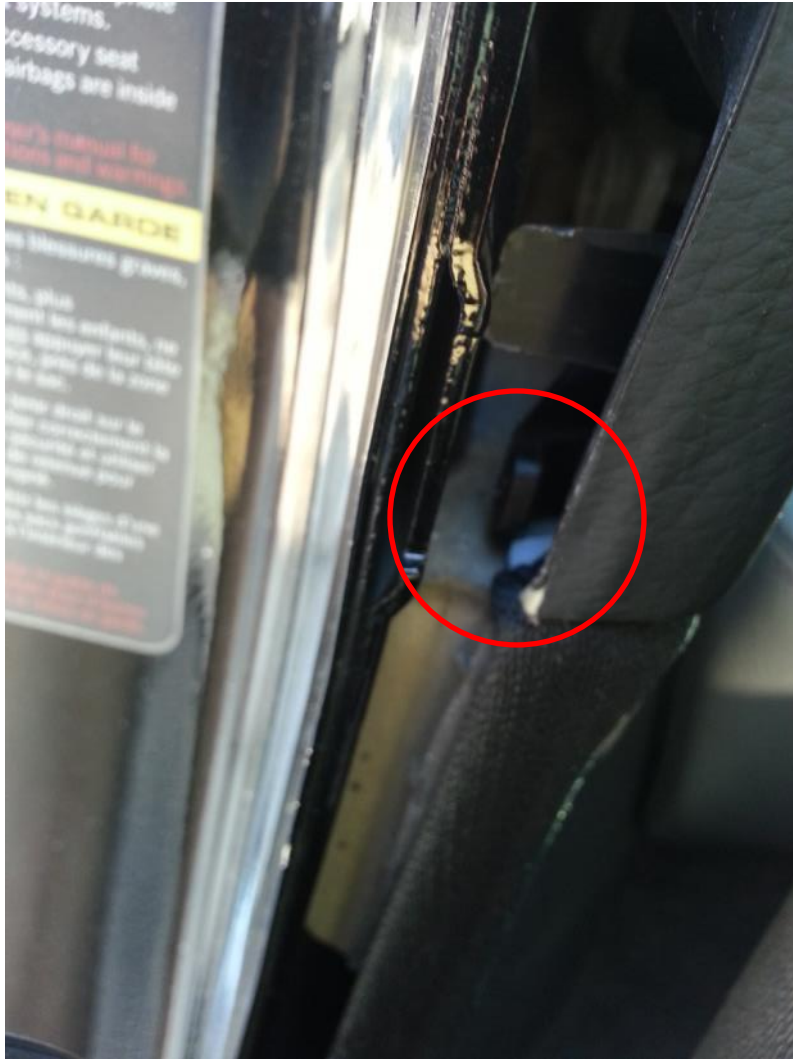
4. About $\frac{3}{4}$ of the way down the door there is a tiny little plastic tab thing. It has a hole in it. You need to use some needle nose pliers or something to grab it and pull it out. That will release the clips.

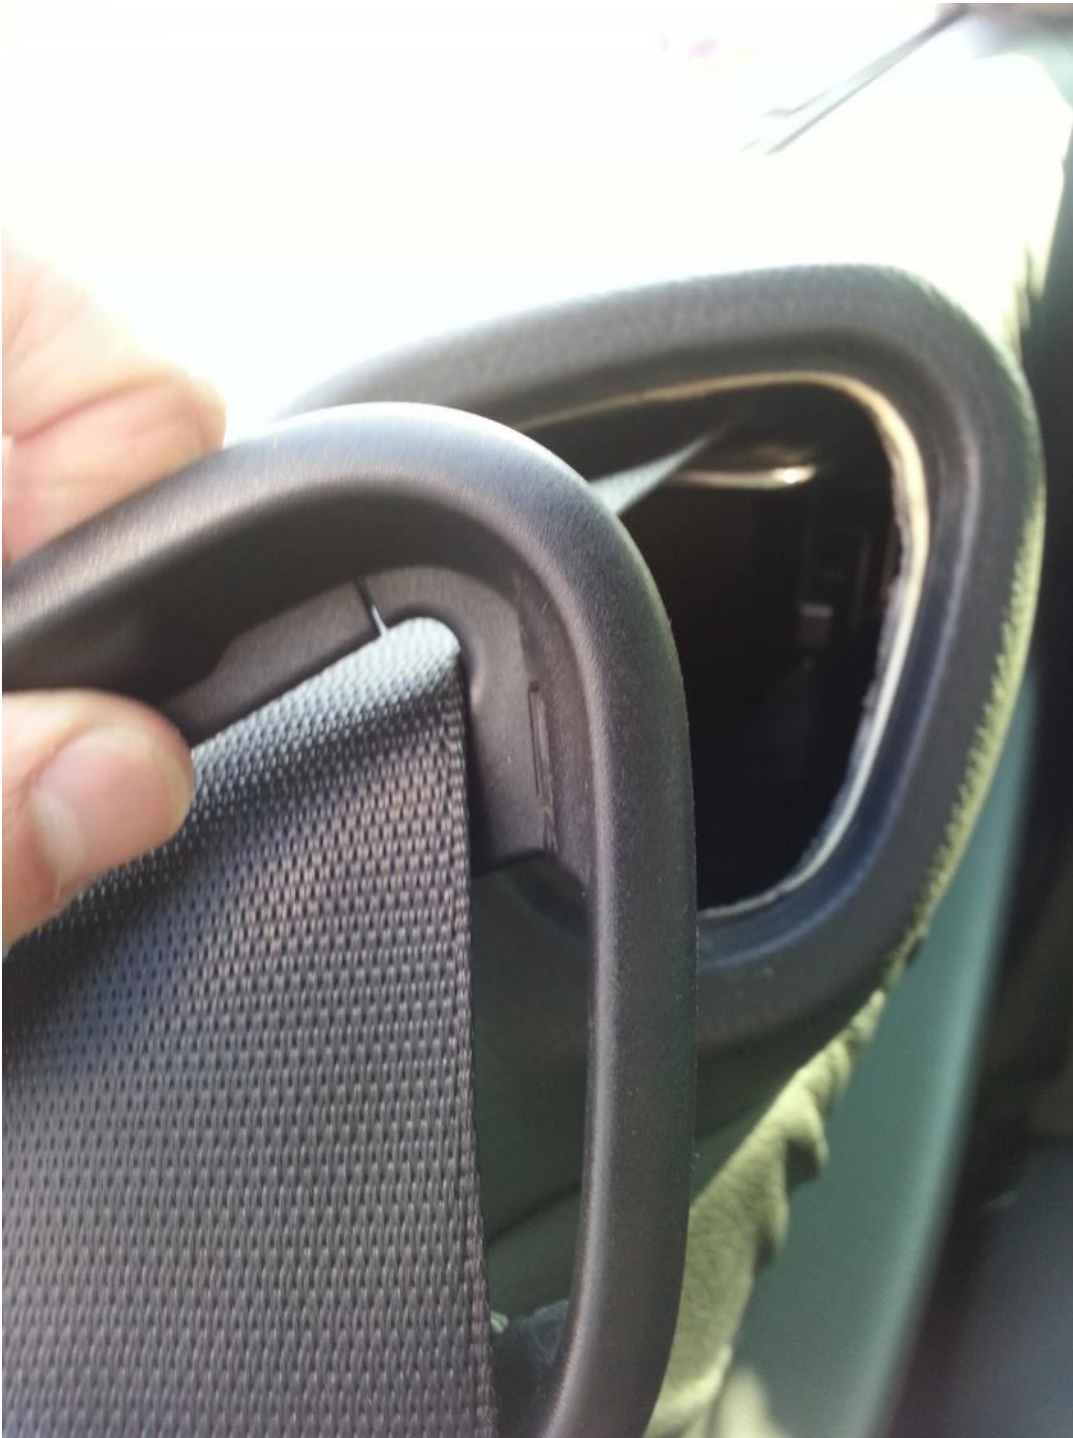
5. Remove this plastic thing. Press up first, easier.

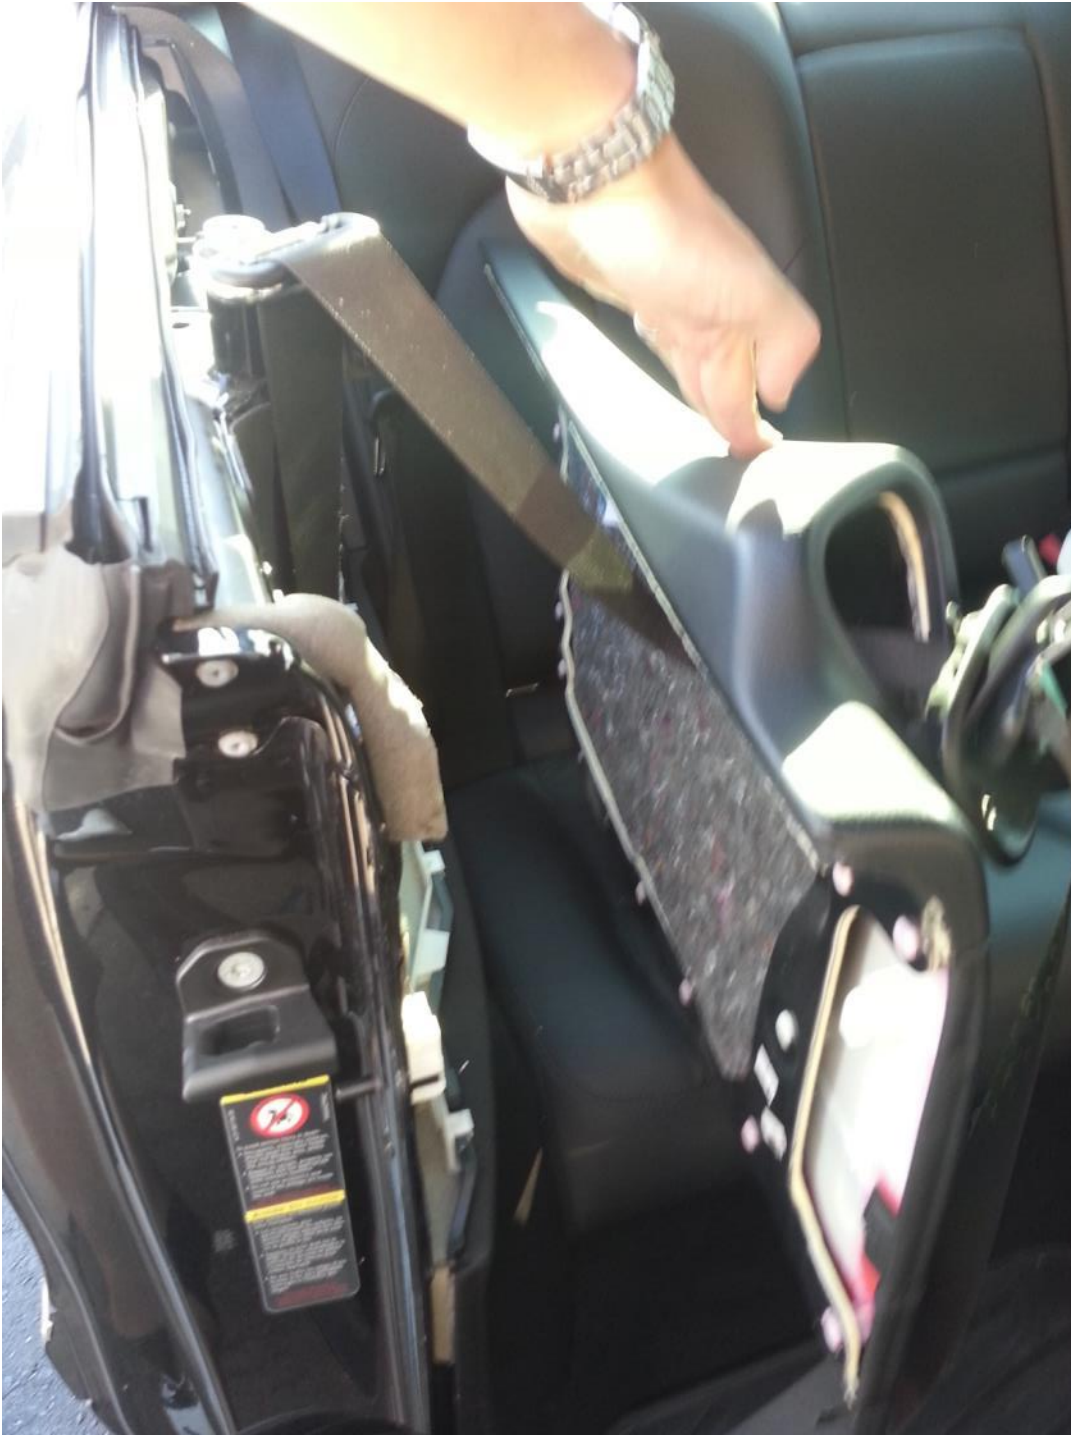
6. Now the entire side panel can just come off. There are two clips on the rear side that hold it down. Just lift from the rear/bottom area where it meets the rear seats. May take a bit of effort and might accidentally remove some of the window weatherstripping....no biggie just press it back in. You can lay the whole thing flat on the back seat.

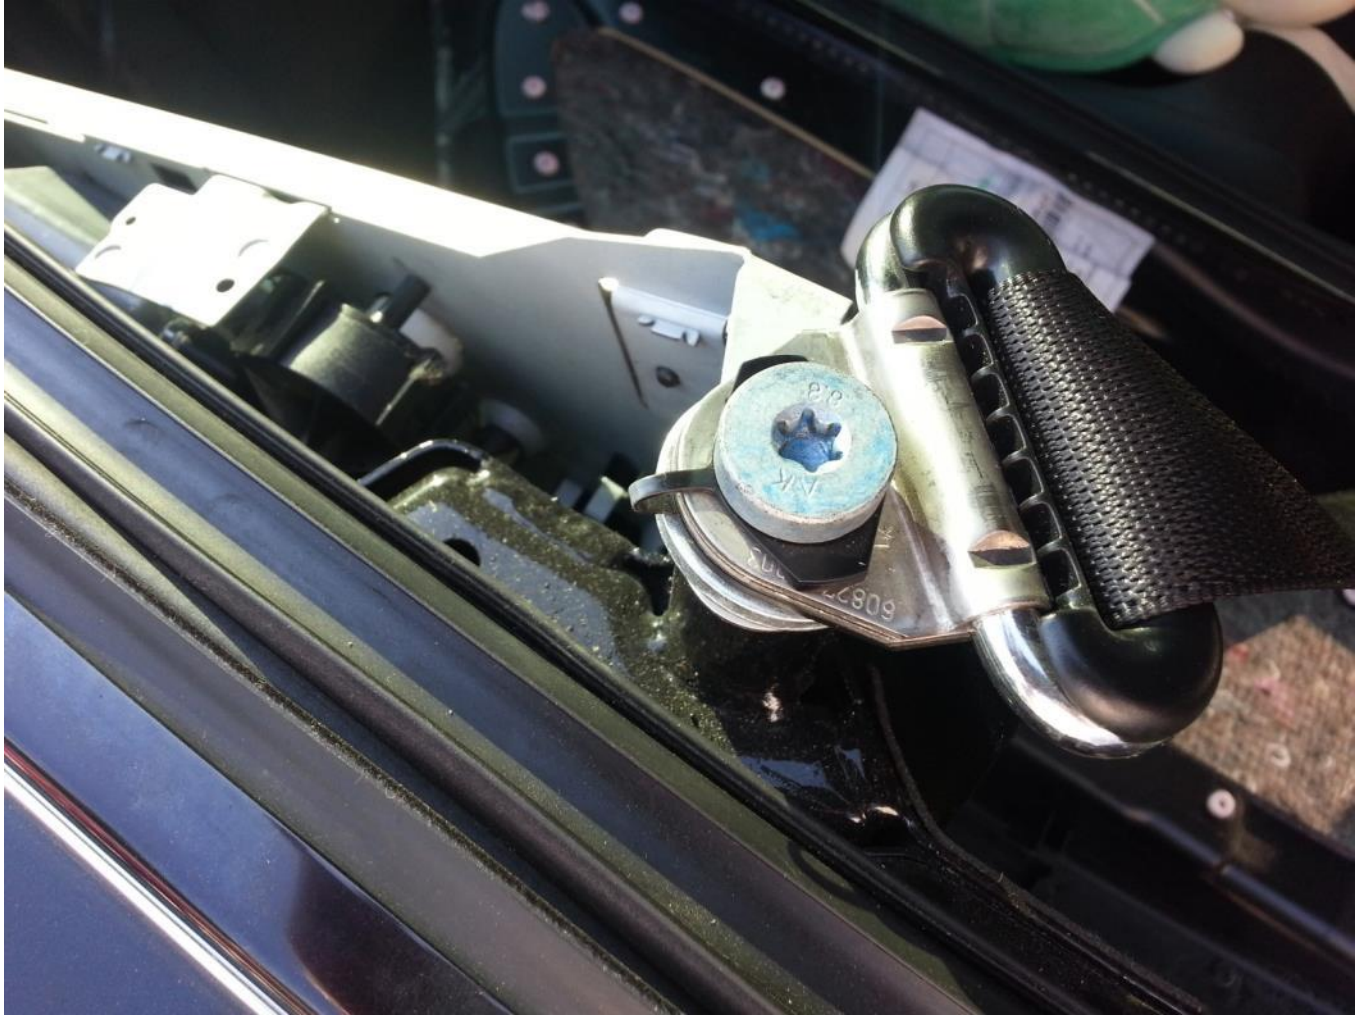
7. Now get the T45 socket bit. Remove this massive bolt that holds your seatbelt shoulder mount point to the frame of the car. **Be careful. There's quite a few washers in there, and I assume they all have a reason to exist. Don't lose anything. Torque spec is 30 Nm or about 22 lbft, so a standard size wrench should be plenty.**

12. Reinstall in reverse order. You need to torque the T45 seatbelt mount bolt properly. This is where the torque wrench comes in.

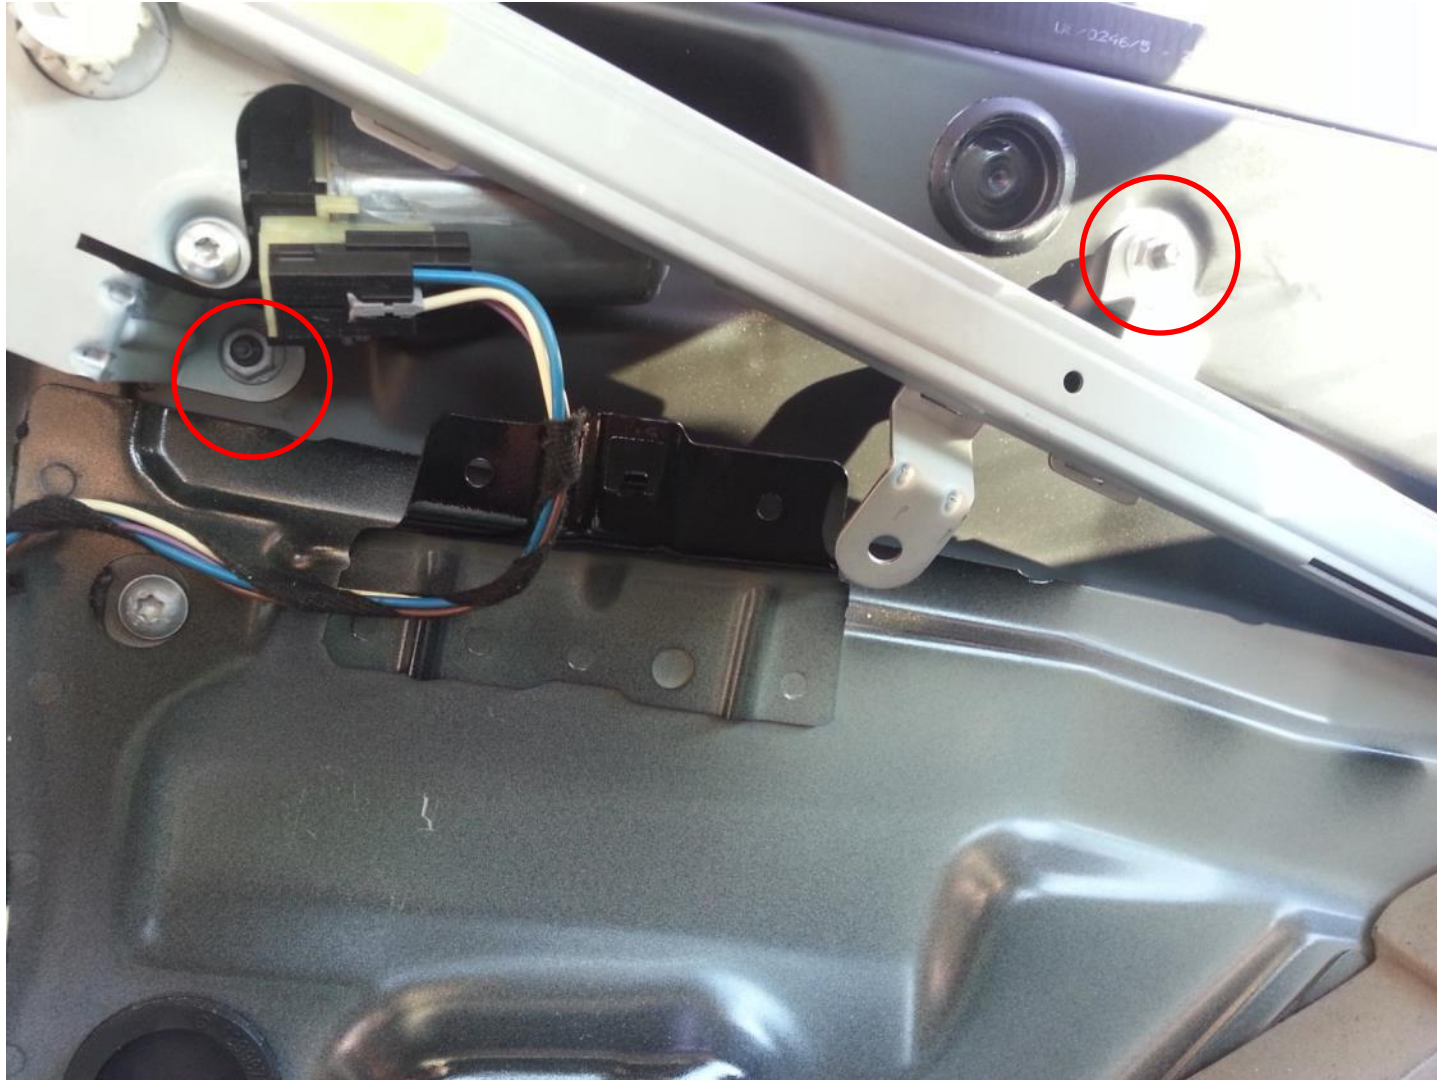
8. The assembly is held on by two 10mm nuts. Remove them. Don't drop anything – if you do, solid chance the nut ends up in the deep recesses of the door panel that would be a huge pain to get to...imagine years of endless rattling. Be cautious. Also, remove the wiring molex thing. A screwdriver (precision type) helps here.

Note the pic is taken from inside the car.

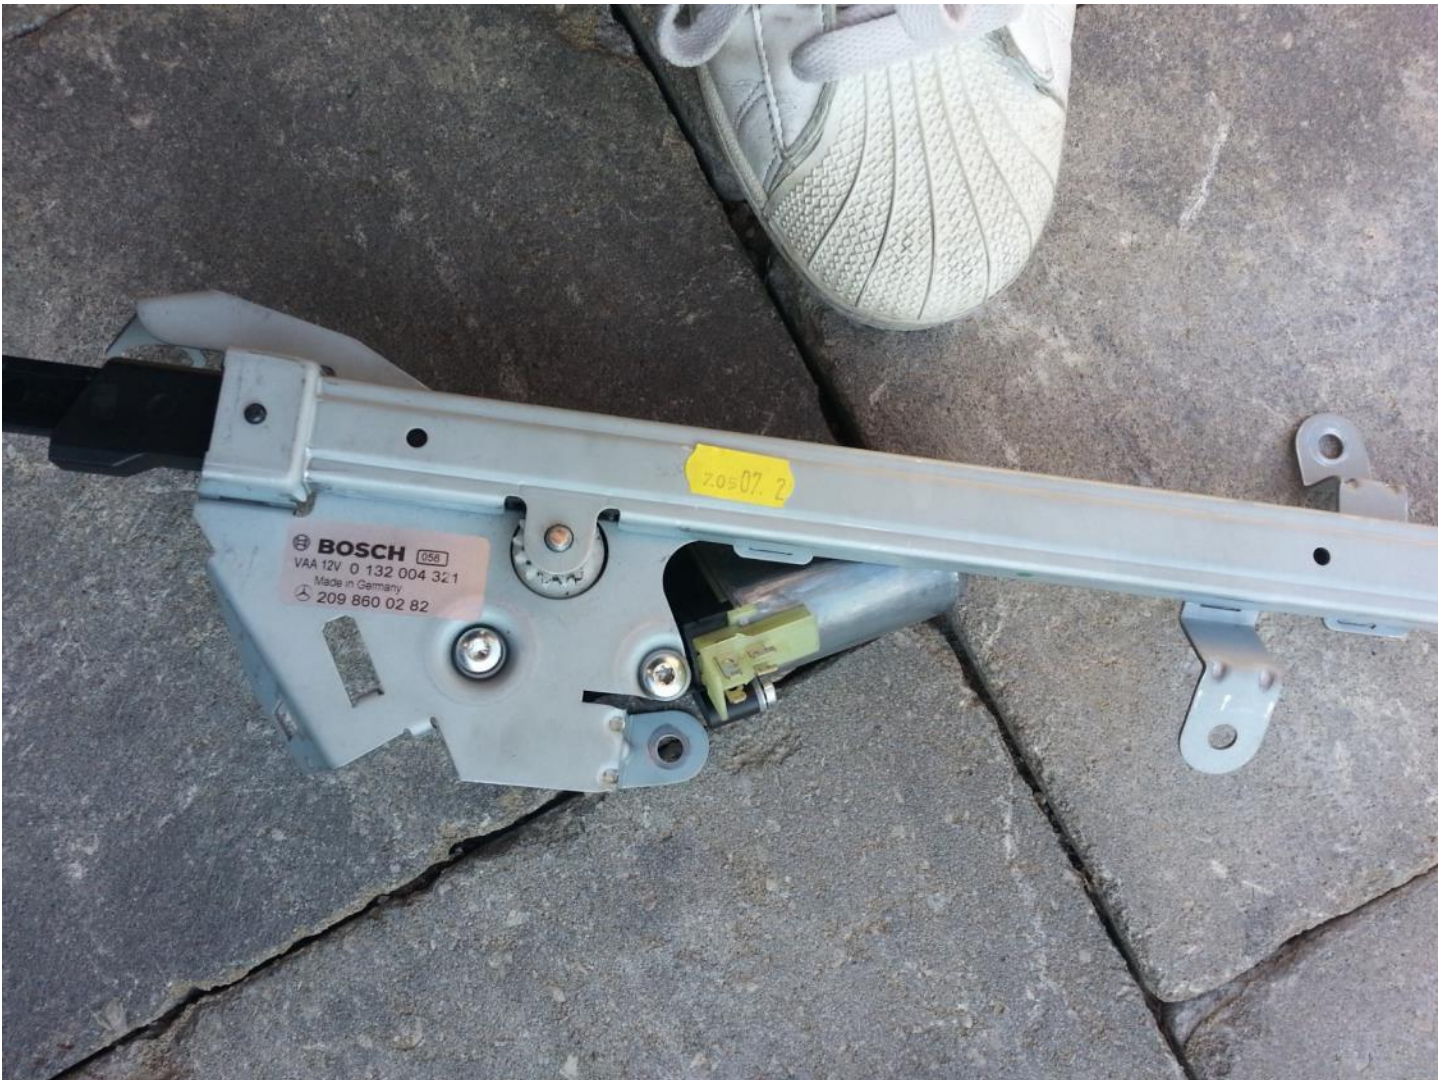
9. The assembly comes right out now. If you haven't already, remove the plastic arm by pulling SLOWLY. You will be forcing the sprocket to drive the worm gear of the motor, so don't yank like it's the apocalypse. If you need to, you can remove the motor with a T20. The two screws below.

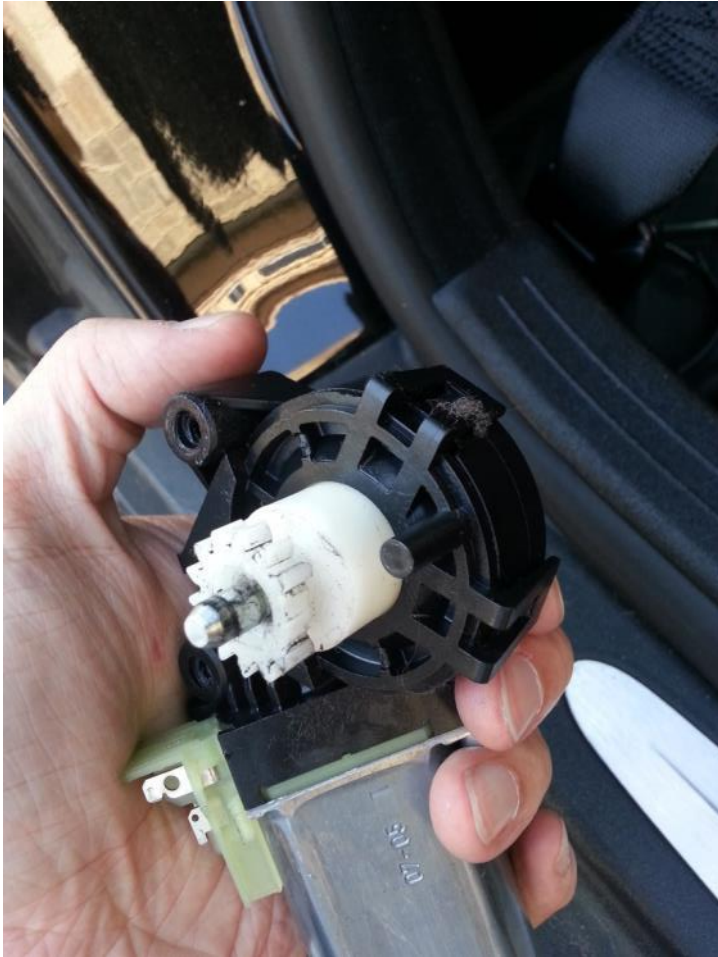
10. The culprit in my case. Note a tooth is missing from the sprocket. The whole thing is held on by three clips which you can just pry off. Open it up and replace the sprocket if that's what you need to do. Or just replace the whole motor.

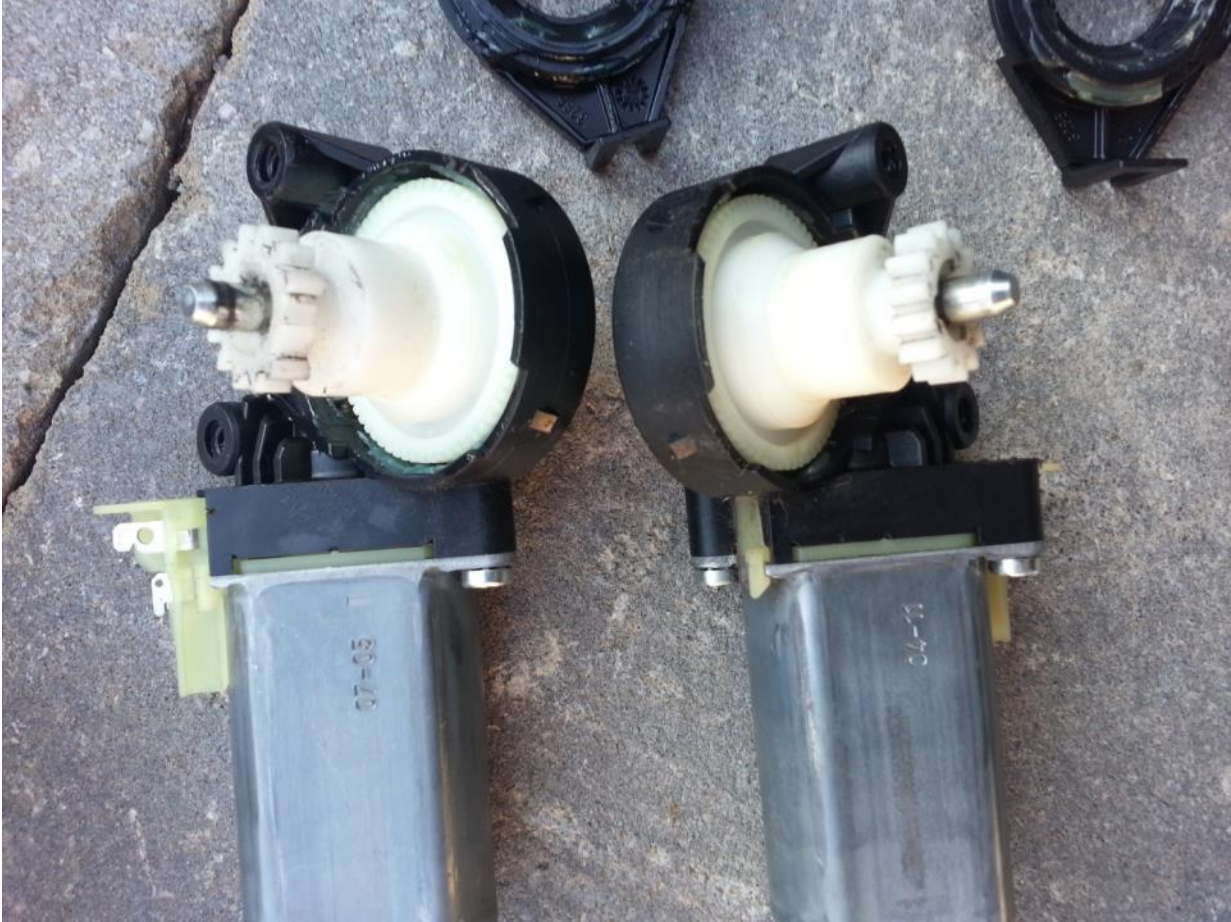
11. Good sprocket with bad sprocket. Side by side.

The two motors might actually be the same, just with the plastic output side reversed. The mounting is rotationally symmetric I believe (haven't verified, but that's my guess).
