Model 218.3

Shown up to model year 2015

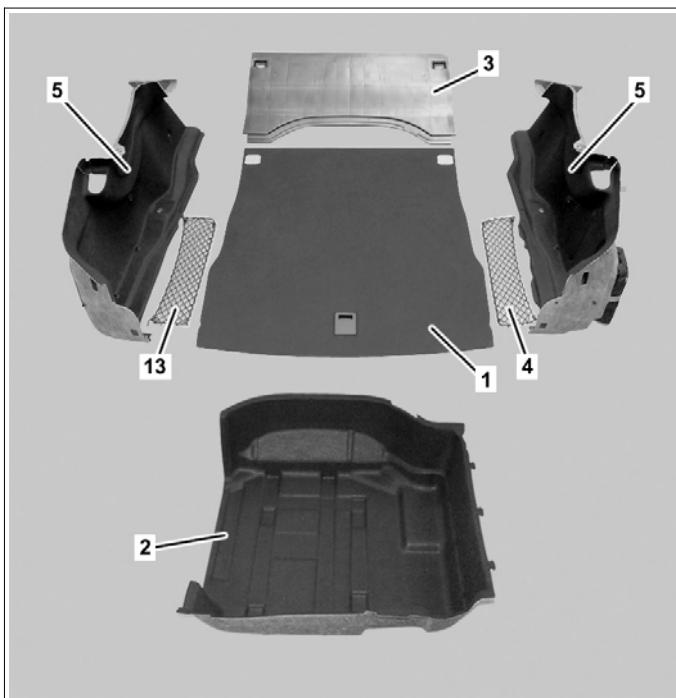
P68.30-3549-12

- 1 Cover
- 2 Spare wheel well paneling (except CODE U42 (Diesel exhaust treatment BlueTEC (SCR)) and except CODE U77 (Diesel exhaust treatment BLUETEC (SCR)))
- 3 Trim on trunk floor, front
- 4 Right luggage net (up to model year 2015)
- 5 Side paneling
- 13 Left luggage net

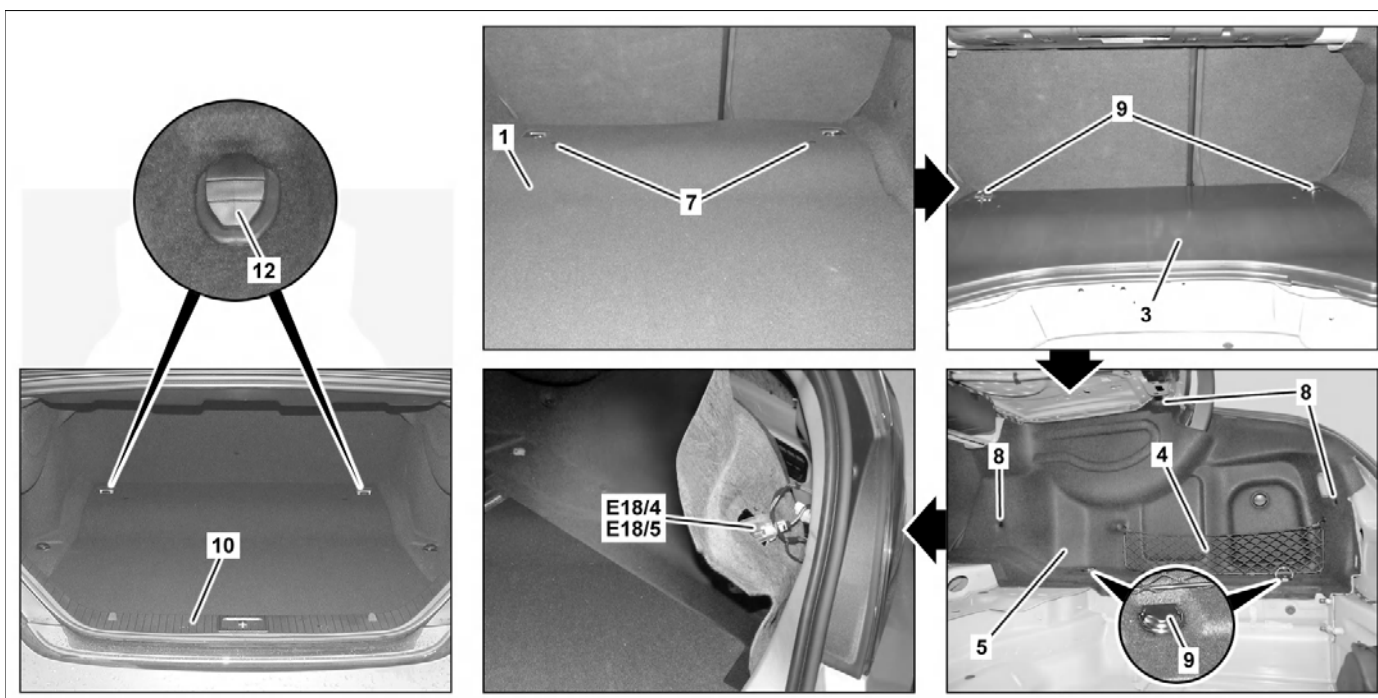
P68.30-3550-09

| 1 | Cover | 7 | Retaining clips | 12 | Tie-down hooks (except CODE 287 (Folding rear seat backrests)) |
| 3 | Trim on trunk floor, front | 8 | Retaining clips | E18/4 | Right luggage compartment lamp |
| 4 | Right luggage net (up to model year 2015) | 9 | Tie-down eyes (with CODE 287 (Folding rear seat backrests)) | E18/5 | Left luggage compartment lamp |
| 5 | Side paneling | 10 | Rear center section paneling | | |

Remove/install		
1	Remove retaining clips (7)

Clip remover	*452589016300
2	Remove cover (1)		
3.1	Remove spare tire well paneling (2)	Model 218.3 except code U42 (BlueTEC diesel exhaust treatment (SCR)) except code U77 (Diesel Emission control BLUETEC (SCR))

Clip remover	*452589016300
7	Remove front trunk floor paneling (3)		
8	Remove right luggage net (4) from right side paneling (5)	Model 218.3 up to model year 2015	
9	Remove left luggage net (13) from left side paneling (5)		
10	Remove retaining clips (8) from left and right side paneling (5)

Clip remover	*452589016300
11	Unclip left trunk lamp (E18/5) and right trunk lamp (E18/4) and lay down to side with electrical line connected		
12	Lift right side paneling (5) and disconnect electrical connector from cargo area socket	Model 218.3 with code 460 (Canada version) Model 218.3 with code 494 (US version)	
13	Detach side paneling (5) in lower area of trunk floor, pull toward center of trunk and remove

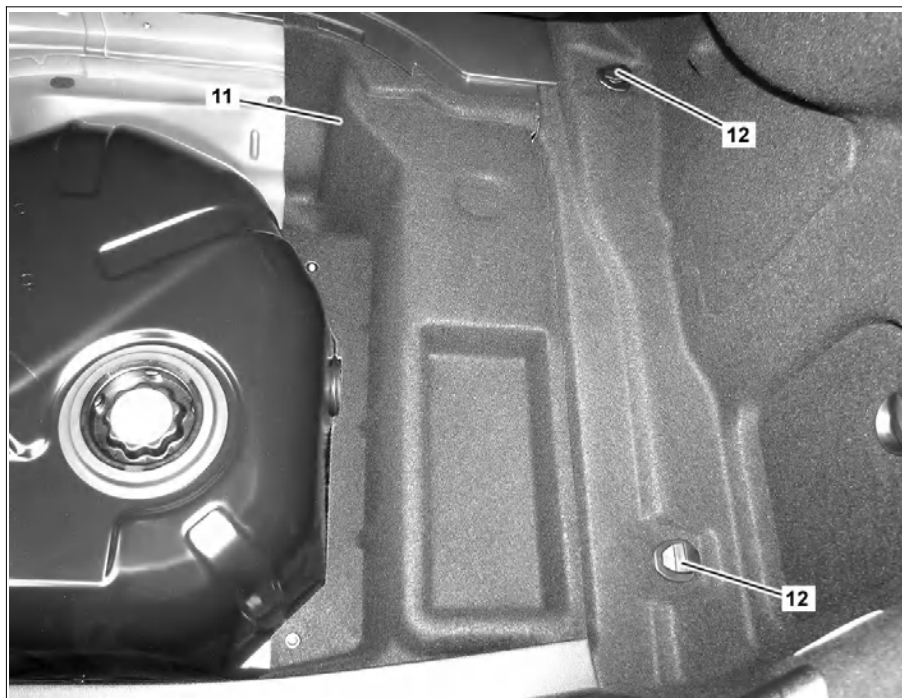
P68.30-3802-06

Shown as of model year 2015 on right side of vehicle except CODE 287 (Folding rear seat backrests) with CODE U77 (Diesel exhaust treatment BLUETEC (SCR))

- 11 Side paneling (with CODE U42 (Diesel exhaust treatment BlueTEC (SCR)) or with CODE U77 (Diesel exhaust treatment BLUETEC (SCR)))
- 12 Tie-down hooks (except CODE 287 (Folding rear seat backrests))

3.2	Remove side paneling (11)	Model 218.3 with code U42 (BlueTEC diesel exhaust treatment (SCR)) Model 218.3 with code U77 (Diesel Emission control BLUETEC (SCR))	
4	Remove rear center section paneling (10)		AR68.30-P-4785EW

Screw/bolt for tie-down eye	*BA68.50-P-1001-03I
6.2	Release tie-down hook (12) with suitable screwdriver and then unclip	Model 218.3 except code 287 (Folding rear seat backrests)
