- Parts list -

Mode	BM mode	BM overview	CLS 500
VIN/mod. des.	WDD2183731A096870	Catalog	D33
VIN	WDDLJ7DB6EA096870	Group	50 RADIATOR
Assortment class	PC	Sub-group	165 EXPANSION TANK, MOUNTING AND HOSES
Market

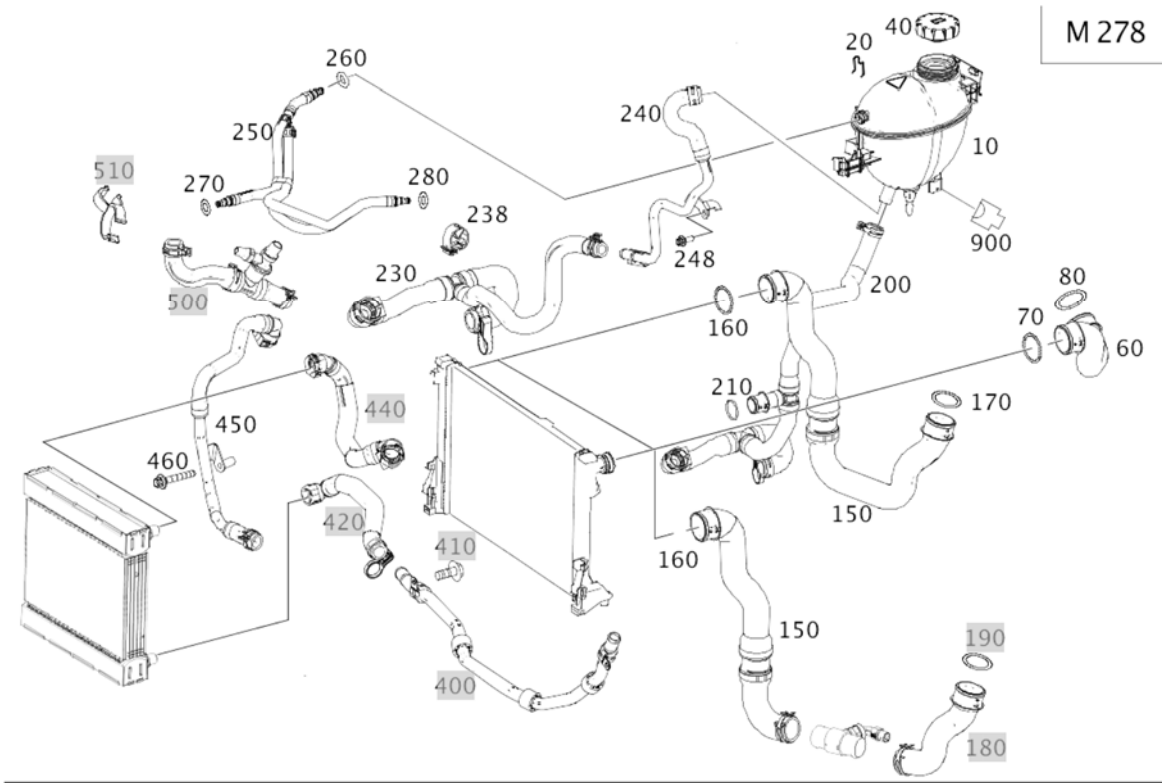
Image ID: drawing_B50165000425

Item	Part number	Designation/additional information	Qty
10	A 204 500 06 49	EXPANSION RESERVOIR Replaced by: A 204 500 09 49 Code: M278+-228/M157;	1
10	A 204 500 09 49 ⚙️	EXPANSION RESERVOIR Replaces: A2045000649 Code: M278+-228/M157; 🔧 Fault location 50101	1
20	A 007 993 40 01 ⚙️	* CATCH SPRING DE-AERATION LINE TO EXPANSION TANK; 8.8 MM Code: M278/M157; 🔧 Fault location 5001W	1
40	A 210 501 06 15	CAP ON COMPENSATION RESERVOIR 🔧 Fault location 50101	1
