Model 204, 207, 212, 218

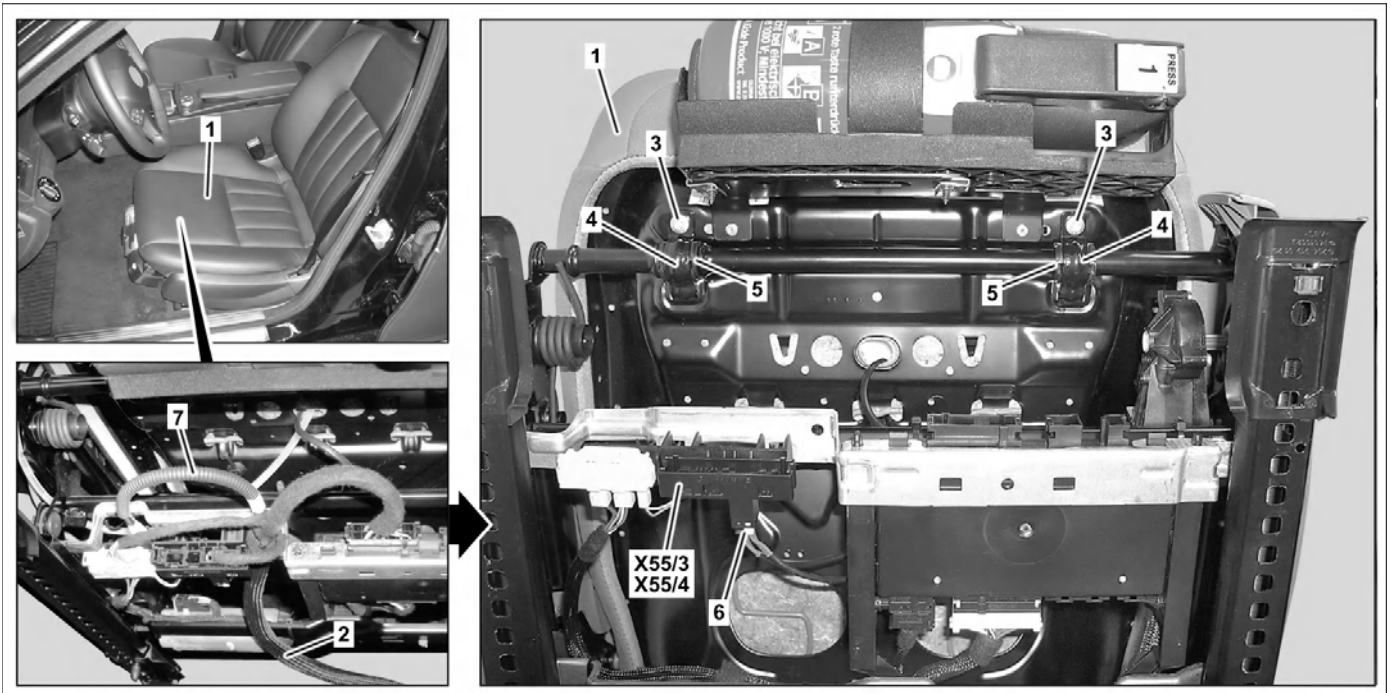
P91.10-3252-09

Shown on MODEL 204.0 with CODE 409 (Left/right front multicontour seats) and CODE 873 (Seat heater for driver and front passenger)

| 1 | Seat cushion | 6 | Electrical connector for seat heaters |
| 2 | Electrical wiring harness | 7 | Pneumatic line |
| 3 | Screw | X55/3 | Driver seat connector block |
| 4 | Bow | X55/4 | Front passenger seat connector block |
| 5 | Bearing shell | | |

4	Remove stowage box under seat	Model 204 with code 932 (Stowage box under both front seats)	
5	Expose electrical wiring harness (2) at seat adjustment unit and disconnect at driver seat connector block (X55/3) or front passenger seat connector block (X55/4)		
6	Disconnect pneumatic line (7) from bottom of seat adjustment unit	Model 204 (except 204.9), 207, 212, 218 with code 409 (Left/right front multicontour seat) Model 212, 218 with code 432 (Left and right dynamic multicontour seat)

10	Expose pneumatic lines (10) at bottom of seat cushion (1)	Model 204 (except 204.077/277/9), 207, 212, 218 with code 409 (Left/right front multicontour seat)	
11	Unclip driver seat connector block (X55/3) or front passenger seat connector block (X55/4) and turn to one side until seat heater electrical connector (6) can be disconnected	Model 204, 207, 212, 218 with code 873 (Seat heating for driver and front passenger)	
12	Disconnect seat heater electrical connector (6) from driver seat connector block (X55/3) or front passenger seat connector block (X55/4)	Model 204, 207, 212, 218 with code 873 (Seat heating for driver and front passenger)	
13	Fold housing halves of seat heater electrical connector coupling (6) away from one other	Model 204, 207, 212, 218 with code 873 (Seat heating for driver and front passenger)	
14	Disconnect seat occupied recognition electrical connector at front passenger seat connector block (X55/4)	When removing the seat cushion (1) at the passenger side.

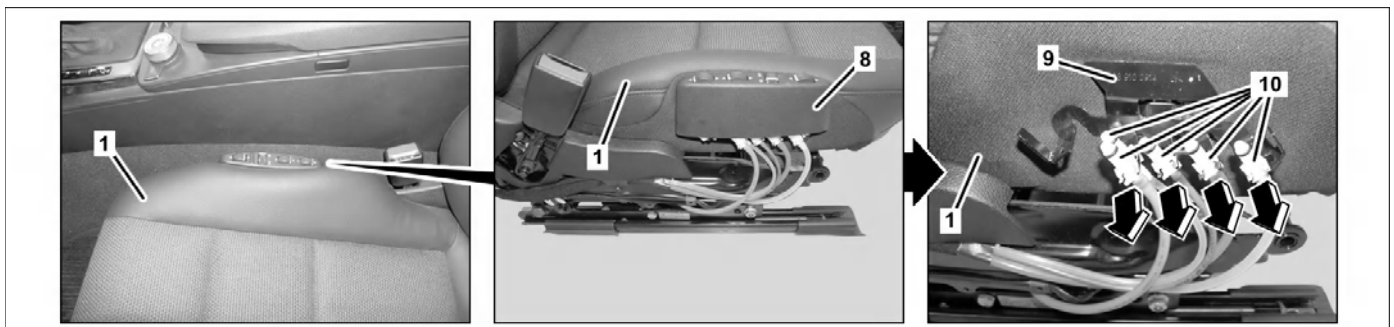
P91.10-3253-07

MODEL 204.0/2/3 (except 204.077/277), 207, 212, 218 with CODE 409 (Left/right front multicontour seat), shown on left front seat

| 1 | Seat cushion | 9 | Bracket |
| 8 | Control valve | 10 | Pneumatic lines |

Pliers	*000589043700
7	Remove the switch group for the dynamic seat	Model 212 up to model year 2014 with code 432 (Left and right dynamic multicontour seat) Model 218 up to model year 2015 with code 432 (Left and right dynamic multicontour seat)	AR91.25-P-1820EW
8	Remove control valve (8)	Model 204 (except 204.077/277/9), 207, 212, 218 with code 409 (Left/right front multicontour seat)	AR91.25-P-1710CW
9	Unclip pneumatic lines (10) from bracket (9)	Model 204 (except 204.077/277/9), 207, 212, 218 with code 409 (Left/right front multicontour seat)

<b>Installation:</b> Ensure correct routing and attachment of pneumatic lines (10).

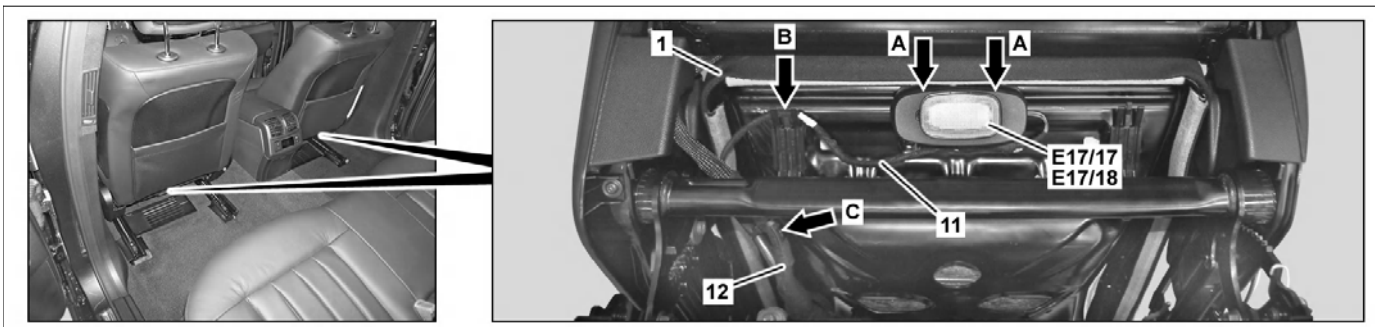
P91.10-3457-07

**MODEL 218, 212 with CODE 954 (Avantgarde) or with CODE 955 (Elegance)**

| 1 | Seat cushion | E17/17 | Left rear footwell lamp |
| 11 | Electrical wiring harness | E17/18 | Right rear footwell lamp |
| 12 | Electrical wiring harness | | |

15	Raise seat cushion (1) at rear and unclip left rear footwell lamp (E17/17) or right rear footwell lamp (E17/18) at seat cushion (1) (arrows A)	Model 212, 218 with code 954 (Avantgarde) Model 212, 218 with code 955 (Elegance)	
16	Unclip electrical wiring harness (11) at seat cushion (1) from bracket (arrow B)	Model 212, 218 with code 954 (Avantgarde) Model 212, 218 with code 955 (Elegance)	
17	Unclip electrical wiring harness (12) at bottom of seat cushion (1) (arrow C)	Model 212	
18	Expose electrical lines belonging to seat cushion (1) at seat adjustment unit

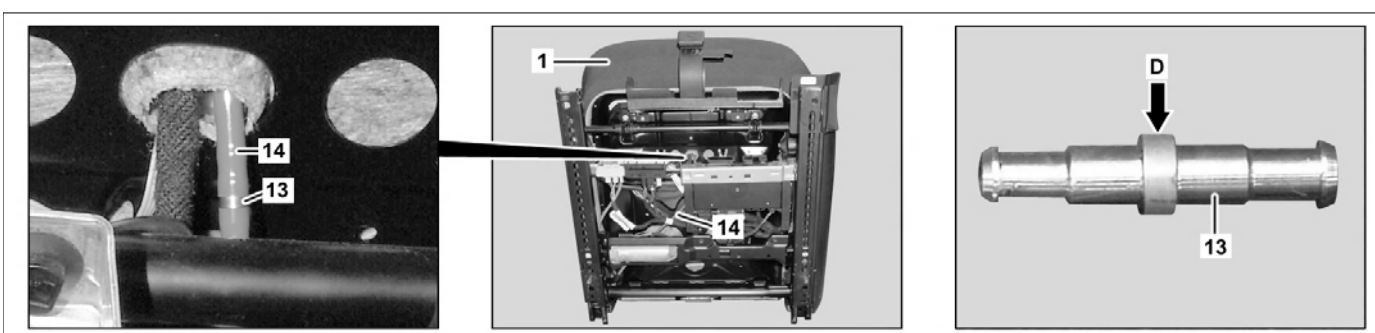
P91.25-2511-07

**MODEL 212, MODEL 218 up to model year 2015 with CODE 432 (Left/right dynamic multicontour seat)**

| 1 | Seat cushion | 13 | Terminal blocks | 14 | Pneumatic line |

19.1	Cut through pneumatic line (14) below seat cushion (1) at an easily accessible location	Model 212 with code 432 (Left and right dynamic multicontour seat) Model 218 up to model year 2015 with code 432 (Left and right dynamic multicontour seat)

Do not disconnect the pneumatic line (14) at an existing terminal block (13). Otherwise, leaks can occur at the pneumatic line (14).

<p><b>i</b> <b>Installation:</b> Connect pneumatic line (14) as shown using a terminal block (13). Slide both sides of pneumatic line (14) up to collar (arrow D) onto terminal block (13).</p> <p>
