Engine 256.9 in model 167

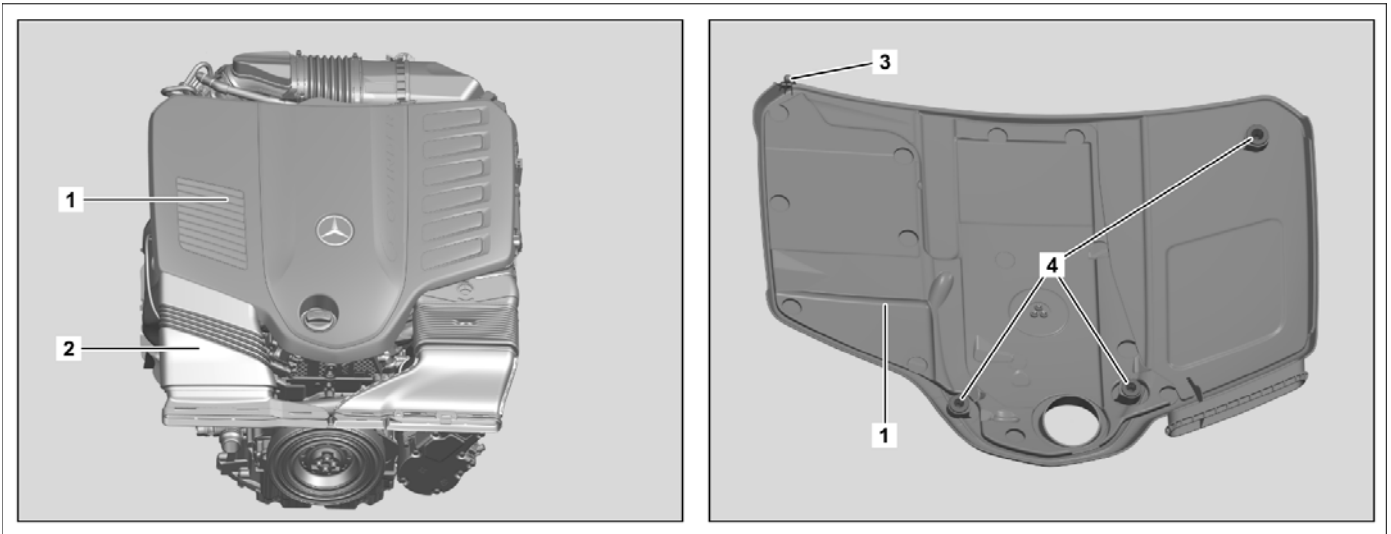
P01.10-3379-08

- 1 Engine cover
2 Cold air guide

- 3 Ball head
4 Elastomer bearing

Caution	Risk of injury caused by scraping or cutting body parts on sharp vehicle parts	Always wear protective gloves when working on or near sharp and non-deburred vehicle parts. Deburr repair panels.	AS00.00-Z-0017-01A
	Remove/install		
1	Release cold-air ducting (2) at cold air intake manifold.		
2	Detach ball head (3) from the elastomer bearing on the air filter housing.	Installation: Coat elastomer bearing at air filter housing with antiseize paste. Lubricant, rubber assembly 1 l	*BR00.45-Z-1010-06A
3	Release elastomer bearings (4) and remove engine cover (1) with cold-air ducting (2) in upward direction.	Installation: Coat elastomer bearings (4) with antiseize paste. Lubricant, rubber assembly 1 l	*BR00.45-Z-1010-06A
4	Check the elastomer bearings (4) and the elastomer bearing at the air filter housing for damage, and replace them if necessary.		
5	Install in the reverse order.
