P82.62-3498-09

- N40/3 Sound system amplifier control unit

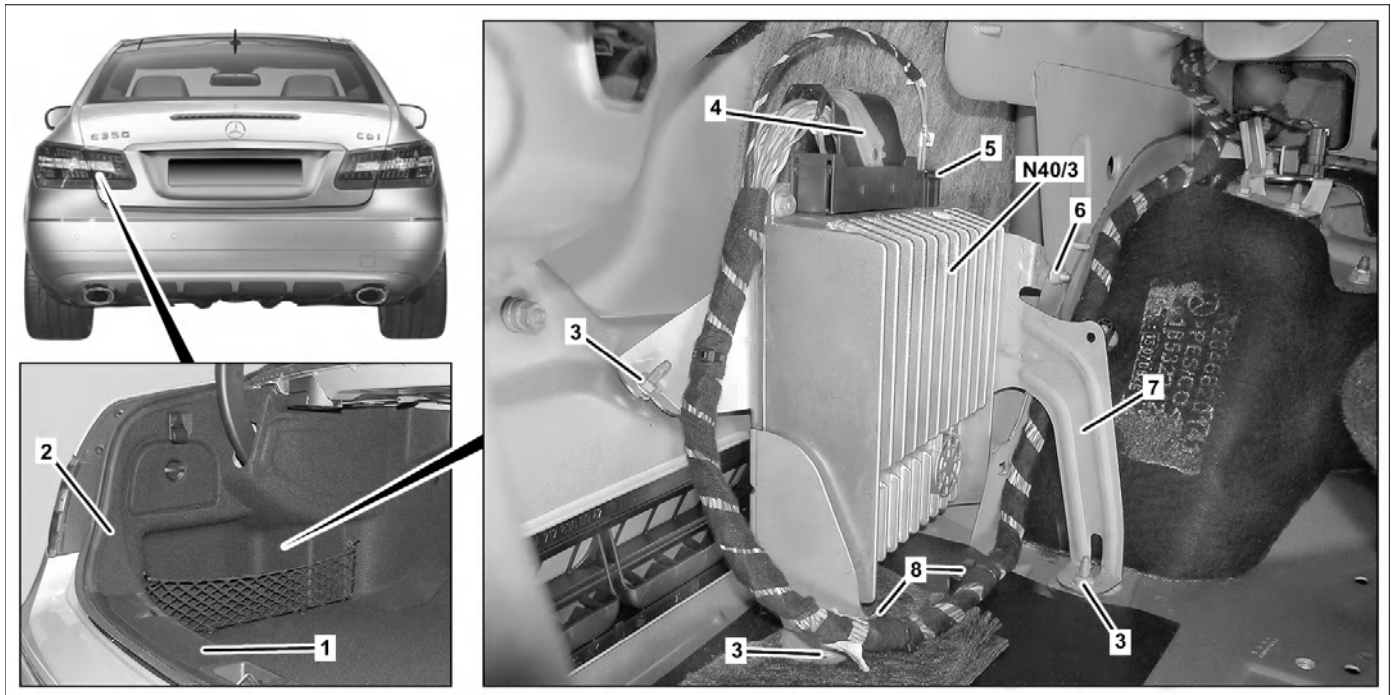
- 1 Rear center section paneling  
 2 Left side paneling  
 3 Nut  
 4 Electrical connector

- 5 Electrical connector with fiber optic cable  
 6 Nut  
 7 Bracket  
 8 Clip

Remove/install		
	Information on preventing damage to electronic components due to electrostatic discharge		AH54.00-P-0001-01A
	Notes on avoiding damage to fiber optic cables during repair work		AH82.60-P-0001-05AK
1	Buffer basic data of sound system amplifier control unit (N40/3) in STAR DIAGNOSIS	When replacing the sound system amplifier control unit (N40/3). <b>i</b> <b>Installation:</b> Transmit buffered basic data to new sound system amplifier control unit (N40/3).	
AD	Connect STAR DIAGNOSIS and read out fault memory		AD00.00-P-2000-04A
2	Switch off ignition and remove transmitter key or KEYLESS-GO start/stop button from electronic ignition lock control unit	<b>i</b> KEYLESS-GO start/stop button only on vehicles with code (889) Keyless-Go.	
3	Remove rear center section paneling (1)		AR68.30-P-4785EC
4	Detach left side paneling (2) far enough to enable the sound system amplifier control unit (N40/3) to be removed		AR68.30-P-4600EC

5	Unscrew nuts (3)		
6	Slacken off nut (6) until the bracket (7) is accessible		
7	Unclip clips (8) on bracket (7)		
8	Separate electrical connectors (4)		
9	Disconnect electrical connector with fiber optic cable (5)		
	Notes on avoiding damage to fiber optic cables during repair work	With Media Oriented System Transport (MOST)	AH82.60-P-0001-05AK
10	Remove sound system amplifier control unit (N40/3) with bracket (7)		
11	Remove bracket (7) of sound system amplifier control unit (N40/3)	When replacing bracket (7) or sound system amplifier control unit (N40/3).	
12	Install in the reverse order
