## MODEL 204, 207

## Shown on MODEL 204.0 with CODE 523 (Radio MB Audio 20) and CODE 423 (Automatic 5-speed transmission)

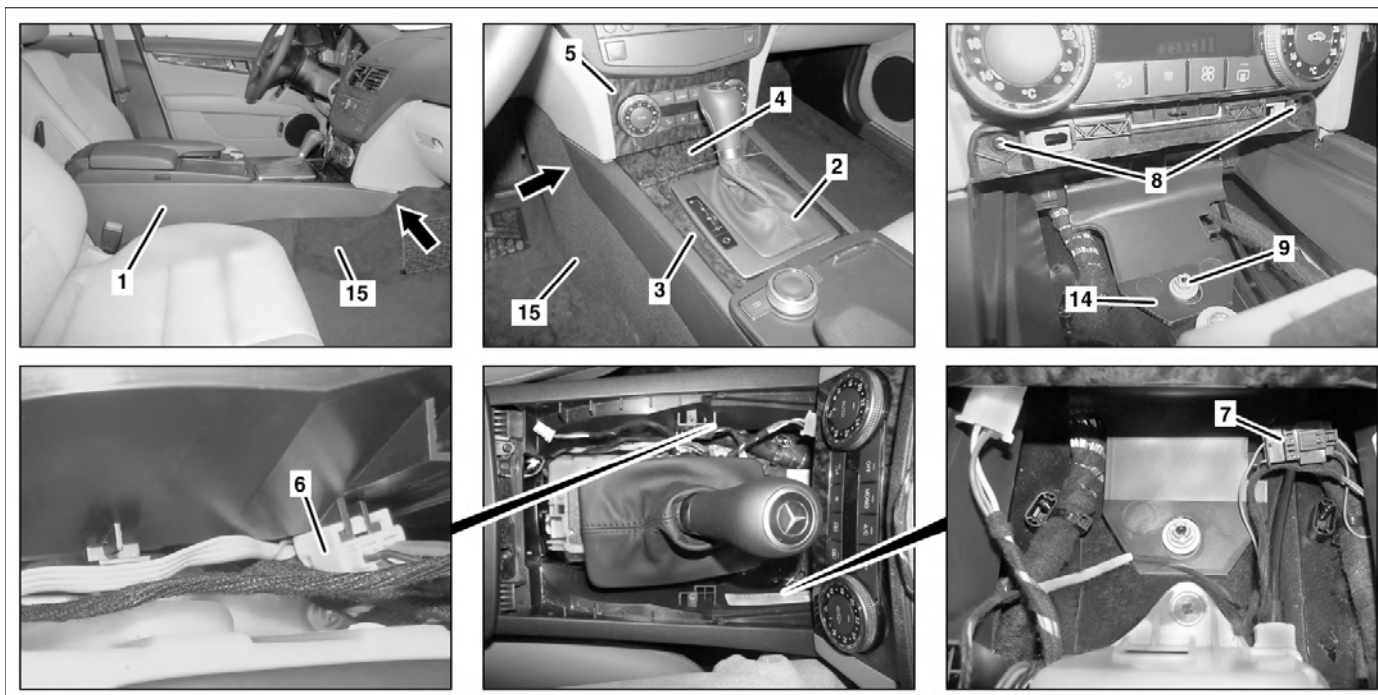
P68.20-3697-09

| 1 | Center console | 5 | Cover | 9 | Nut |
| 2 | Boot (MODEL 204.0/2/3, MODEL 204.9 as of model year 2013 except CODE 427 (Automatic transmission 7G-TRONIC PLUS), MODEL 204.9 up to model year 2013, MODEL 207 as of model year 2014 except CODE 427 (Automatic transmission 7G-TRONIC PLUS), MODEL 207 up to model year 2014) | 6 | Electrical connector (MODEL 204, MODEL 207 up to model year 2014) | 14 | Tab |
| 3 | Cover (MODEL 204.0/2/3, MODEL 204.9 as of model year 2013 except CODE 427 (Automatic transmission 7G-TRONIC PLUS), MODEL 204.9 up to model year 2013, MODEL 207 as of model year 2014 except CODE 427 (Automatic transmission 7G-TRONIC PLUS) except CODE 494 (USA version), MODEL 207 up to model year 2014) | 7 | Electrical connector (MODEL 204.0/2/3, MODEL 204.9 up to model year 2013, MODEL 207 up to model year 2014) | 15 | Floor covering |
| 4 | Stowage box/tray or ashtray (MODEL 204.0/2/3, MODEL 204.9 up to model year 2013, MODEL 207 as of model year 2014 except CODE 427 (Automatic transmission 7G-TRONIC PLUS) except CODE 494 (USA version), MODEL 207 up to model year 2014) | 8 | Bolts | | |

30.1	Lift lug (14) and guide center console (1) toward rear out of instrument panel and remove	MODEL 204.0/2/3 MODEL 204.9 up to model year 2013 <b>i</b> <b>Installation:</b> Insert center console (1) into dashboard from top at an angle. Position floor covering (15) on left and right below center console (1) (arrows). Position electrical lines in center console (1) before tightening nuts (9, 12).

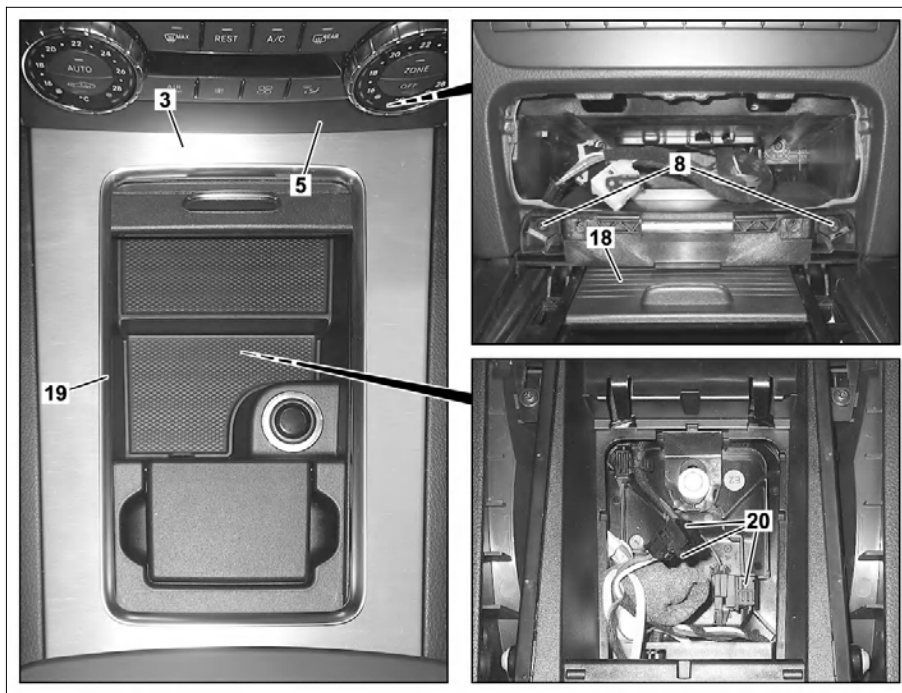
P68.20-4555-06

**Shown on model 204.9 as of model year 2013**

- 3 Cover
- 5 Cover
- 8 Bolts
- 18 Louver (MODEL 204.9 as of model year 2013 with CODE 427 (Automatic transmission 7G-TRONIC PLUS))
- 19 Housing
- 20 Electrical connectors

14	Remove housing (19) and ashtray or stowage box/tray	<p>MODEL 204.9 as of model year 2013</p> <p>

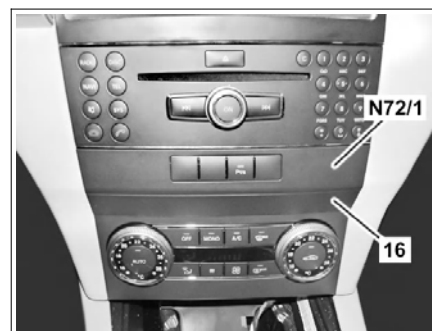
P68.20-4018-01

**Model 204.9 up to model year 2013**

- 16 Cover
- N72/1 Upper control panel control unit

Ashtray or stowage box/tray according to vehicle equipment.</p>	
15	Unclip cover (16) from upper control panel control unit (N72/1)	<p>MODEL 204.9 up to model year 2013</p>

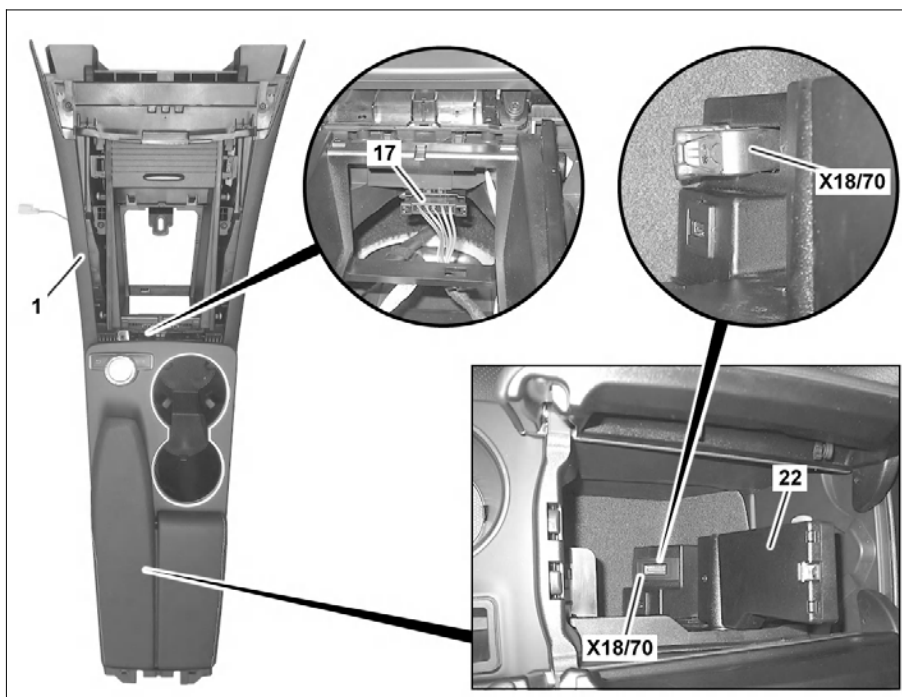
P68.20-4554-06

**Shown on model 204.9 as of model year 2013**

- 1 Center console
- 17 Electrical connector (MODEL 204.9 as of model year 2013, MODEL 207)
- 22 Retaining plate (MODEL 204.9 as of model year 2013 with CODE 386 (Comfort telephony), MODEL 207 as of model year 2012 with CODE 386 (Comfort telephony))
- X18/70 Electrical connector for Media Interface (MODEL 204.9, 207 with CODE 518 (Media Interface))

28	Fold retaining plate (22) upward	MODEL 204.9 up to model year 2013 with CODE 386 (Comfort telephony) MODEL 207 as of model year 2012 up to model year 2014 with CODE 386 (Comfort telephony)	
29	Unclip Media Interface electrical connector (X18/70) and feed through downwards	MODEL 204.9, 207 with CODE 518 (Media interface) <b>i</b> <b>Removal:</b> Media Interface electrical connector (X18/70) remains in vehicle. <b>i</b> <b>Installation:</b> Ensure that Media Interface electrical connector (X18/70) is seated correctly.

30.2	Lift lug (14) and move center console (1) toward rear until electrical connector (17) is accessible	MODEL 204.9 as of model year 2013 MODEL 207	
31	Disconnect electrical connector (17)	MODEL 204.9 as of model year 2013 MODEL 207	
32	Guide out center console (1) and remove	MODEL 204.9 as of model year 2013 MODEL 207 <b>i</b> <b>Installation:</b> Insert center console (1) into dashboard from top at an angle. Position floor covering (15) on left and right below center console (1) (arrows). Position electrical lines in center console (1) before tightening nuts (9, 12).	
33	Install in the reverse order

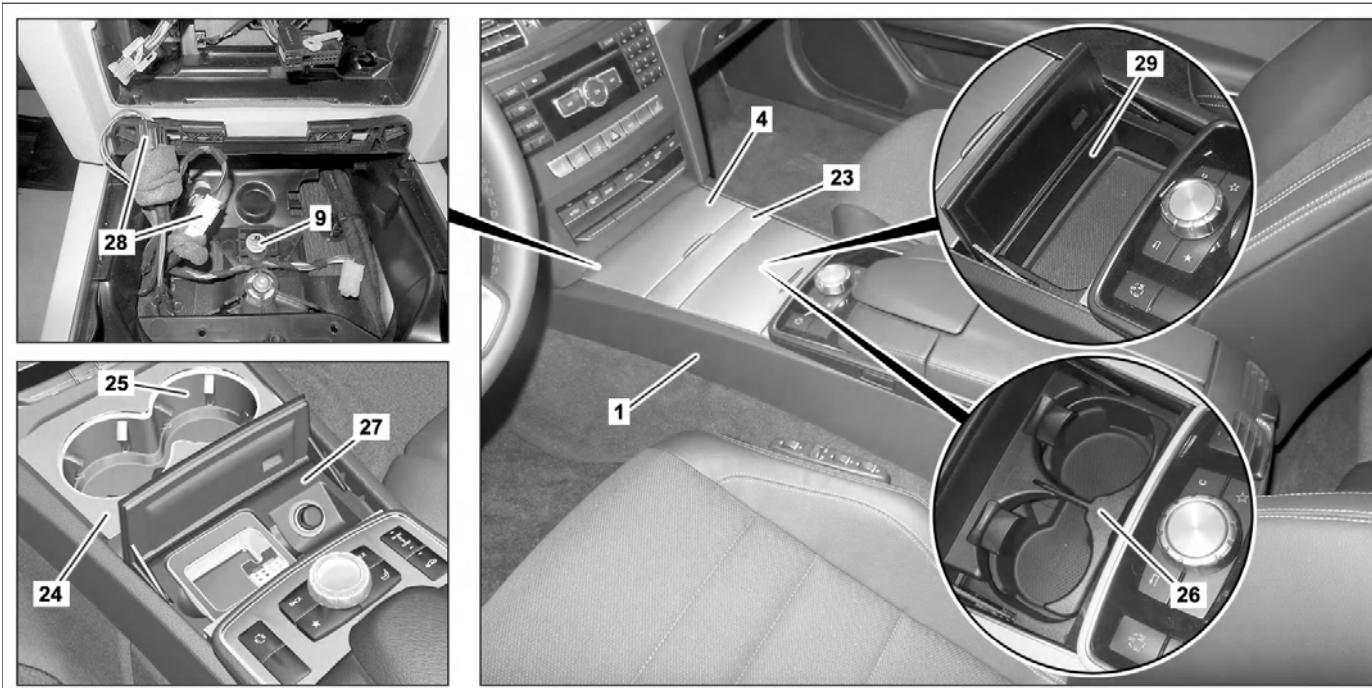
P68.20-4711-09

**Model 207 as of model year 2014**

| 1 | Center console | 24 | Cupholder cover (with CODE 494 (USA version)) | 28 | Electrical connectors |
| 4 | Stowage box/tray or ashtray (without CODE 494 (USA version)) | 25 | Cupholder (with CODE 494 (USA version)) | 29 | Stowage box/tray (with CODE 427 (Automatic transmission 7G-TRONIC PLUS), without CODE 310 (Cupholder), without CODE 494 (USA version)) |
| 9 | Nut | 26 | Cupholder (with CODE 427 (Automatic transmission 7G-TRONIC PLUS) and CODE 310 (Cupholder), without CODE 494 (USA version)) | | |
| 23 | Cover (with CODE 427 (Automatic transmission 7G-TRONIC PLUS), without CODE 494 (USA version)) | 27 | Ashtray (with CODE 494 (USA version)) | | |

Stowage box/tray or ashtray (4) according to equipment.</p>	
6	Unclip cover (3) upward in front area and remove	<p>MODEL 204.0/2/3 MODEL 204.9 as of model year 2013 without CODE 427 (7-speed automatic transmission) MODEL 204.9 up to model year 2013 MODEL 207 as of model year 2014 without CODE 427 (7-speed automatic transmission) MODEL 207 up to model year 2014</p>	
7	Unclip cover (23) toward front by hand and remove	<p>MODEL 207 as of model year 2014 with CODE 427 (7-speed automatic transmission) without CODE 494 (US version)</p>	
8	Unclip and remove cupholder cover (24)	<p>MODEL 207 with CODE 494 (US version)</p>

9	Remove cup holder (25)	<p>MODEL 207 with CODE 494 (US version)</p>	
10	Remove cup holder (26)	<p>MODEL 207 as of model year 2014 with CODE 310 (Cup holder) with CODE 427 (7-speed automatic transmission) without CODE 494 (US version)</p>	
11	Remove stowage tray (29)	<p>MODEL 207 with CODE 427 (7-speed automatic transmission) without CODE 310 (Cup holder) without CODE 494 (US version)</p>	
12	Remove ashtray (27)	<p>MODEL 207 with CODE 494 (US version)</p>	
13	Open stowage box/tray (4) or ashtray	<p>MODEL 204.0/2/3 MODEL 204.9 up to model year 2013 MODEL 207 as of model year 2014 without CODE 494 (US version) MODEL 207 up to model year 2014</p> <p>

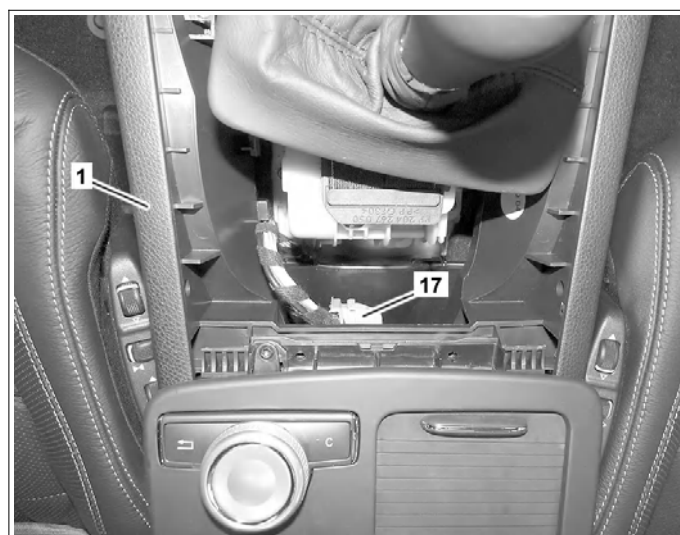
P68.20-4260-11

**Shown on model 207.4**

| 1 | Center console |
| 17 | Electrical connector (MODEL 204.9 as of model year 2013, MODEL 207) |

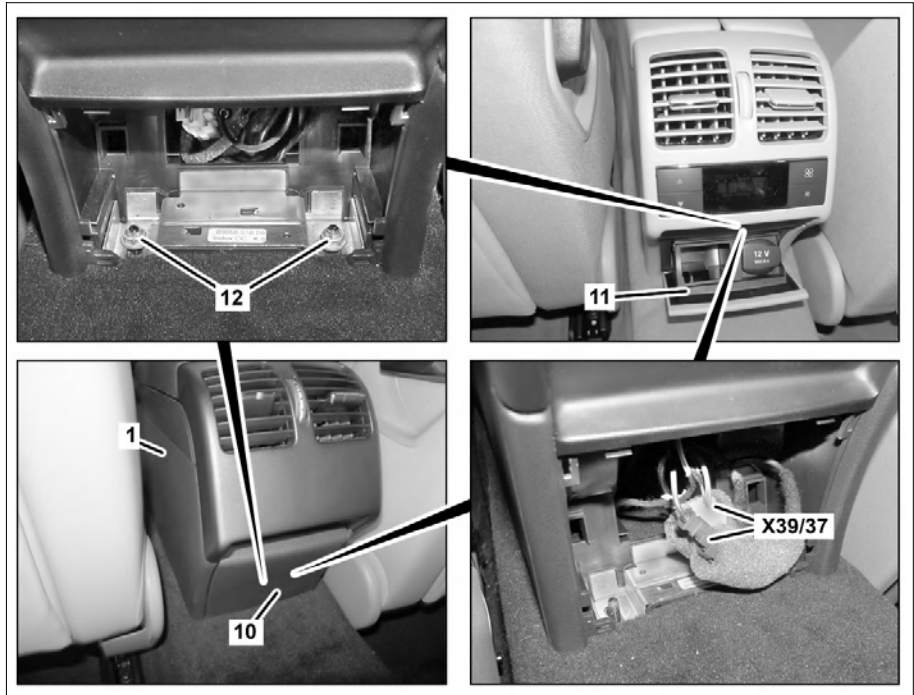
P68.20-3796-06

**Shown on model 204.0**

- 1 Center console
- 10 Cover (without CODE 301 (Ashtray package/smoker package))
- 11 Ashtray (with CODE 301 (Ashtray package/smoker package))
- 12 Nuts
- X39/37 Electrical connector for mobile phone (with code (386) Comfort telephony)

23.1	Unclip cover (10) from center console (1)	MODEL 204, 207 without CODE 301 (Ashtray package/smoker package)	
23.2	Remove ashtray (11)	MODEL 204, 207 with CODE 301 (Ashtray package/smoker package)	AR68.20-P-2230CW
24	Remove DVD player bracket	MODEL 204.9 with CODE 864 (Rear entertainment system)	AR82.60-P-7506CY
25	Unscrew nuts (12)	<b>i</b> <b>Installation:</b> Ensure that center console (1) is installed without tension.	
26	Disconnect electrical connectors from mobile phone (X39/37)	MODEL 204, 207 with CODE 386 (Comfort telephony)	
27	Disconnect separating point for USB electrical connector (X115x1)	MODEL 204.0/2 as of 3/1/11, 204.3/9 with CODE 512 (COMAND APS with DVD changer) MODEL 207 as of 6/1/12 MODEL 207 up to 5/31/12 with CODE 088 (Control code NTG 4.5) with CODE 510 (Audio 20 CD with CD changer) MODEL 207 up to 5/31/12 with CODE 088 (Control code NTG 4.5) with CODE 512 (COMAND APS with DVD changer) MODEL 207 up to 5/31/12 with CODE 088 (Control code NTG 4.5) with CODE 523 (MB Audio 20 radio) MODEL 207 up to 5/31/12 with CODE 088 (Control code NTG 4.5) with CODE 526 (Comand DVD (without navigation)) MODEL 207 up to 5/31/12 with CODE 088 (Control code NTG 4.5) with CODE 527 (COMAND APS) MODEL 207 up to 5/31/12 with CODE 088 (Control code NTG 4.5) with CODE 528 (COMAND with DVD changer)

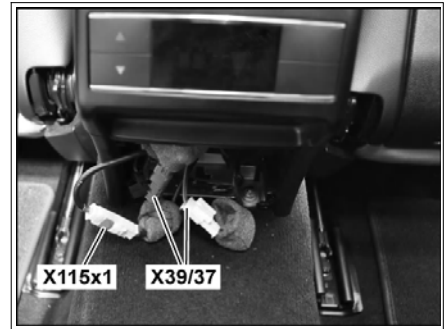
P82.70-7617-01

**Shown on MODEL 207.4 as of 01.06.12 with CODE 386 (Comfort telephony) and with CODE 512 (COMAND APS incl. DVD changer)**

- X39/37 Electrical connector for mobile phone (with code (386) Comfort telephony)
- X115x1 Electrical connector USB (MODEL 204.0/2 as of 01.03.11 with CODE 512 (COMAND APS incl. DVD changer), MODEL 204.3/9 with CODE 512 (COMAND APS incl. DVD changer), MODEL 207 up to 31.05.12 with CODE 088 (control code NTG 4.5) and CODE 510 (Audio 20 CD with CD changer) or CODE 512 (COMAND APS incl. DVD changer) or CODE 523 (Radio MB Audio 20) or CODE 526 (Comand DVD (without Navigation)) or CODE 527 (COMAND APS) or CODE 528 (COMAND incl. DVD changer), MODEL 207 as of 01.06.12)
