MODEL 207, 212, 218

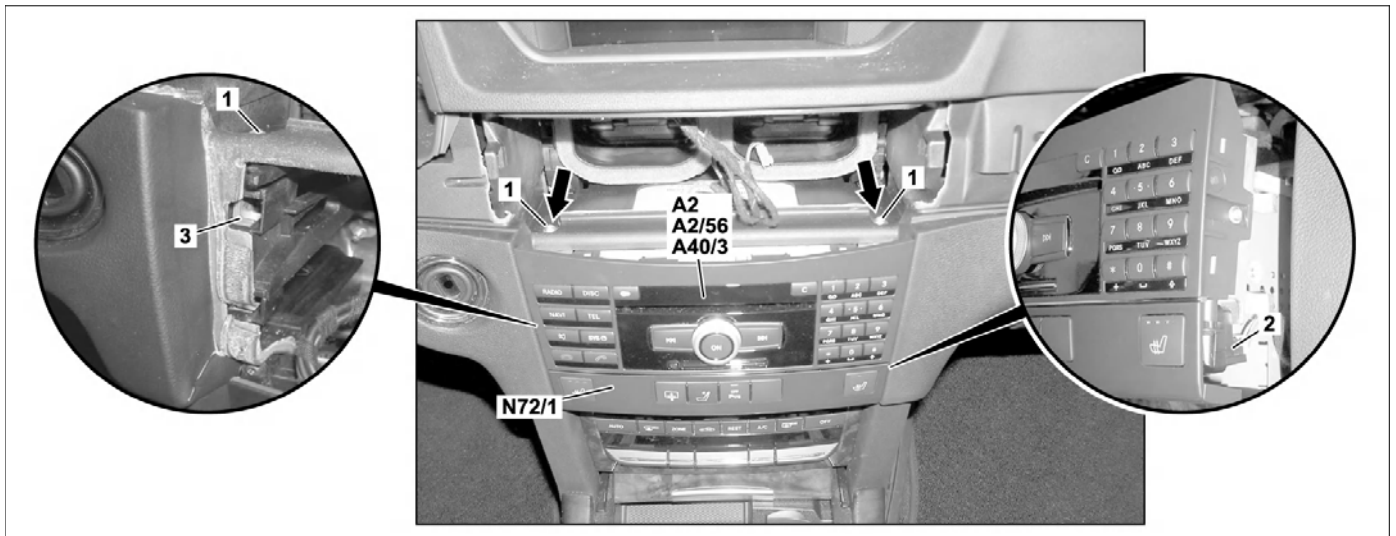
P82.60-7926-08

Shown on model 212 with open lock

1	Screw	A2	Radio (with CODE 505 (Radio 20 NTG5 without navigation capability) or with CODE 510 (Audio 20 with CD changer) or with CODE 522 (Audio 20 radio) or with CODE 523 (MB Audio 20 radio))	N72/1	Upper control panel control unit
2	Electrical connector	A2/56	Radio with auto pilot system (with CODE 511 (Audio 50 APS with DVD changer) or with CODE 525 (MB Audio 50 APS radio))		
3	Lock	A40/3	COMAND controller unit (with CODE 512 (COMAND APS with DVD changer) or with CODE 526 (COMAND (without navigation)) or with CODE 527 (COMAND APS with single DVD drive (with navigation)) or with CODE 528 (COMAND with DVD changer USA (without navigation) or with CODE 531 (COMAND APS))

8	Cover center console with a dry cloth and pull radio (A2) or radio with auto pilot system (A2/56) or COMAND controller unit (A40/3) far enough out of the instrument panel for the electrical connector (2) of the upper control panel control unit (N72/1) to be accessed		
9	Disconnect electrical connector (2) of upper control panel control unit (N72/1)		
10	Pull radio (A2) or radio with auto pilot system (A2/56) or COMAND controller unit (A40/3) far enough out of instrument panel until electrical connectors or optical fiber connector are accessible on the back of the unit		
11	Disconnect electrical connectors and optical fiber connector on back of radio (A2) or radio with auto pilot system (A2/56) or COMAND controller unit (A40/3), unhook retaining clip and remove radio (A2) or radio with auto pilot system (A2/56) or COMAND controller unit (A40/3)		
12	Remove upper control panel control unit (N72/1)	When replacing radio (A2) or radio with auto pilot system (A2/56) or COMAND controller unit (A40/3).	AR54.21-P-1262CY

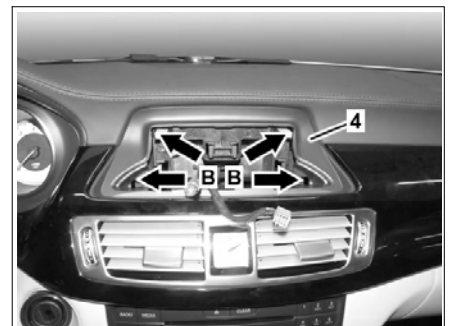
P82.60-9473-01

MODEL 218 as of model year 2015

4 Cover
