MODEL 207, 212, 218

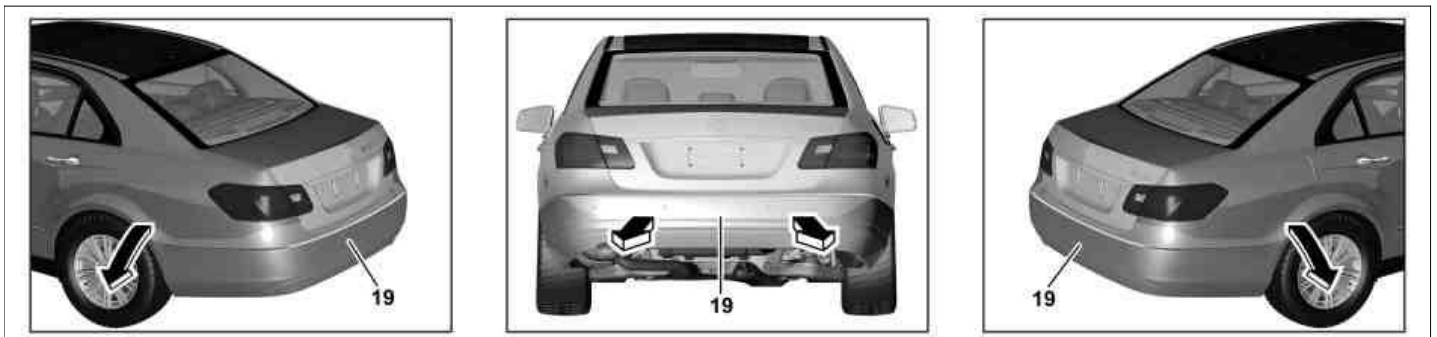
P88.20-3307-07

Shown on model 212.0

19 Rear bumper

20	Remove radar sensors for lane keeping assist in rear bumper	MODEL 207 as of model year 2014 with CODE 238 (Active lane keeping Assist) MODEL 212 as of model year 2014 with CODE 238 (Active lane keeping Assist) MODEL 218 as of model year 2015 with CODE 238 (Active lane keeping Assist) When replacing rear bumper (19).	AR54.71-P-0200ECM
21	Install in the reverse order
