Model 205.4
 Model 238.4

P68.30-3966-09

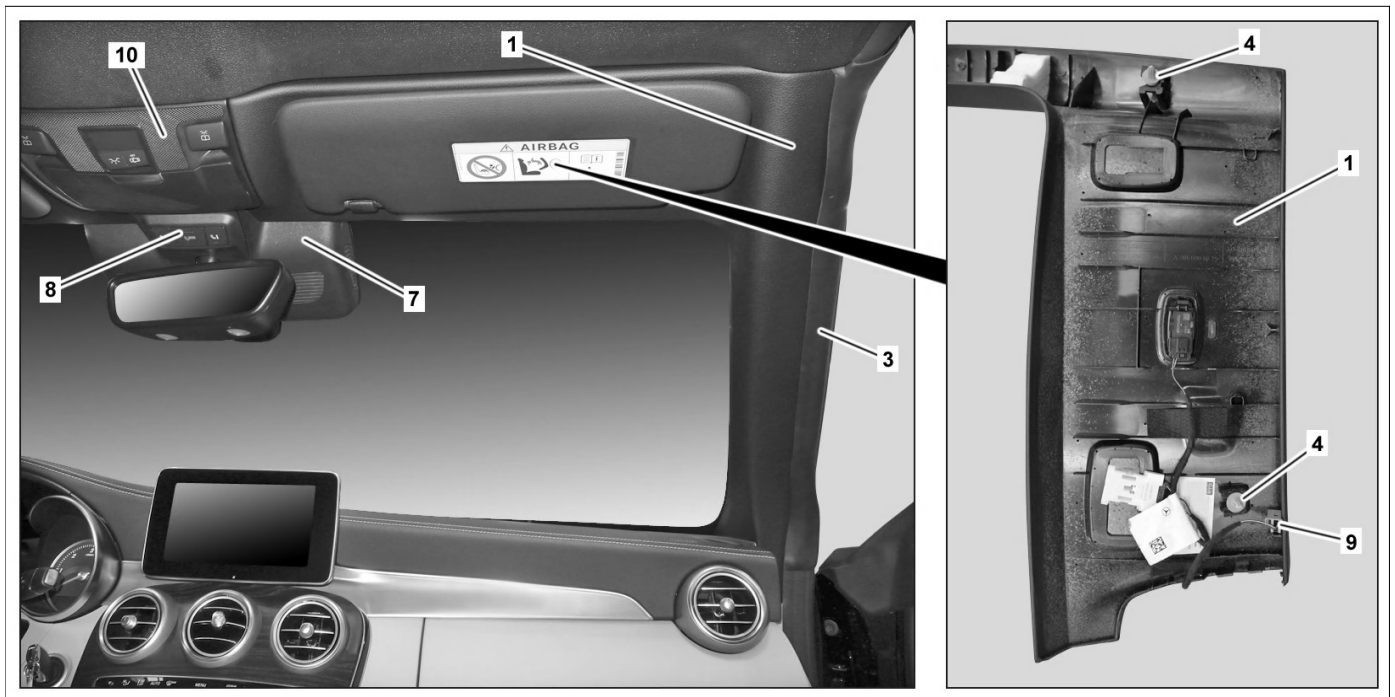
Shown on right side of vehicle, model 205.4

- 1 Detach cover (7).
- 2 Unclip cover (8).
- 6 Model 238.4
 Remove top A-pillar paneling (1) until electrical connector of hands-free system microphone can be disconnected.

| 4 | Detach edge guard (3) in area of A-pillar paneling (1). | 9 | Pull A-pillar paneling (1) towards rear and up out of instrument panel, and remove. |
| 5 | Unclip A-pillar paneling (1) from the retaining clips (4) with long wedge. | | |

| 3 | Remove cover (7). | 7 | Model 238.4

Disconnect electrical connector of hands-free system microphone. |

with code 351 (Emergency call system (HERMES))
It is not necessary to disconnect the electrical connector from the emergency call system button group. | 8 | Model 205.4
with code 876 (Interior Light package)
Model 238.4
Disconnect electrical connector (9) from overhead control panel (10). |

| | Installation: Ensure that edge guard (3) is seated correctly. | 10 | Install in the reverse order. |
