MODEL 211.0

## **Modification notes**

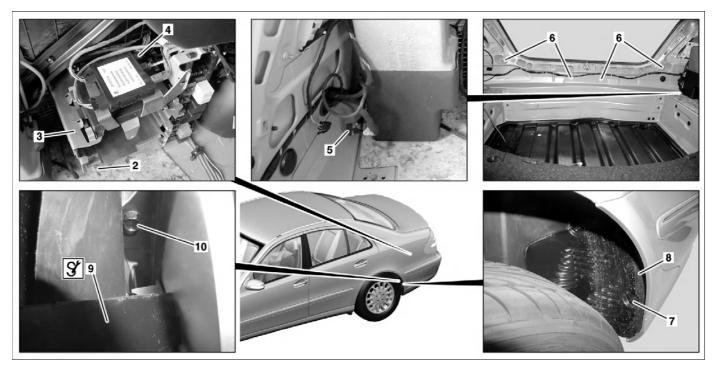
P88.20-2252-09

- 4 Electrical connector (with code (889) Keyless Go)
- 5 Electrical connector (with code (220) Parktronic system (PTS))
- 6 Nuts
- 7 Nut
- 8 Left fender liner

1	Remove trim from rear end center assembly		AR68.30-P-4785T
2	Remove spare tire well paneling		
3	Loosen left and right side paneling in trunk	On vehicles without code (287) Through- loading feature, except CODE (924) Bivalent natural gas drive	AR68.30-P-4800T
		On vehicles with code (287) Through-loading feature.	AR68.30-P-4800TA
4	Separate electrical connectors (4)	On vehicles with code (889) Keyless Go.	
5	Disconnect electrical connectors (5)	On vehicles with code (220) Parktronic system (PTS).	
6	Unscrew nuts (6)		
7	Loosen pressure reservoir with lines connected and lay down to side.	On vehicles with code (489) Airmatic (semi-active air suspension).	
3	Remove bolts (11)		
9	Remove nut (7)		
10	Loosen left inner fender (8) from fender with assembly wedge (9)	i Until screw (10) is accessible.	
		8	*110589035900
11	Unscrew bolt (10)		
12	Unscrew nuts (12)		
13	Loosen right inner fender (13) from fender with assembly wedge (9)	i Until screw (14) is accessible.

8	*110589035900
14	Unscrew bolt (14)		
15	Remove bolts (15)		
16	Remove rear bumper (1)		
17	Install in the reverse order

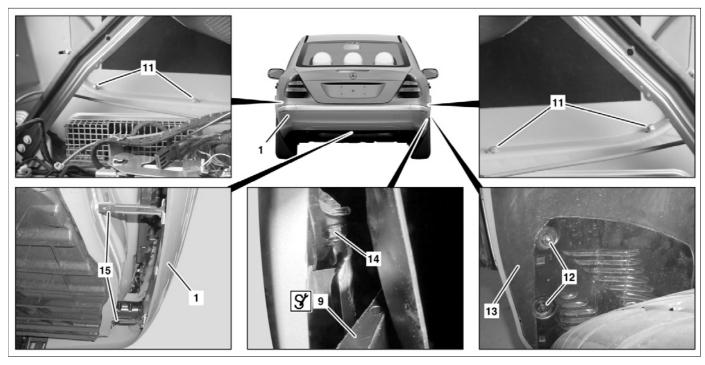
P88.20-2253-09

- 1 Rear bumper
- 9 3 Mounting wedge
- 11 Bolts

- 12 Nuts
- 13 Right fender liner

- 14 Bolt
- 15 Bolts
