P68.30-2485-09

Remove/install		
1	Switch off luggage compartment lamp (E18/1) by locking trunk lid lock with suitable screwdriver	i Installation: Actuate opening handle on outside of trunk lid to unlock trunk lid lock.	
2	Remove warning triangle (2)		
3	Remove hazard warning triangle bracket (4)		
4	Remove expansion rivets (5)		
5	Unscrew screws (6) and remove cover (7)		
6	Remove luggage compartment lamp (E18/1)		
7	Remove trunk lid paneling (1)		
8	Install in the reverse order

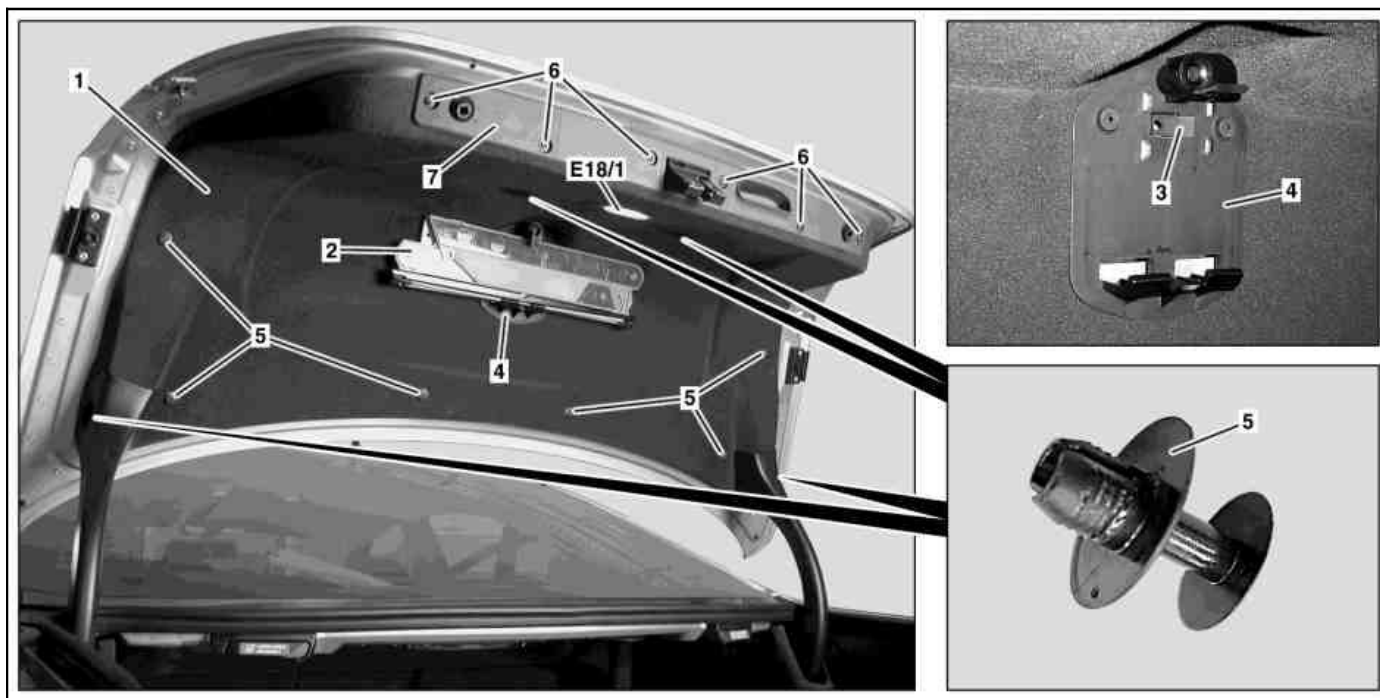
- 1 Trunk lid paneling
 2 Hazard warning triangle
 4 Hazard warning triangle bracket

- 5 Expansion rivets
 6 Bolts
 7 Cover

E18/1 Trunk lamp
