MODEL 211.0
with CODE (433) Left dynamic seat, incl. multicontour seat
with CODE (434) Right dynamic seat, incl. multicontour seat

M40/1 Pneumatic pump for dynamic seat control

P91.25-2360-04

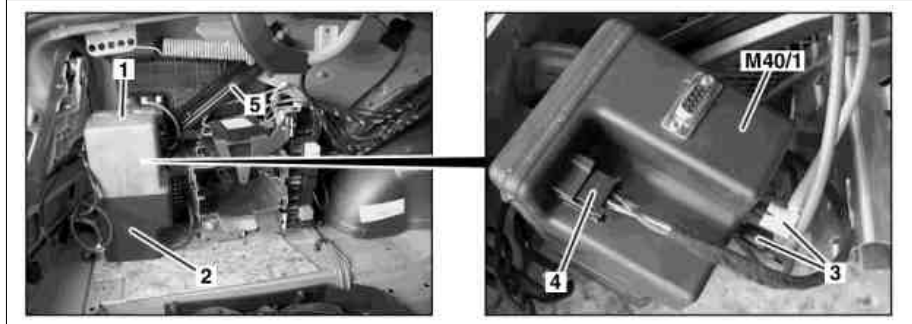
- 1 Soundproofing
- 2 Bracket
- 3 Pneumatic lines
- 4 Electrical connector
- 5 Strut

Remove/install	
	☒ ☒	1	Remove left side trim in trunk	On vehicles without code (287) Through-loading feature and without code (924) Bivalent natural gas drive On vehicles with code (287a) Through-loading feature. On vehicles with code (924) Bivalent natural gas drive AR68.30-P-4800T AR68.30-P-4800TA AR68.30-P-4800TB
		2	Remove pneumatic pump for dynamic seat control (M40/1) together with soundproofing (1) upward out of bracket (2)	
		3	Remove soundproofing (1) from pneumatic pump for dynamic seat control (M40/1)	
		4	Disconnect electrical connector (4)	
		5	Seal off pneumatic lines (3) of pneumatic pump for dynamic seat control (M40/1)	☒ *000589043700
		6	Remove pneumatic pump for dynamic seat control (M40/1)	
		7	Remove strut (5)	Only when installing a new pneumatic pump for dynamic seat control (M40/1), on vehicles up to 31.8.06
		8	Install new pneumatic wiring harness for dynamic seat control pneumatic pump (M40/1)	Only when installing a new pneumatic pump for dynamic seat control (M40/1), on vehicles up to 31.8.06 AR91.25-P-1580-01T

9	Install in the reverse order	
		10	Activate pneumatic pump for dynamic seat control (M40/1) Connect STAR DIAGNOSIS and read out fault memory	After installing new pneumatic pump for dynamic seat control (M40/1). AD00.00-P-2000-04A
	☒ AD	11	Carry out function check
